International Aero Engines

Subject: Transmittal of Revision 1 to Service Bulletin V2500-ENG-72-0347.

# V2500-ENG-72-0347

ENGINE - HP COMPRESSOR DISKS (STAGES 9-12) - INTRODUCTION OF REVISED HP  
COMPRESSOR STAGE 9-12 DISK ASSEMBLY WITH INCREASED ABRASIVE LINING BOND  
COAT THICKNESS

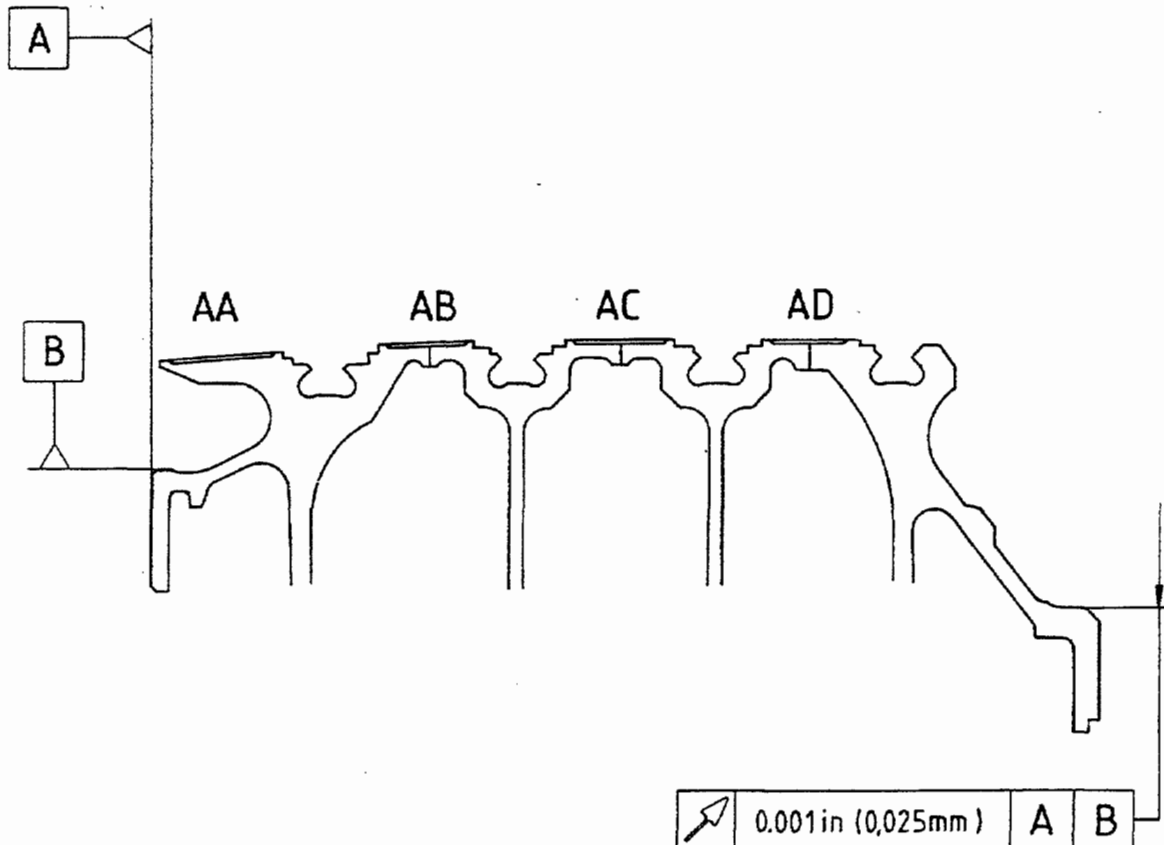
Repair details and dimensions - (A1 Engine only)

See Figure 1  
Use CoMat 02-001 masking tape  
or Refer to operation 3. A.  
for approved vendor tools

See Figure 1.  
Refer to SPM  
TASK 70-12-02-120-501  
Use CoMat 05-001 abrasive  
with abrasive blast equipment

See Figure 1  
Use CoMat 02-001 masking tape.  
Alternatively refer to operation 3. A.  
for approved vendor tools

See Figure 1, 5, 6 and 9  
Refer to SPM TASK 70-34-01-340-501  
SUBTASK 70-34-01-340-007  
Use CoMat 03-037 metal spray powder or  
CoMat 03-416 metal spray powder  
with metal spraying equipment.  
Apply a thickness of 0.008 to 0.010in.(0,203 to  
0,254mm.)

See Figure 1, 5, 6 and 9  
Refer to SPM  
TASK 70-34-01-340-501  
SUBTASK 70-34-01-340-013  
Use CoMat 03-043 metal spray powder  
with metal spraying equipment  
Apply a layer of sufficient  
thickness to get the correct  
dimensions after assembly is  
machined

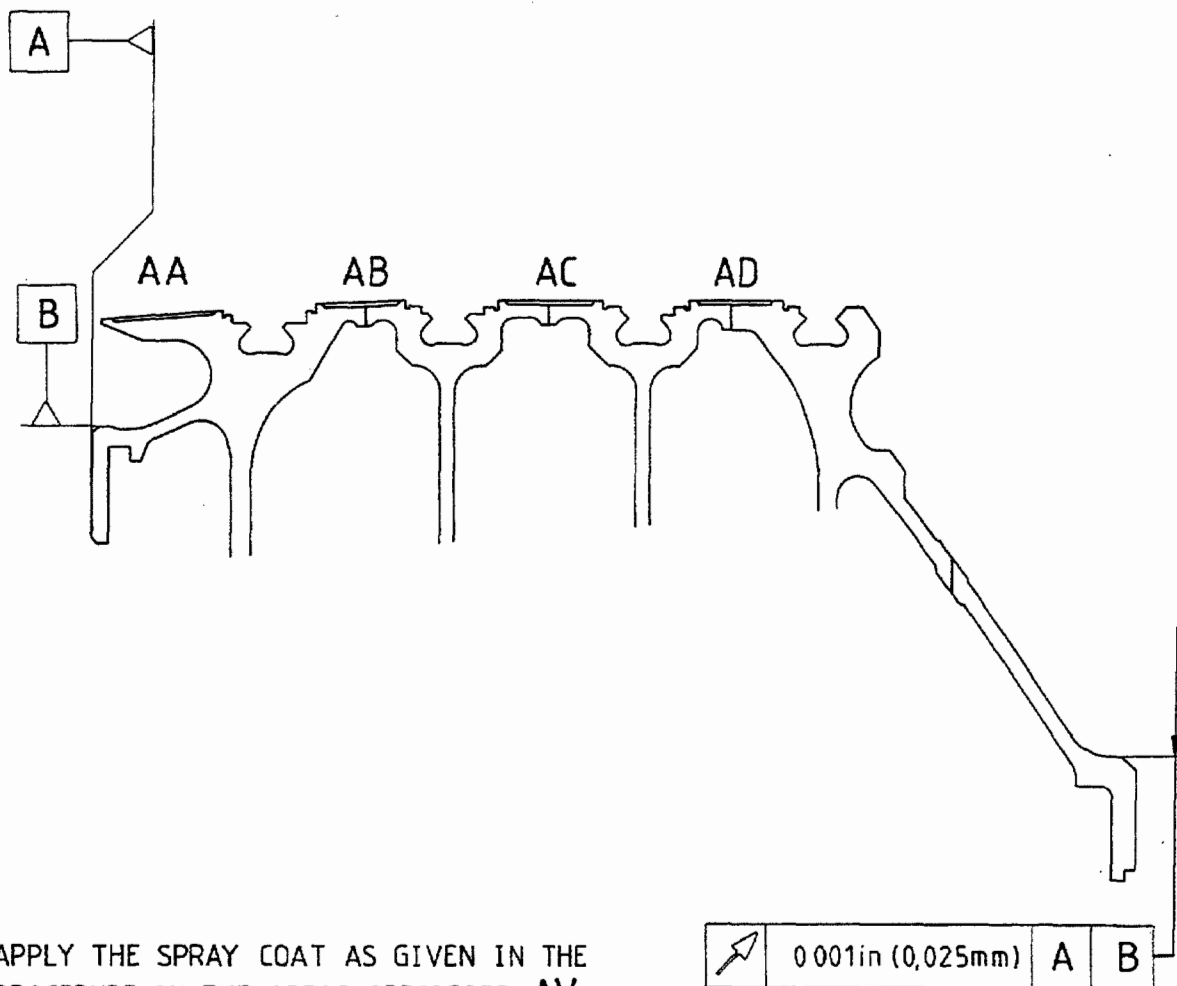
Repair details and dimensions - (A5/D5 Engines only)

See Figure 2  
Use CoMat 02-001 masking tape  
or Refer to operation 3. A.  
for approved vendor tools

See Figure 2  
Refer to SPM TASK 70-12-02-120-501  
Use CoMat 05-001 abrasive with abrasive blast equipment

See Figure 2

See Figure 2, 7, 8 and 9

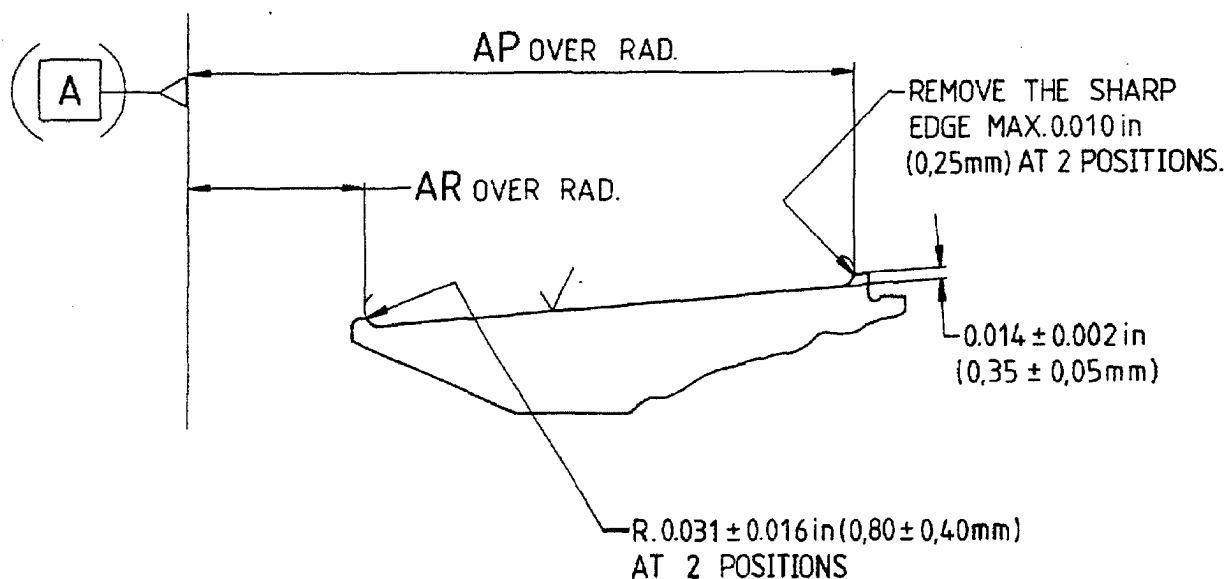
Repair details and dimensions - (All Marks)  
Figure 3

See Figure 3 and Figure 4  
Use standard workshop tools.  
The depth of the groove must not be  
more than 0.016in. (0,40mm.)

See Figure 1 and Figure 3  
Refer to SPM TASK 70-33-59-300-503  
Use CoMat 01-025 nitric acid HNO<sub>3</sub>  
with chemical cleaning equipment.  
Put the assembly into nitric acid  
solution and keep below surface  
until bubbles stop

See Figure 3 and Figure 4  
Make sure all the lining material  
has been removed. If not do operation (b)  
and operation (c) again as necessary

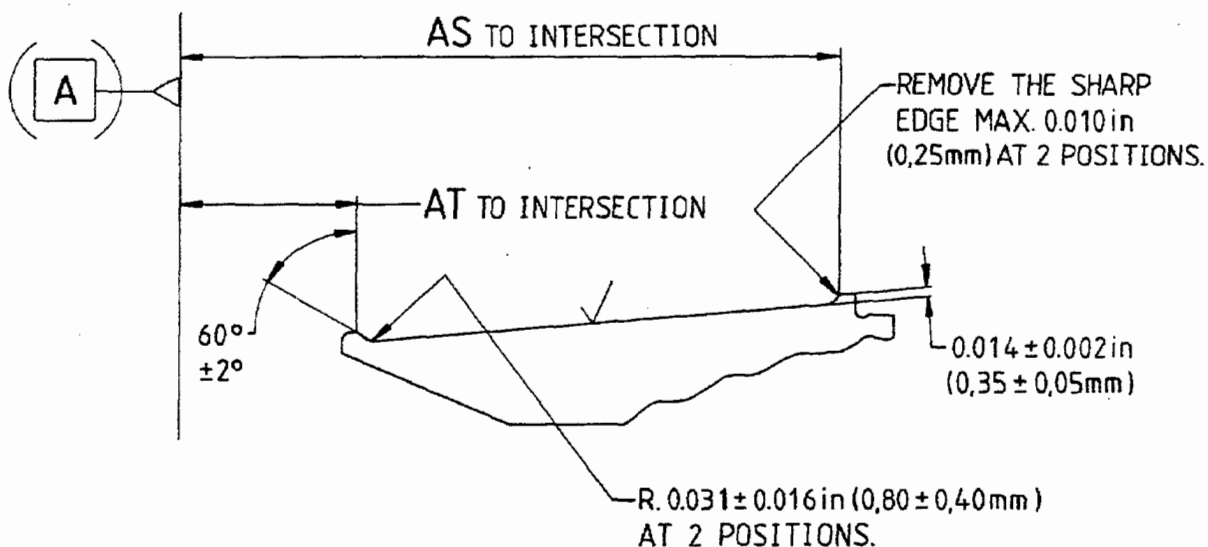
Repair details and dimensions - (All Marks)

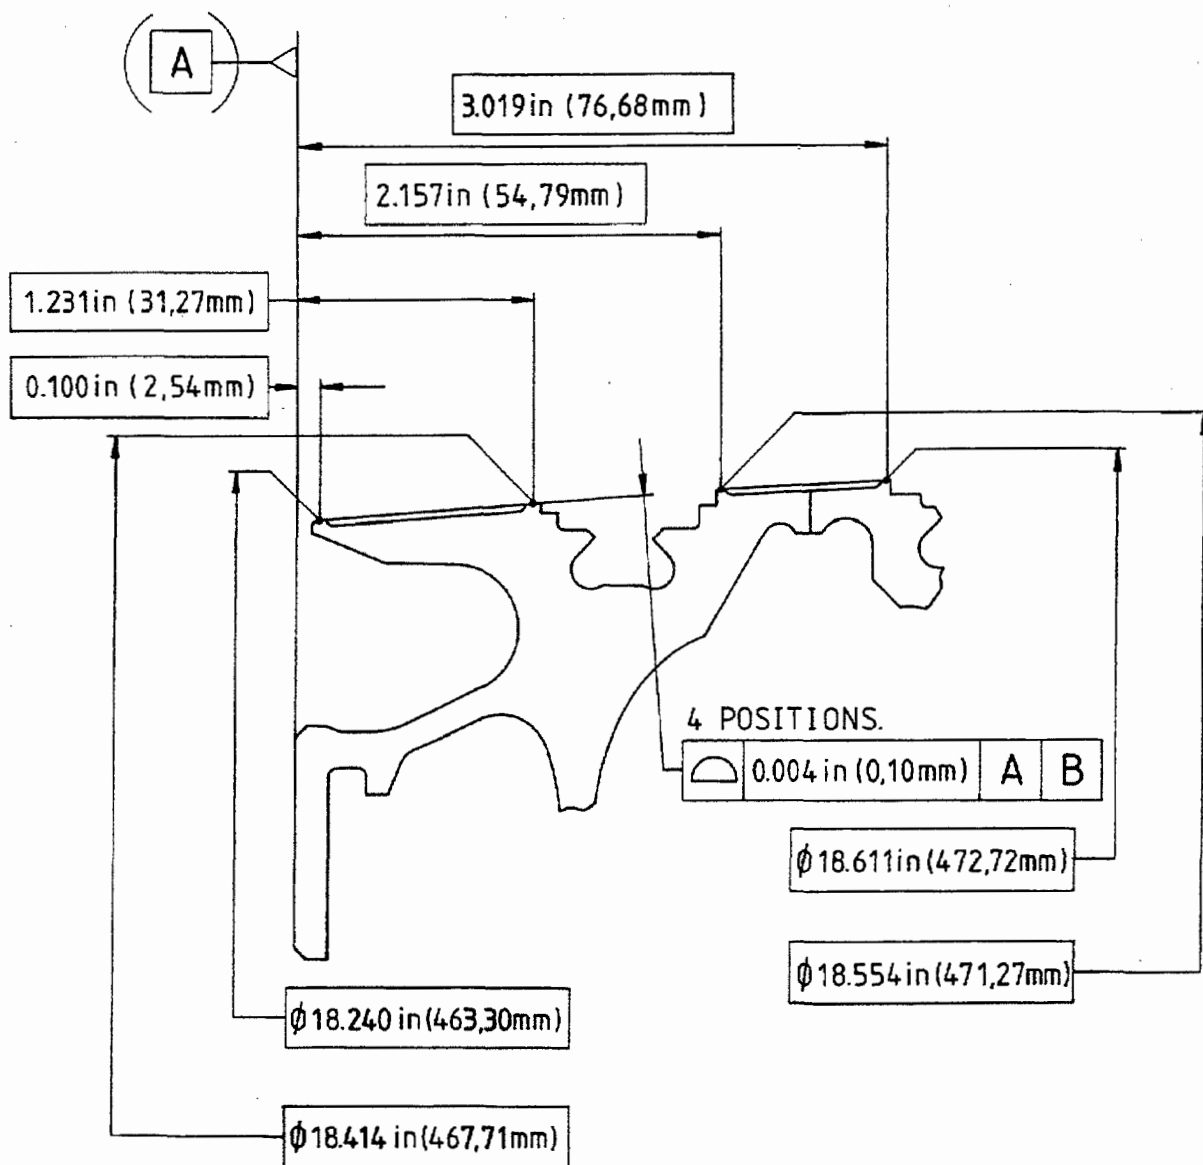
Repair details and dimensions - (A1 Engine only)
