International Aero Engines

SERVICE BULLETIN

ENGINE - ACTUATING MECHANISM HP COMPRESSOR VARIABLE VANES - INTRODUCTION OF STAGE-4 AND 5 VSV BRIDGE-PIECE ASSEMBLIES WITH REVISED METHOD OF MANUFACTURE

V2500-ENG-72-0348

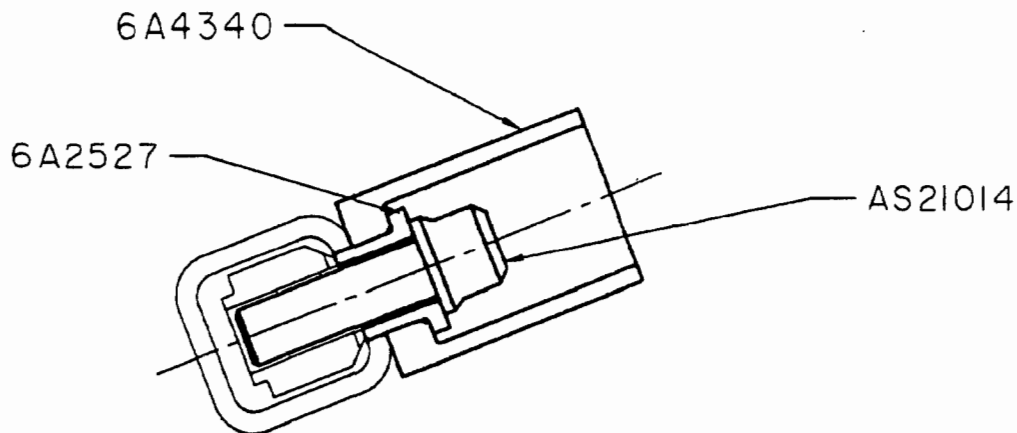
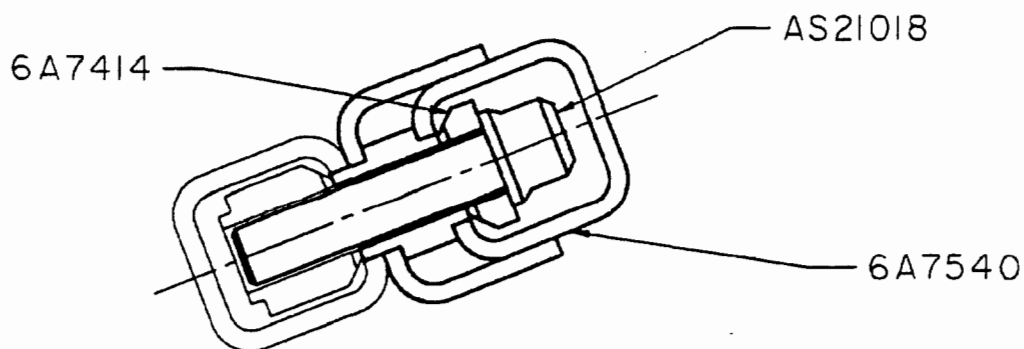
Figure 1 - Sheet 2
View of section AD - Before and after alteration

- (a) The central section of the bridge assembly is extended to overlap the ends of the unison rings.
- (b) The two machined end pieces are replaced by U-Section channels which are fillet welded to the central section.
- (c) To position the bridge-piece assembly radially and to provide spigot location on the unison rings, four integral spacers are introduced.
- (d) To attach the bridge-piece to the unison ring, a revised bolt with an increase in length is introduced on each stage.
- (e) The dowel under the bolt head is deleted.
- (f) An additional washer is introduced between the bolt head and the spacer.

SECTION AD
TYP.4 POS MARKED AE
PRIOR TO ALTERATION

SECTION AD
TYP.4 POS MARKED AE
AFTER ALTERATION

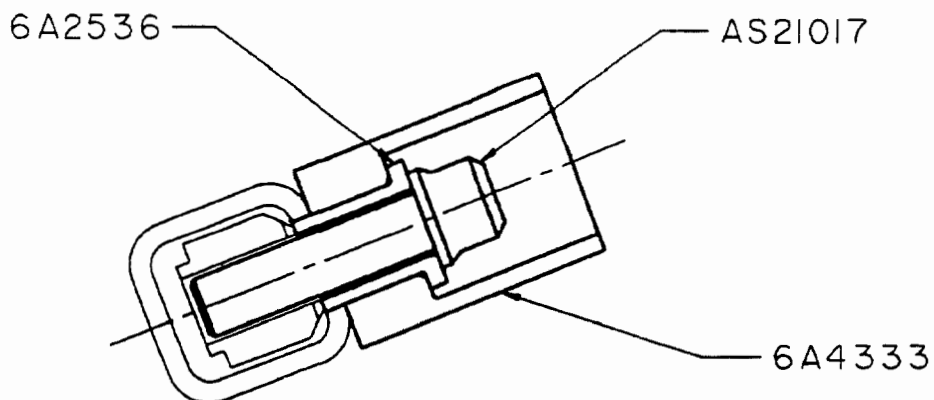
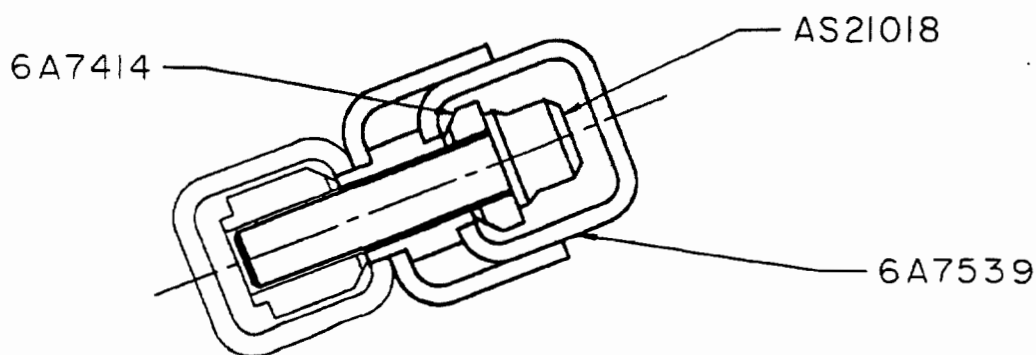
Figure 2 - Sheet 2
View of section AB - Before and after alteration

SECTION AB
TYP.4 POS MARKED AC
PRIOR TO ALTERATION

SECTION AB
TYP.4 POS MARKED AC
AFTER ALTERATION
