International Aero Engines

SERVICE BULLETIN

ENGINE - L. P. COMPRESSOR - INTRODUCTION OF NEW HIGH TENSION BOLT FOR
NO.2 BEARING SUPPORT FLANGE

V2500-ENG-72-0350

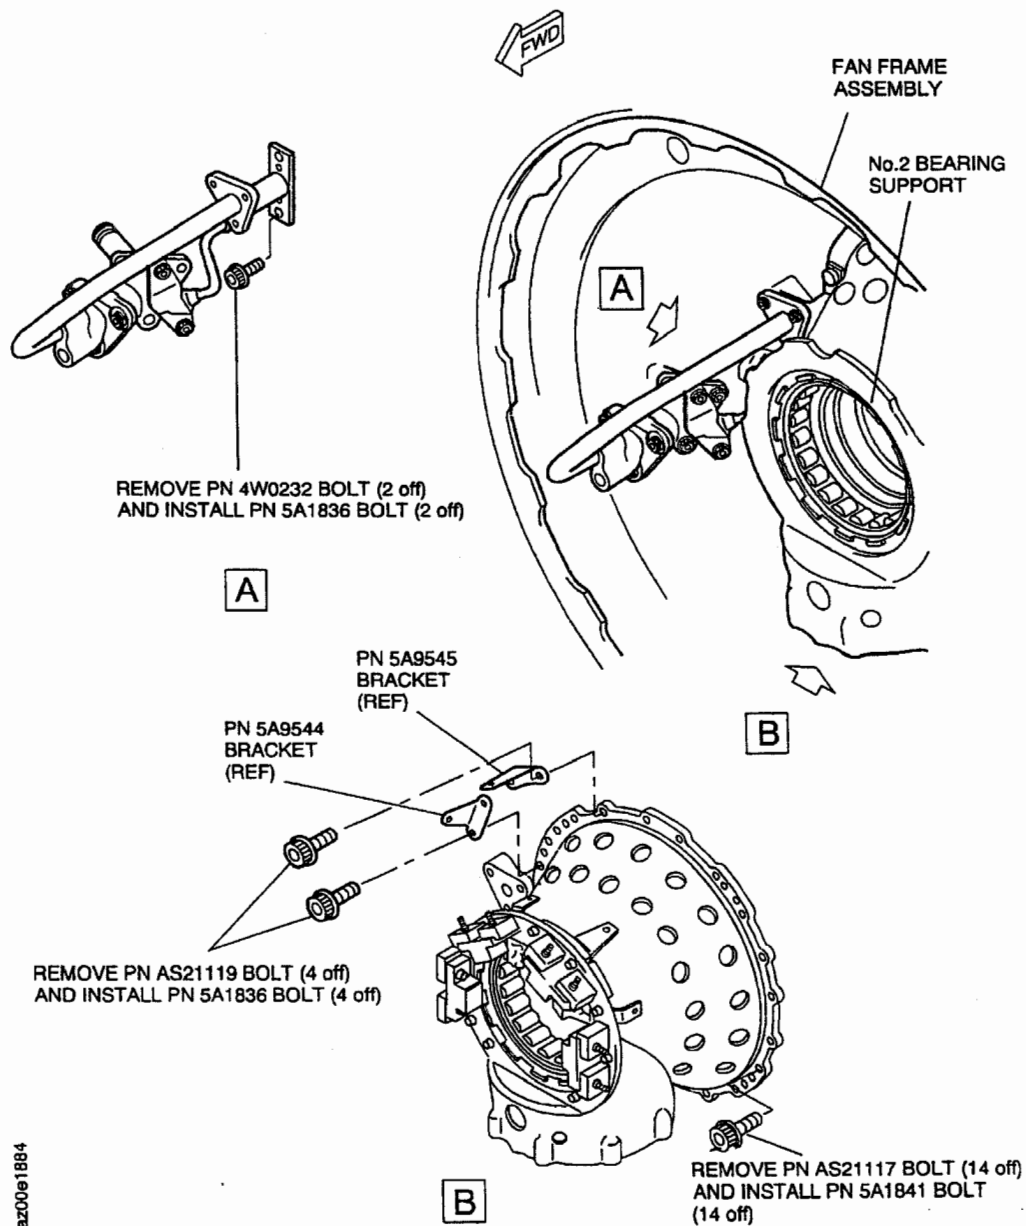
The extension of bolts that join the No.2 bearing support and the Fan Frame was experienced on V2500-A1, V2500-A5 and V2500-D5 engines that had a fan blade-off.

Analysis shows that the fan blade-off load causes the extension of the bolt.

Location of the bolts that connect the No.2 Bearing Support to the Fan Frame for V2500-A1 and V2500-A5
Figure 1

The material of bolts that connect the No.2 Bearing Support to the Fan Frame has been changed from steel to nickel alloy.

Install new 5A1836 bolt (6 off) and new 5A1841 bolt (14 off) to the No.2 Bearing Support Assembly by the procedure given in reference (1), Engine Manual (E-V2500-1IA), 72-30-00, Assembly-03 and Assembly-04.

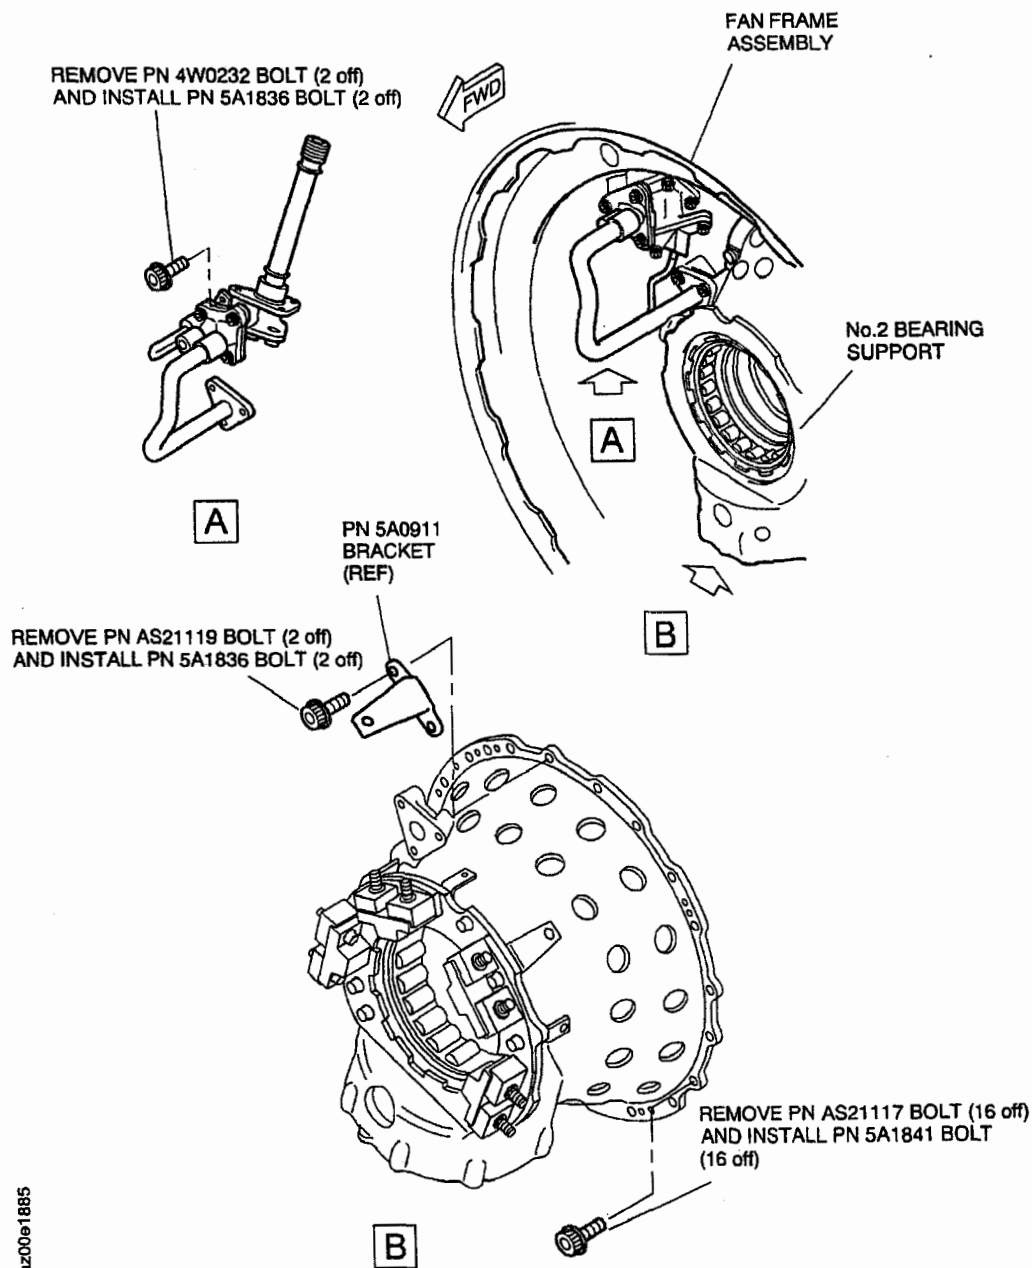
Figure 2

Location of the bolts that connect the No.2 Bearing Support to the Fan Frame for V2500-D5

Install new 5A1836 bolt (4 off) and new 5A1841 bolt (16 off) to the No.2 Bearing Support Assembly by the procedure given in reference (2), Engine Manual (E-V2500-3IA), 72-30-00, Assembly-03 and Assembly-04.
