## V2500-A1 SERIES PROPULSION SYSTEMS SERVICE BULLETIN

This document transmits Revision 4 to Service Bulletin EV2500-72-0351

# V2500-ENG-72-0351

ENGINE - HP TURBINE ROTOR AND STATOR ASSEMBLY - INTRODUCE A NEW FIRST STAGE TURBINE  
AIR SEAL

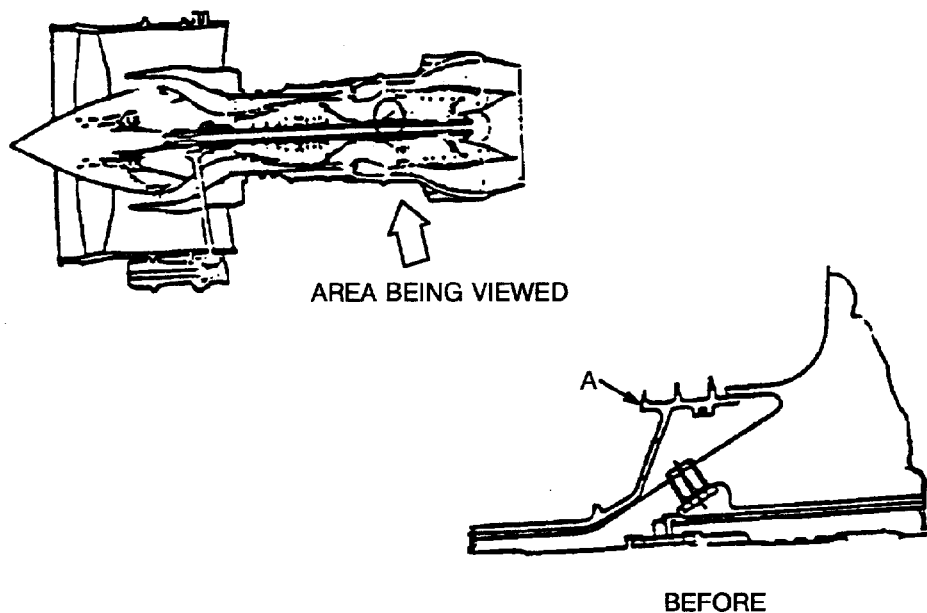
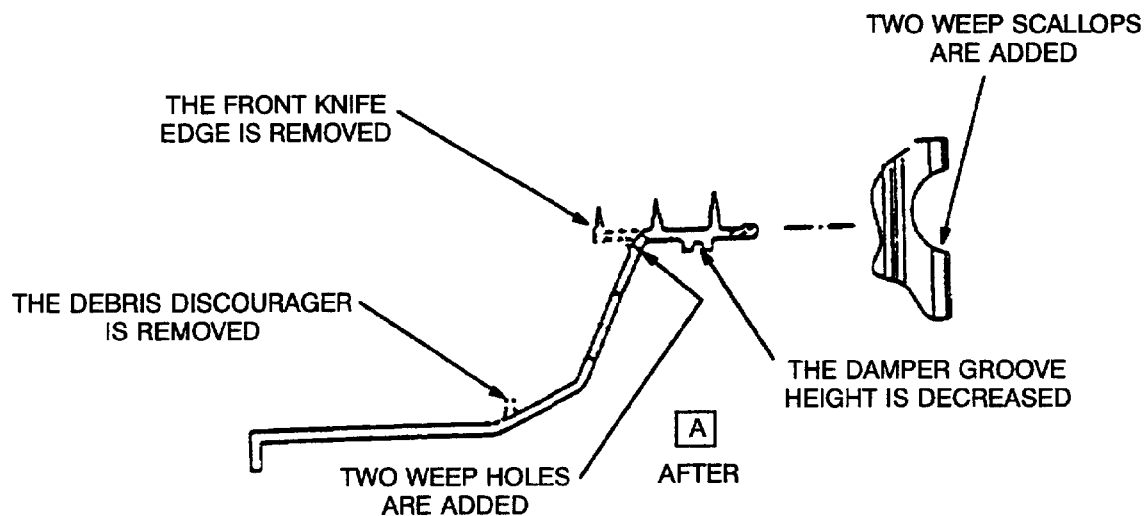
Before and After views of configuration changes that effect the High Pressure Turbine Rotor and Stator Assembly  
Figure 1

Under certain engine windmill operating conditions, engine oil can flood the No.4 bearing compartment, leak out and accumulate in the area of the HPT Stage 1 inner rotating air seal. Subsequent engine operation can ignite the accumulated oil and result in heat distress to the surrounding hardware.

The No.4 bearing compartment has reduced scavenging capability during engine windmilling operation. Under certain windmilling conditions, engine oil can flood and leak from the No.4 bearing compartment and accumulate in the area of the HPT Stage 1 inner rotating air seal.

- (1) Improve the features of the air seal so that more of the unwanted oil will drain from the area between the air seal and Stage 1 Hub. See Figure 1.
- (2) For the effect on declared life, the Time Limits Manual, 5-10-01, Group A Parts Lives will be updated to include the following:

Modify the HPT Stage 1 inner rotating air seal by providing a drain capacity that will allow any accumulated engine oil to drain away from the HPT area, eliminating the possibility of oil ignition and associated hardware distress.
