### V2500-A1 SERIES PROPULSION SYSTEMS SERVICE BULLETIN

## V2500-ENG-72-0353

### MODIFICATION SERVICE BULLETIN - ENGINE - LP COMPRESSOR - INTRODUCTION OF REVISED RETAINING SPIRAL RING

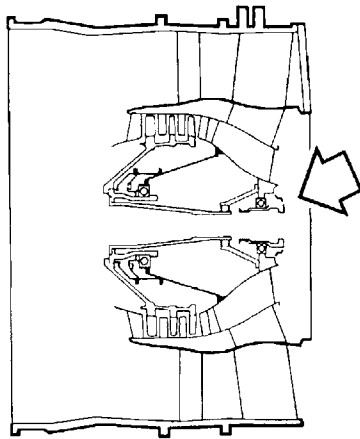
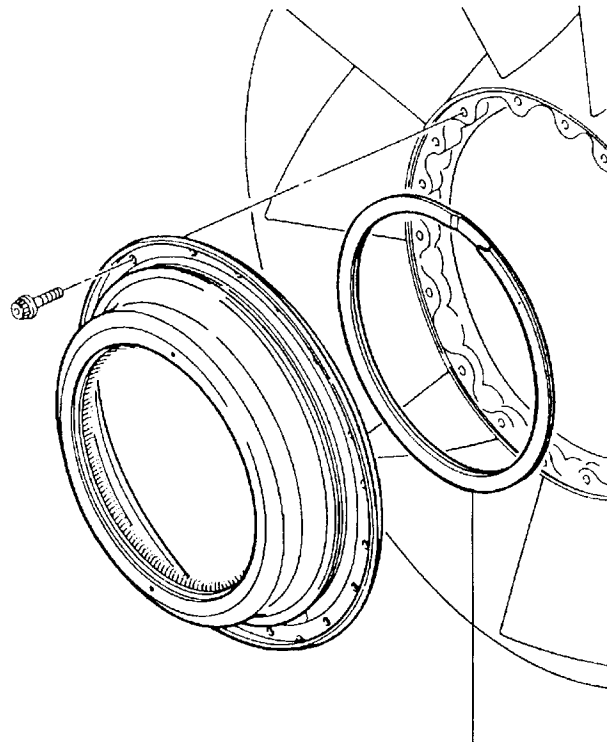
Location of the Retaining Spiral Ring  
Figure 1

INSTALL THE 5R0287 RETAINING  
SPIRAL RING(1 off)

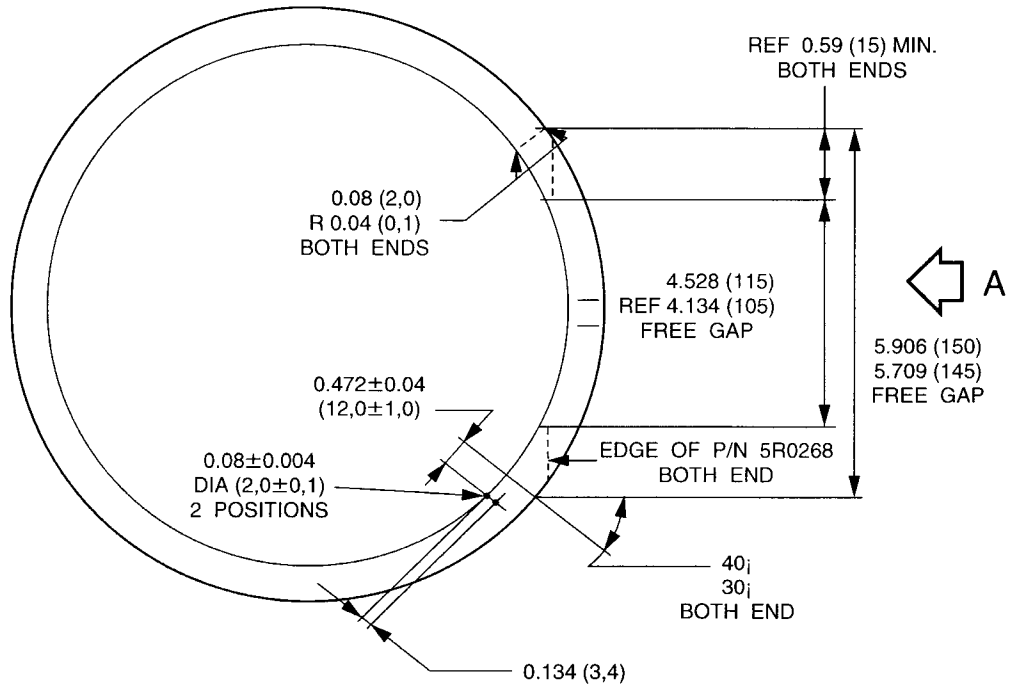
View of rework of the Retaining Spiral Ring  
 Figure 2

The retaining spiral ring is not easy to remove. The surface damage of the retaining ring is caused by the removal steps of the retaining spiral ring from the FBC rear air seal assembly.

- (1) Rework the retaining spiral ring as follows (Refer to Figure 2):
  - (a) Cut the edges with standard work shop equipment take care not to damage the other surface, (if necessary, P/N 5R0268 only).

- (b) Drill the holes in the areas shown with the drilling machine and standard work shop equipment.
  - (c) Remove any sharp edges with standard work shop equipment.

- (d) Do a local penetrant crack test on the rework area with CoMat 06-022 fluorescent penetrant and penetrant inspection equipment, refer to SPM TASK 70-23-05-230-501.

- (e) Visually examine and measure the dimensions of the reworked areas.
  - (f) Delete current part number (P/N 5R0056 or 5R0268) with a single line and renumber with new part number (P/N 5R0287) adjacent to existing part number by vibrating marking pencil.

- (g) Apply the dry film lubricant with CoMat 10-005 colloidal molybdenum disulphide in toluene, refer to SPM TASK 70-38-03-380-501.
