International Aero Engines SERVICE BULLETIN

ENGINE - MAIN GEARBOX ASSEMBLY - PROVIDE A NEW VSCF
SHAFT PLUG ASSEMBLY

Jul.19/99

V2500-ENG-72-0355

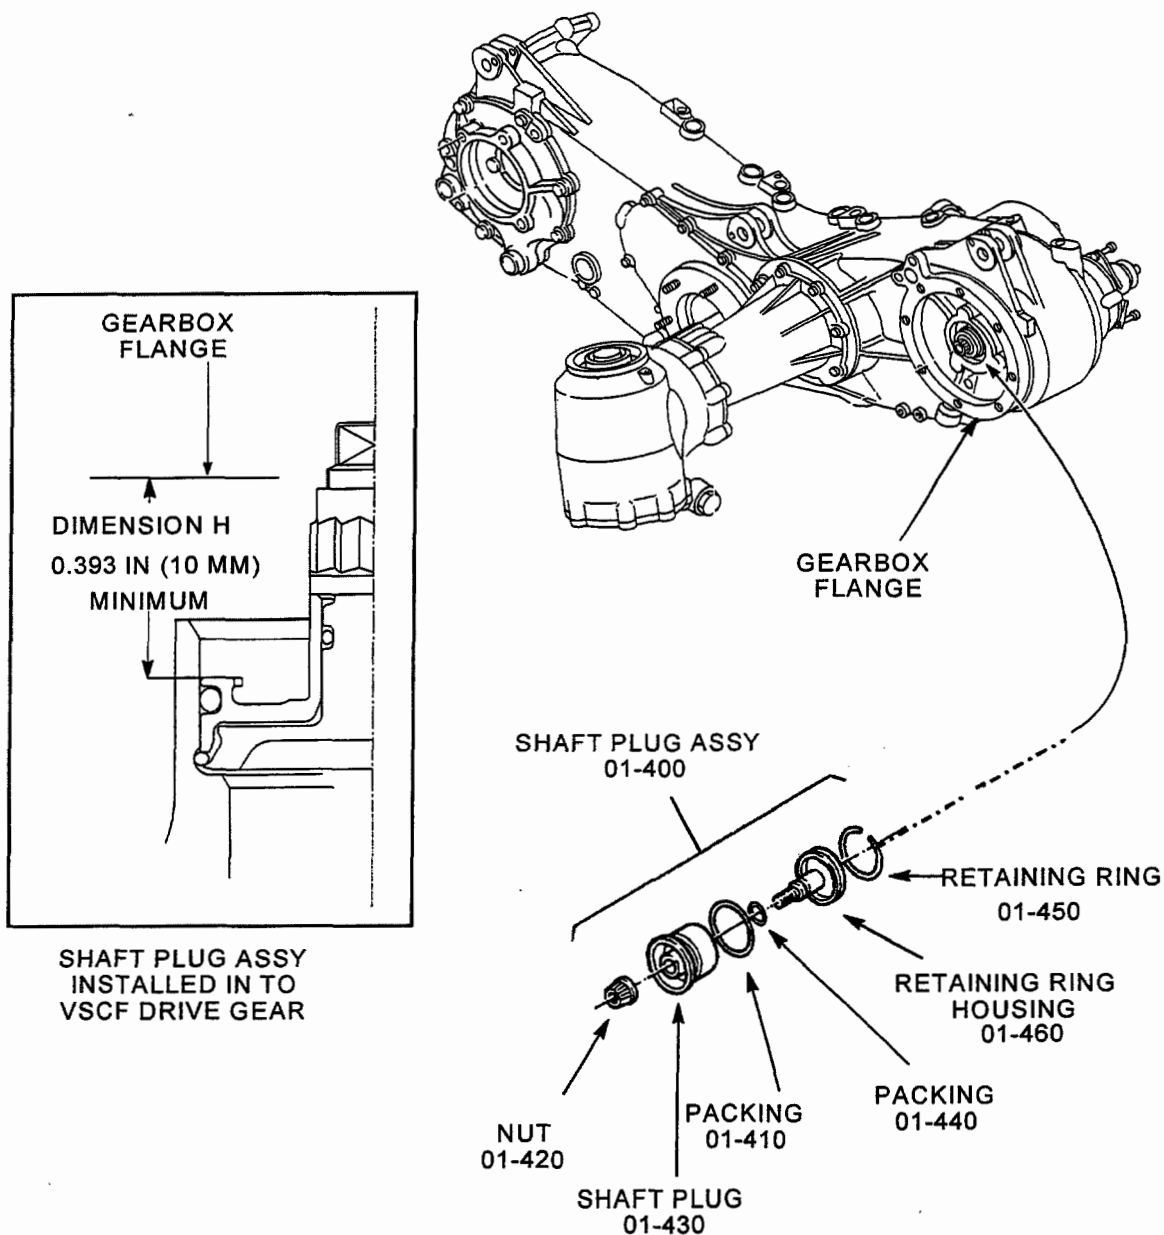
Installation of VSCF shaft plug assy
Figure 1

For the management of VSCF problems in service, it is desirable to perform return flights to main maintenance stations with inoperative failed VSCF's. This condition can be achieved by removal of the VSCF input shaft, but requires installation of a plug assembly in to the VSCF drive gear to prevent oil leakage from gearbox. This requirement has been done issuing SBE-72-0232. During flights with inoperative failed VSCF interference between the plug and the VSCF bearing nut took place several times.

To introduce a revised plug assembly which eliminates the interference condition

- (1) Make sure that proper packings are installed on the retaining ring housing and on the shaft plug. See Figure 1.
- (2) Tighten the nut until the mating faces of the nut, shaft plug, retaining ring and retaining housing touch. Make sure that the retaining ring is evenly seated between the retaining ring housing and the shaft plug.

- (7) To avoid the interference between the VSCF bearing nut and the plug shaft check the dimension H between the shaft plug and the gearbox flange. The dimension H must be 0.393in. (10 mm) minimum. Refer to Figure 1. In addition, as alternative procedure, you can check the dimension between the shaft plug and the external flange of the QAD adaptor P/N 1B193-1. This dimension must be 0.730in. (18,5 mm) minimum.
