IAE Propulsion System NON-MODIFICATION SERVICE BULLETIN

Subject: Transmittal of Revision 3 to Service Bulletin
No.V2500-ENG-72-0356

ENGINE - LP COMPRESSOR- INSPECTION CHECK OF INSTALLED ANNULUS FILLERS
(NON-MODIFICATION)

V2500-ENG-72-0356

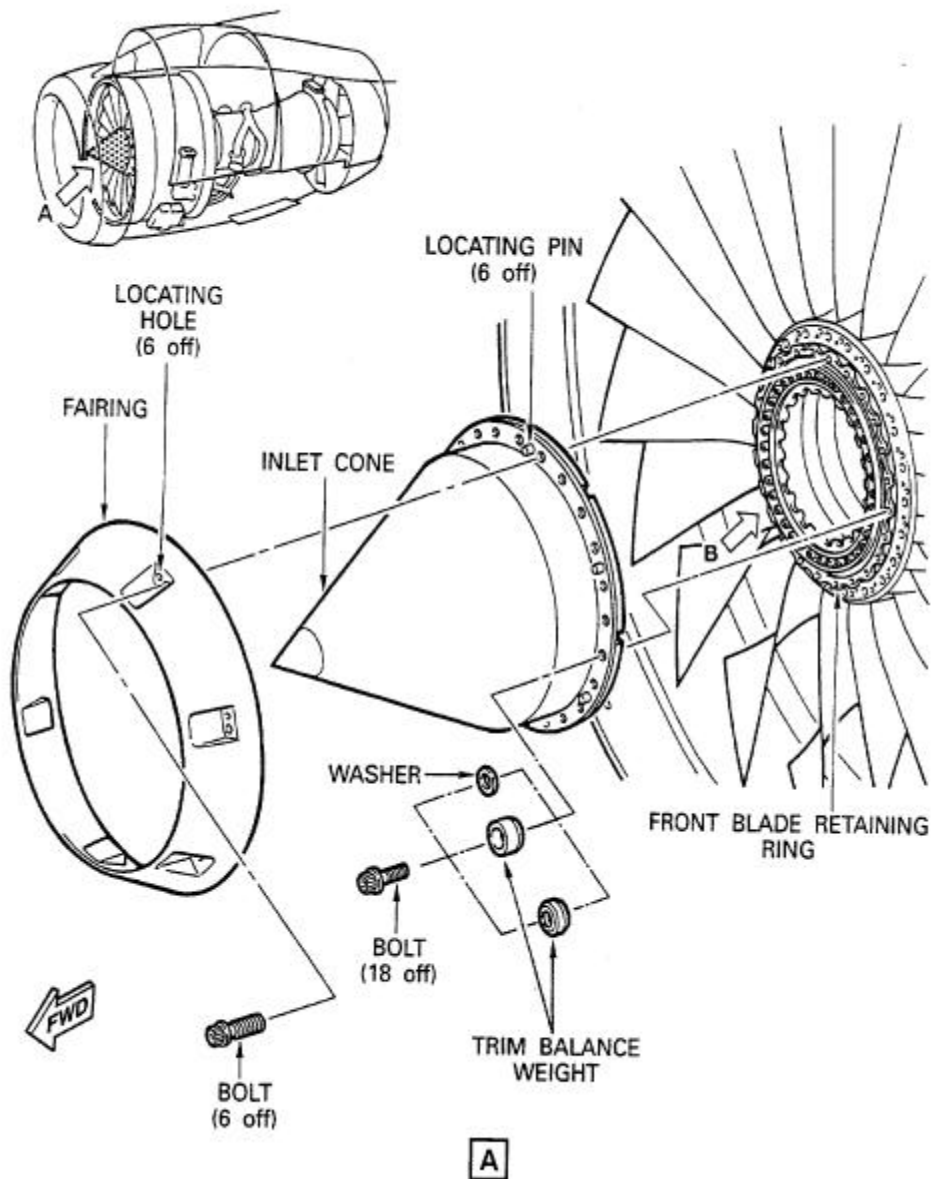
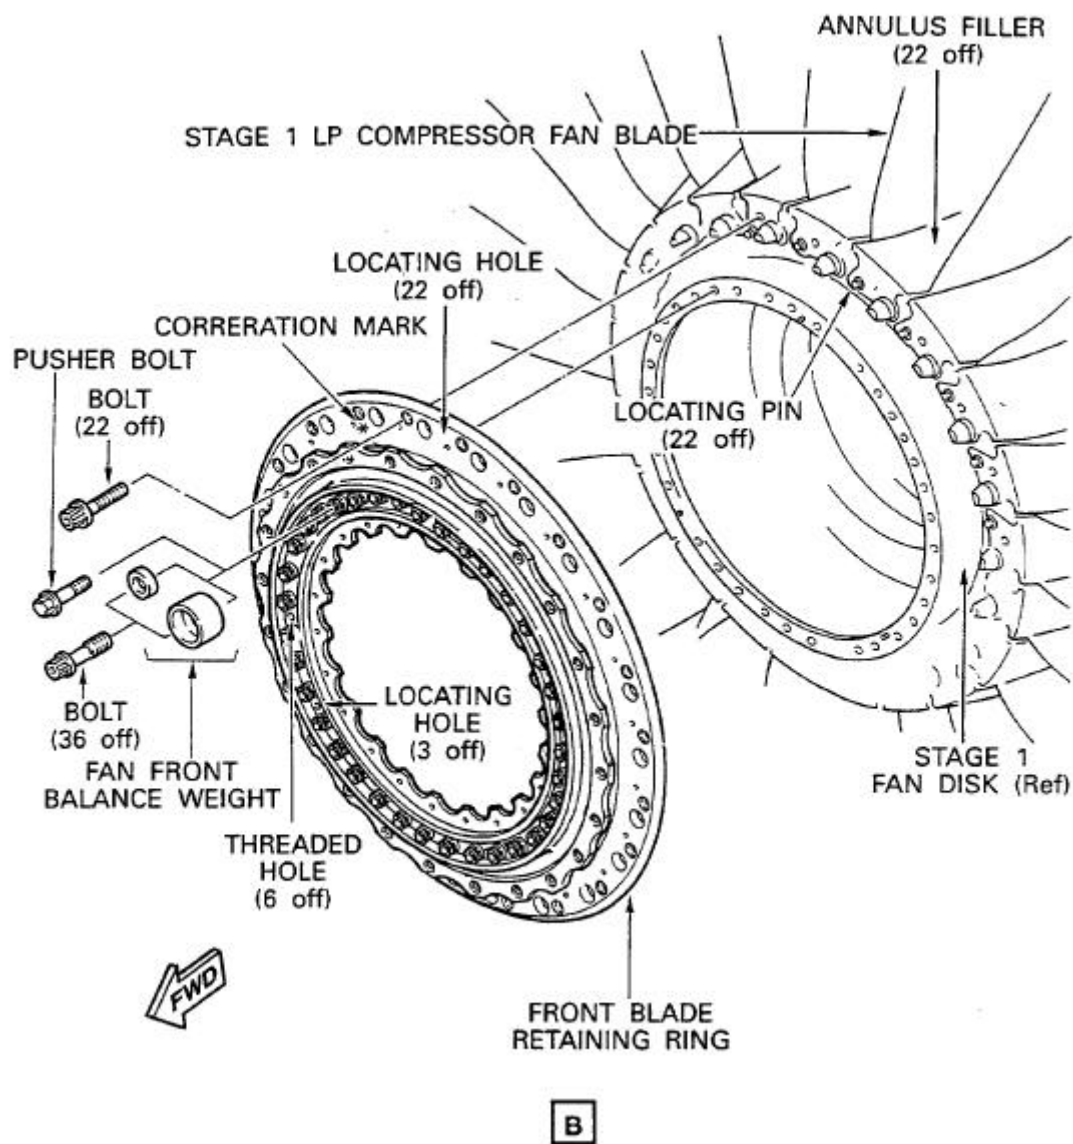
Location of Annulus Fillers
Figure 1 (Sheet 1 of 2)

Location of Annulus Fillers
Figure 1 (Sheet 2 of 2)

- (a) Remove the Inlet Cone Fairing, Inlet Cone, Trim Balance Weights and Fan Blade Front Retaining Ring to gain access to the Annulus Fillers as shown in Figure 1. (Refer to the A320 Aircraft Maintenance Manual (AMM), Chapter/Section, 72-38-11, Removal/Installation and 72-31-11 Removal/Installation (for in service) or refer to the A1 Engine Manual (EM), Chapter/Section 72-38-11, Disassembly and 72-31-00, Disassembly (for in shop)).

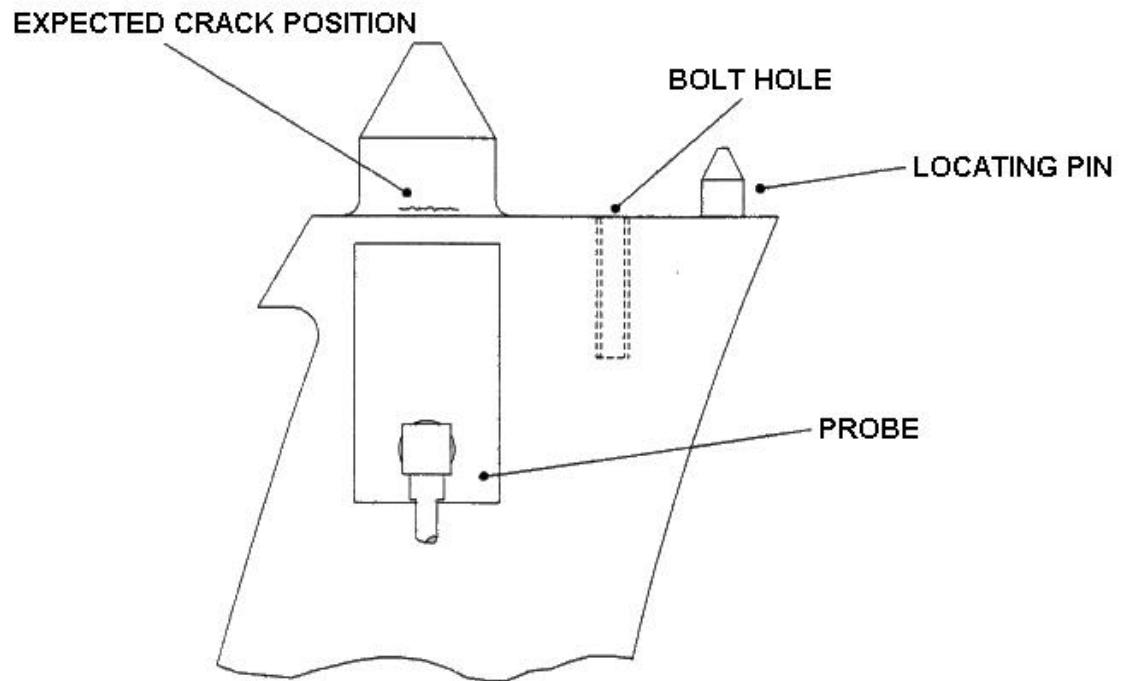
Probe Position on Annulus Filler Upper Surface for Inspection
Figure 3

- (i) Signals appearing between 5.0 and 6.5 division marks on the time base and over 15% screen height indicates that cracking is present at the trunnion location and the part must be rejected.

- (i) Clean Annulus Filler to remove any surface dirt, oil or grease. Refer to Figure 1.
- (ii) Apply Couplant to the Annulus Filler and position the Probe as shown in Figure 3. The Probe should be positioned on the extended center line of the lug which is approximately 0.67 inch (17 mm) from the Fan Blade leading edge radius on the Filler. The front of the Probe should be approximately 0.20 inch (5 mm) from the front edge of the Filler.
- (iii) Move the Probe a small amount from side to side, backwards and forwards and maximize any signal seen.
