V2500-A5/D5 PROPULSION SYSTEMS SERVICE BULLETIN

This document transmits Revision 4 to Service Bulletin EV2500-72-0357 and the Initial Issue of the Supplement

V2500-ENG-72-0357

ENGINE – HP TURBINE ROTOR ASSEMBLY – INTRODUCE NEW FIRST STAGE TURBINE BLADES WITH
PROTECTIVE COATING ON THE INTERNAL CAVITIES

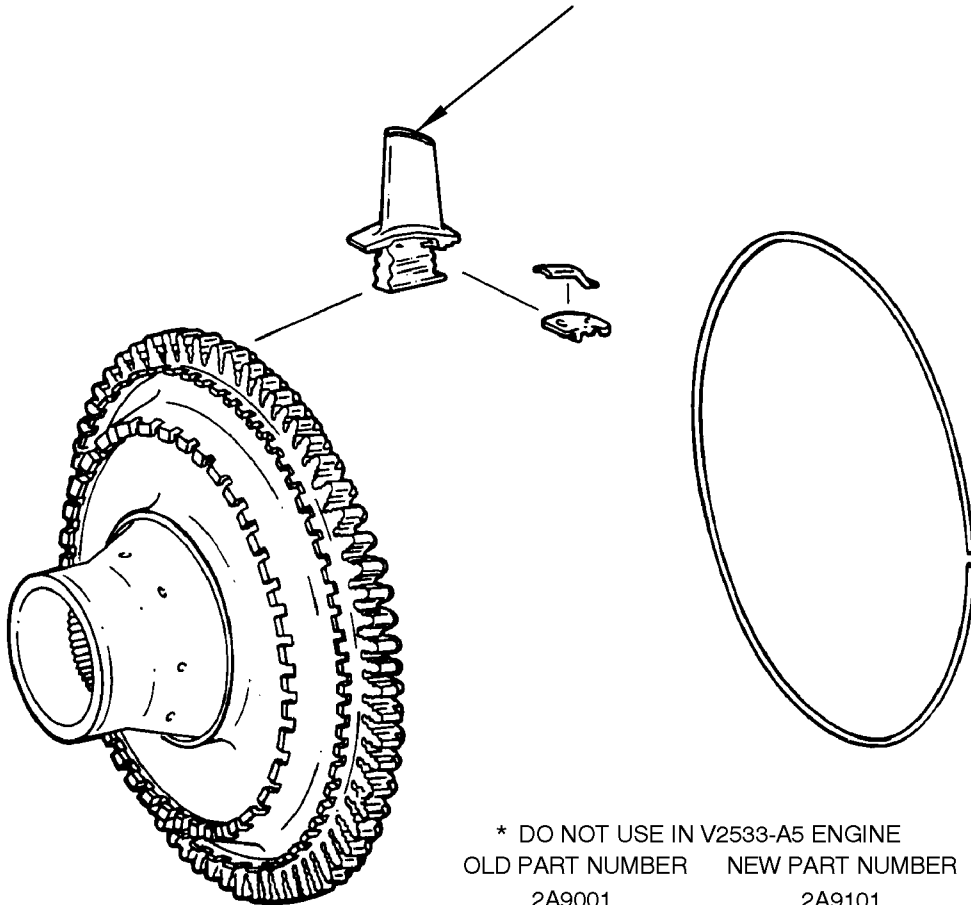
Location of the Stage 1 HPT Blade
Figure 1

R Problem: Recent service experience has found small cracks on V2500–A5/D5
R 1st Stage HPT Blade internal surfaces.

R Evidence: V2500–A5/D5 1st Stage HPT Blade material has been shown to be
R susceptible to corrosion and stress corrosion cracking upon exposure to
R corrosive agents typically found in service. The subject blade's internal
R cavity does not incorporate a protective coating.

- (5) Assembly Procedure
- (a) For V2522-A5, V2524-A5, V2527-A5, V2527E-A5, V2527M-A5, V2530-A5, and V2533-A5 Engines. Replace the Stage 1 HPT Blades (64 off) by the approved procedure given in Reference (4), Chapter/Section 72-45-10, Assembly-01 and Figure 1.

- (b) For V2525-D5 and V2528-D5 Engines. Replace the Stage 1 HPT Blades (64 off) by the approved procedure given in Reference (5), Chapter/Section 72-45-10, Assembly-01 and Figure 1.

REPLACE THE STAGE 1 HPT BLADE
WITH THE APPLICABLE NEW
STAGE 1 HPT BLADE
