V2500-A1/A5/D5 PROPULSION SYSTEMS SERVICE BULLETIN

This document transmits the Revision 6 of Service Bulletin V2500-ENG-72-0359.

V2500-ENG-72-0359

ENGINE - LP TURBINE - INNER TRANSITION DUCT - APPLICATION OF WEAR RESISTANT COATING
TO PREVENT FRETTING

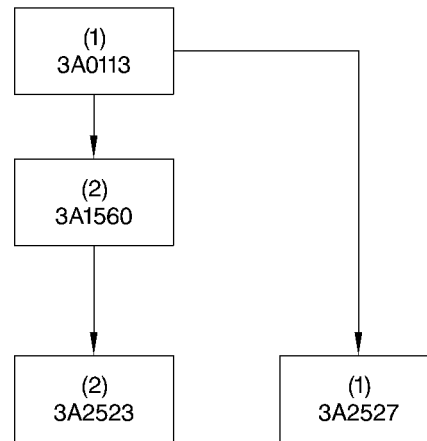
Family Tree – Ring Assy Support
Figure 2

(1) For A1 pre SB 72-0138 only
(2) For A5/D5 and A1 SB 72-0138

Rework existing Ring Assy Support (3A0113 and/or 3A1560) (72-50-24)
