**ENGINE - LP COMPRESSOR - INCORPORATION OF HIGH STRENGTH BOLTS
FOR ANNULUS FILLER ATTACHMENT**

V2500-A1

72-31-00

V2500-ENG-72-0362

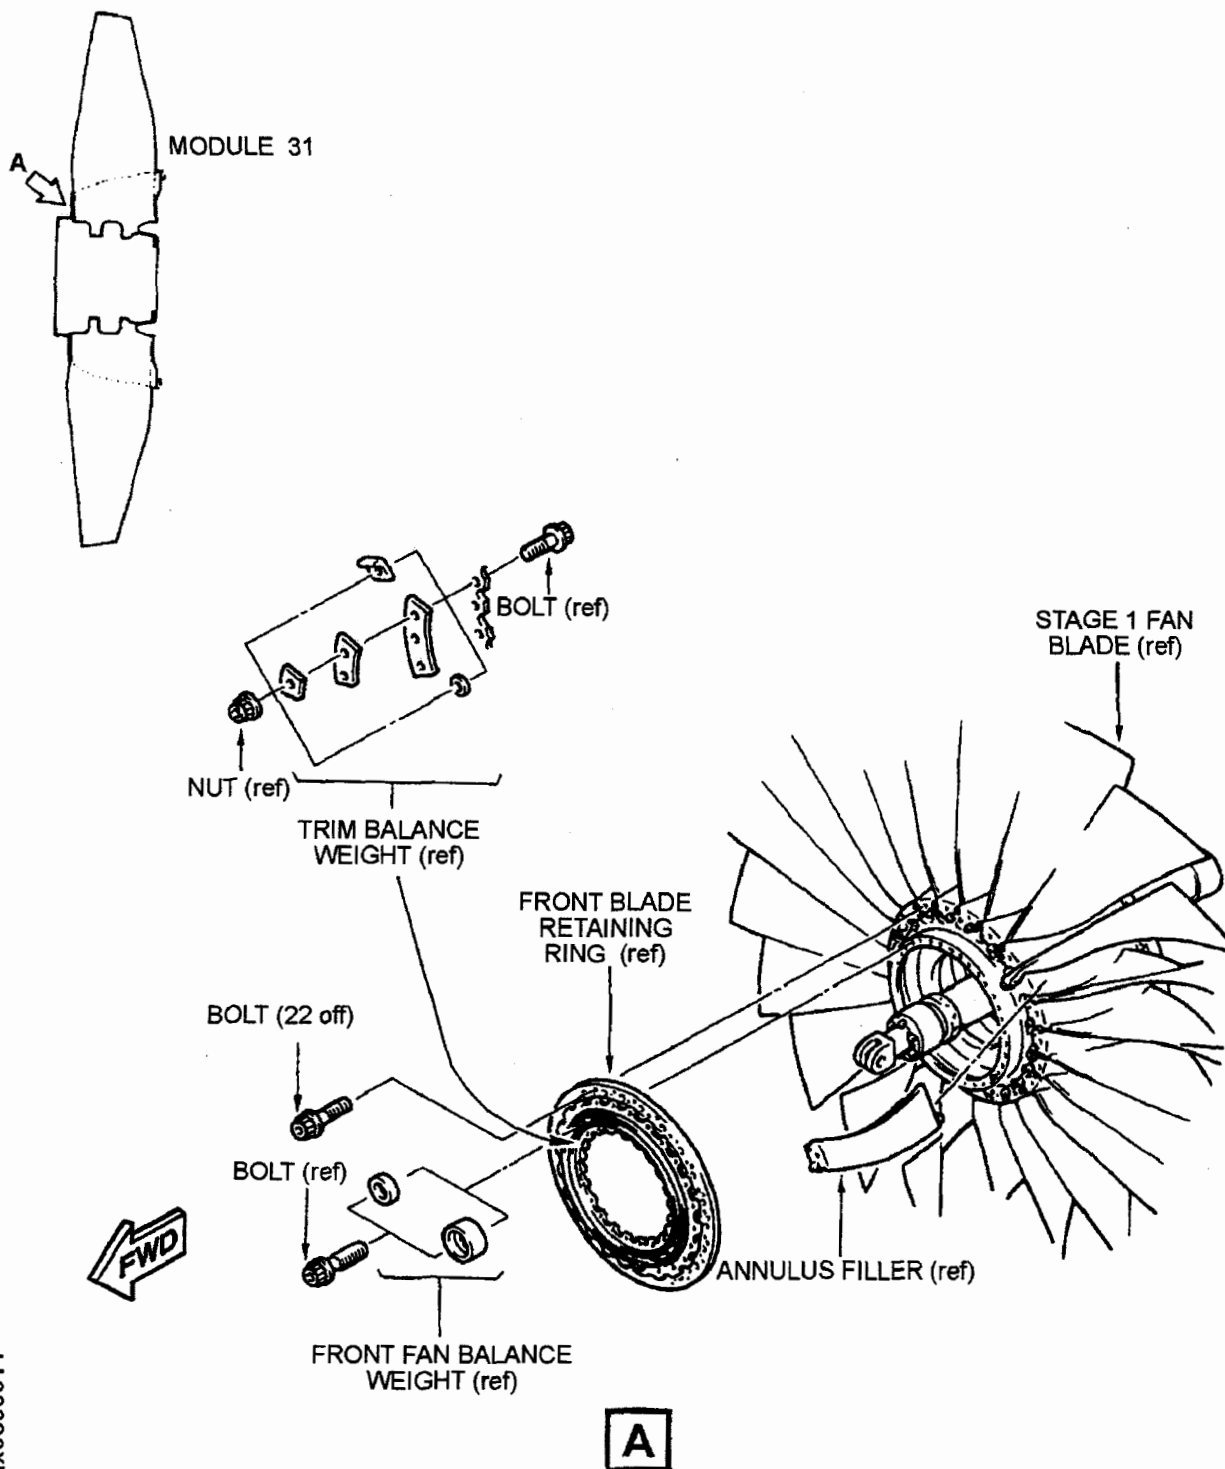
Figure 1

Several instances of annulus filler front trunnion fracture have occurred on A1 engines.

The material of the bolt which join the front blade retaining and the annulus fillers is changed from steel to nickel alloy. When the annulus filler trunnion fractures the filler will be retained by the attachment bolt. The LCF life of bolts made nickel alloy after the trunnion fracture are more than 900 Cycles.

Location of the bolts that joint the front
blade retaining ring and the annulus filler

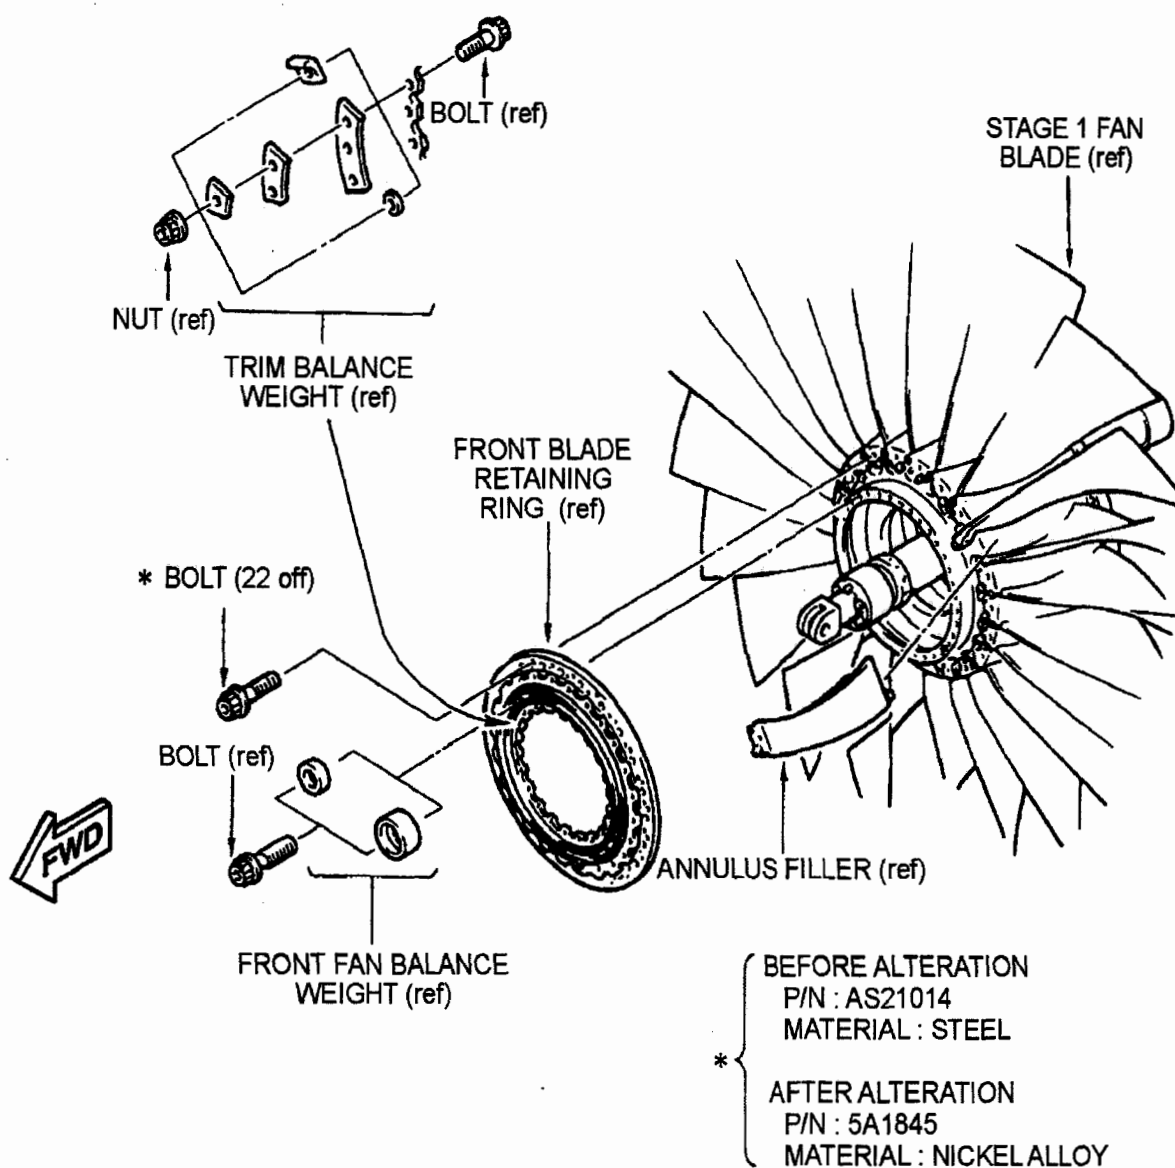
Replacement of the bolts which join the front
blade retaining ring and the annulus filler
Figure 2

- (1) Remove the existing bolts, (AS21014, 22 off) which secure the annulus fillers to the front blade retaining ring. For the correct procedures, refer to the Aircraft Maintenance Manual (AMM), Chapter/Section 72-31-11, Removal/Installation, Task 72-31-11-000-010.

- (1) Install the 22 annulus fillers with the new bolts, (5A1845, 22 off). For the correct procedures, refer to the A319/A320/A321 Aircraft Maintenance Manual (AMM), Chapter/Section 72-31-11, Removal/Installation, Task 72-31-11-000-010.

- (1) Remove the existing bolts, (AS21014, 22 off) which secure the annulus fillers to the front blade retaining ring. For the correct procedures, refer to the Engine Manual (EM), Chapter/Section, 72-31-00, Disassembly.
- (2) Install the front blade retaining ring to the annulus fillers with the new bolts, (5A1845, 22 off). For the correct procedures, refer to the Engine Manual (EM), Chapter/Section, 72-31-00, Assembly.
