V2500-A1/A5/D5 SERIES PROPULSION SYSTEMS SERVICE BULLETIN

This document transmits Revision 2 to Service Bulletin EV2500-72-0365 and the Initial Issue of the Supplement

V2500-ENG-72-0365

ENGINE – PROVIDE PRETRENCHED SECOND STAGE HPT AIR SEALING RING SEGMENTS

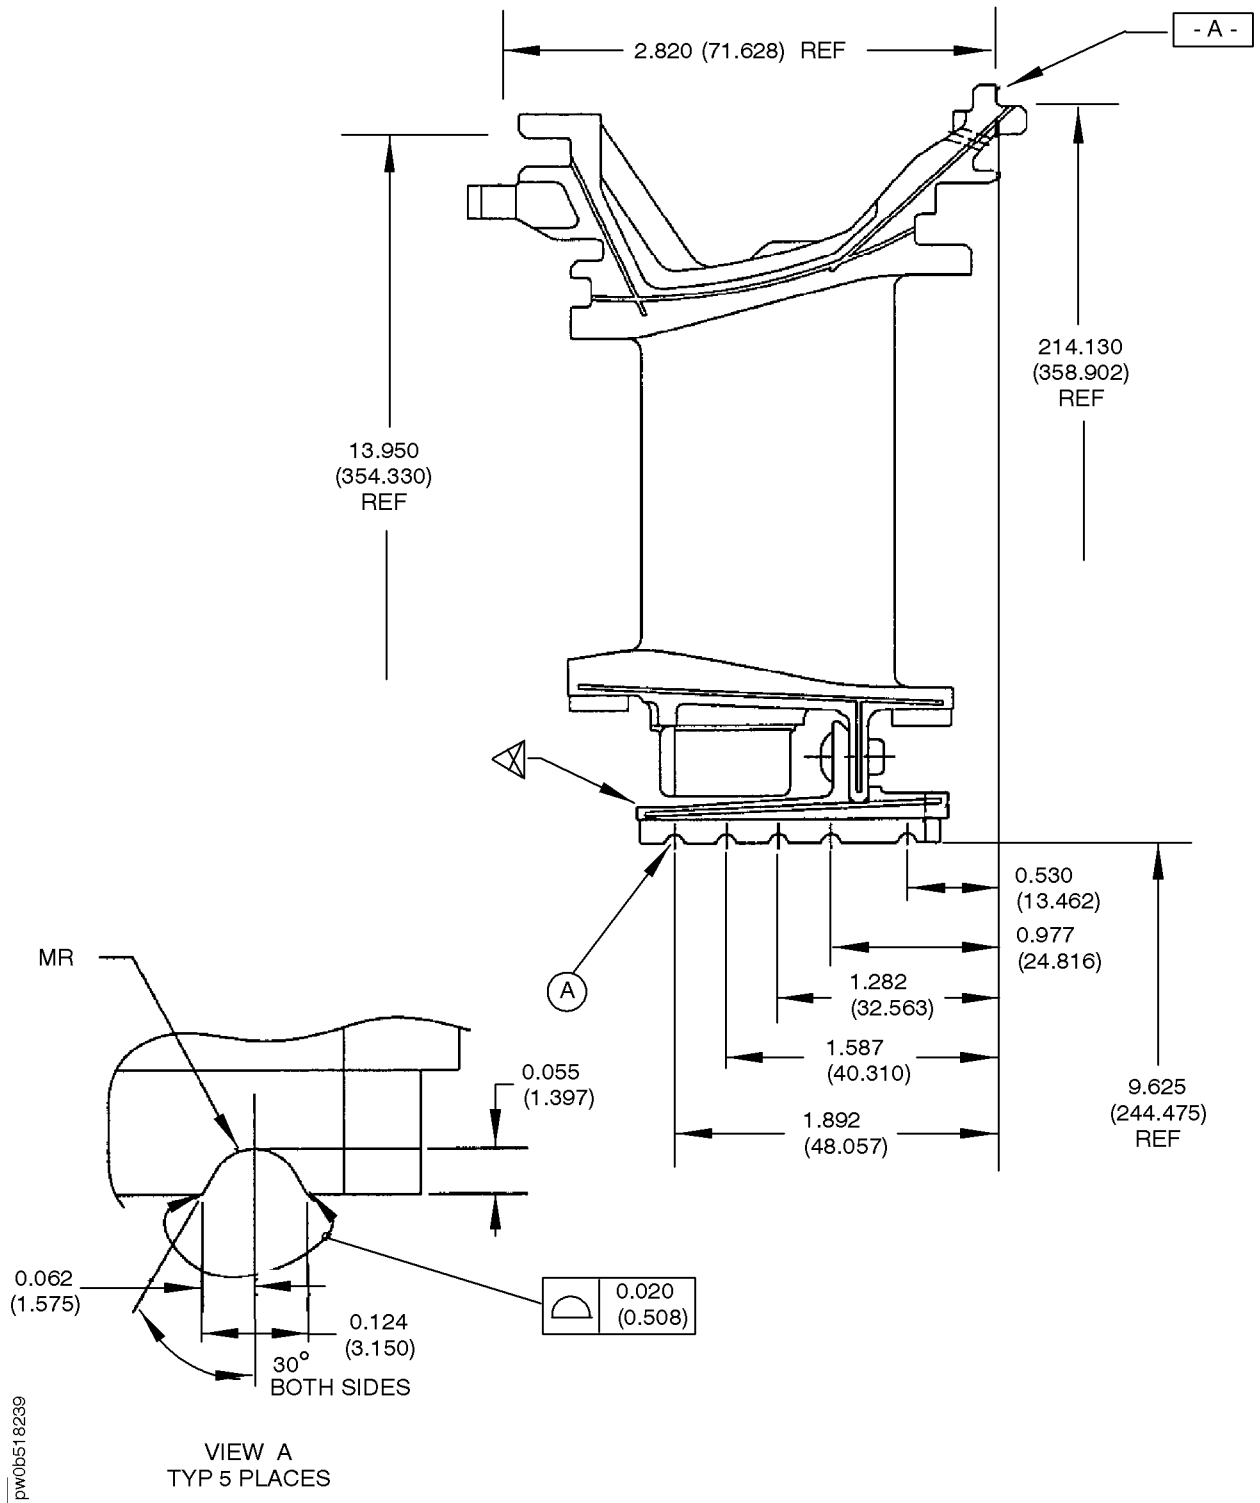
Modification of Turbine Case and Vane Assemblies
Figure 1 (Sheet 1)

During some very specific engine operating conditions, high spool distortion can result in locally heavy rub between the HPT stage 2 rotating air seal knife edges and their mating stage 2 vane honeycomb. Heavy rubs typically can result in knife edge cracking which could be responsible for scrapping air seals.

High Spool Distortion, the result of a specific combination of factors, results in locally reduced clearances between the HP turbine stage 2 rotating air seal knife edges and their mating honeycomb. The reduced clearances directly cause a locally heavy knife edge rub during low speed operation and the resultant cracking.

- (1) Follow the procedures as specified in Reference 5. and 6., Chapter/Section 72-45-20, Disassembly, to gain access to the Ring Segment And Vane Cluster, HPT 2 Stage Assemblies.
- (2) Machine the Ring Segment And Vane Cluster, HPT 2 Stage Assemblies, as specified on Figure 1, Sheets 1 and 2.
- (3) Identify the Ring Segment And Vane Cluster, HPT 2 Stage Assembly as shown below and by the procedures as specified in Reference 7., Chapter/Section 70-09-00, marking of parts. See Figure 1 Sheet 1
