## V2500-A1/A5/D5 SERIES PROPULSION SYSTEMS SERVICE BULLETIN

# V2500-ENG-72-0369

MODIFICATION SERVICE BULLETIN – ENGINE – HP COMPRESSOR RING CASES – INTRODUCTION OF  
HP COMPRESSOR STAGE 6, 7 AND 8 ROTOR PATHS WITH REVISED ABRADABLE LINING

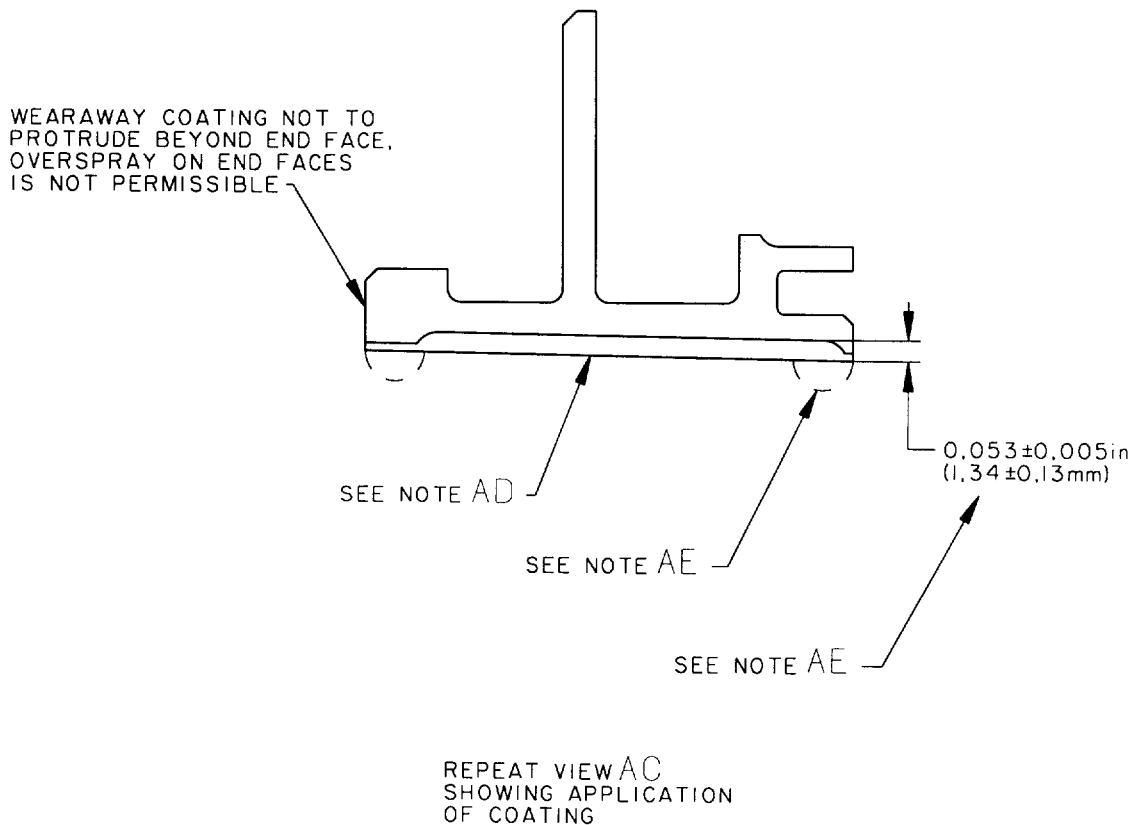
Reworking of existing stage 7 rotor path liners  
Fig.4

NOTE AD  
APPLY BOND COAT  $0.004 \pm 0.001$  in ( $0.105 \pm 0.025$  mm) THICK, THEN APPLY WEARAWAY COATING IN ACCORDANCE WITH ACCOMPLISHMENT INSTRUCTIONS

NOTE AE  
SURFACE UNDULATIONS DUE TO PRODUCTION PROCESSES ARE ACCEPTABLE. SEE MACHINING ASSEMBLY

| (l) Seal the areas not to be sprayed | See Fig.1, Fig.2 and Fig.4.<br>Use CoMat 02-198 adhesive tape (masking metal spray) or locally made fixture |

| (m) Abrasive blast the areas to be sprayed | See Fig.1, Fig.2 and Fig.4.<br>Refer to SPP TASK 70-12-02-120-501.<br>Use CoMat 05-001 abrasive medium with abrasive blast equipment |

See Fig.1, Fig.2 and Fig.4.  
Refer to SPP TASK 70-34-01-340-501, SUBTASK 70-34-01-340-025 or SUBTASK 70-34-01-340-010.  
For powder feed plasma spray gun, use CoMat 03-038 metal spraying powder.  
Alternatively for wire feed combustion spraying, use CoMat 03-036 metal spraying wire.  
Pre-heat the seal ring to 221 deg. F. to 257 deg. F. (105 deg. C. to 125 deg. C.).  
Use metal spray equipment

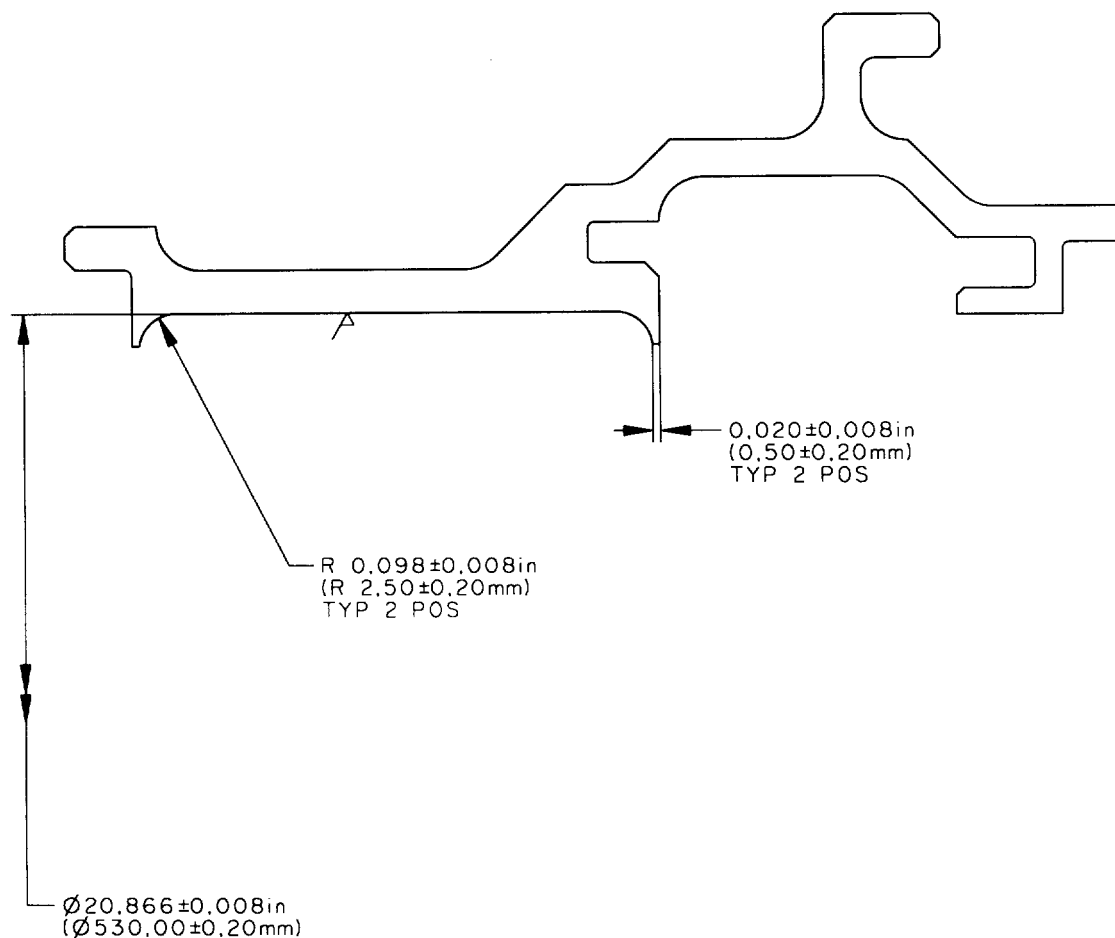
Reworking of existing stage 6 rotor path liners  
Fig.8

NOTE AN  
APPLY BOND COAT  $0.004 \pm 0.001 \text{ in}$  ( $0.105 \pm 0.025 \text{ mm}$ ) THICK, THEN APPLY WEARAWAY COATING IN ACCORDANCE WITH ACCOMPLISHMENT INSTRUCTIONS

NOTE AP  
SURFACE UNDULATIONS DUE TO PRODUCTION PROCESSES ARE ACCEPTABLE  
SEE MACHINING ASSEMBLY

| (c) Chemically remove the<br>abradable lining from the HP<br>compressor rotor path ring,<br>stage 6 | See Fig.1, Fig.7 and Fig.8.<br>Refer to SPP TASK 70-33-59-300-503,<br>SUBTASK 70-33-59-300-003.<br>Use CoMat 01-041 alkaline rust<br>remover with chemical cleaning<br>equipment |

| (g) Visually examine and measure the dimensions of the repaired area | See Fig.1, Fig.7 and Fig.8.<br>Use workshop inspection equipment |

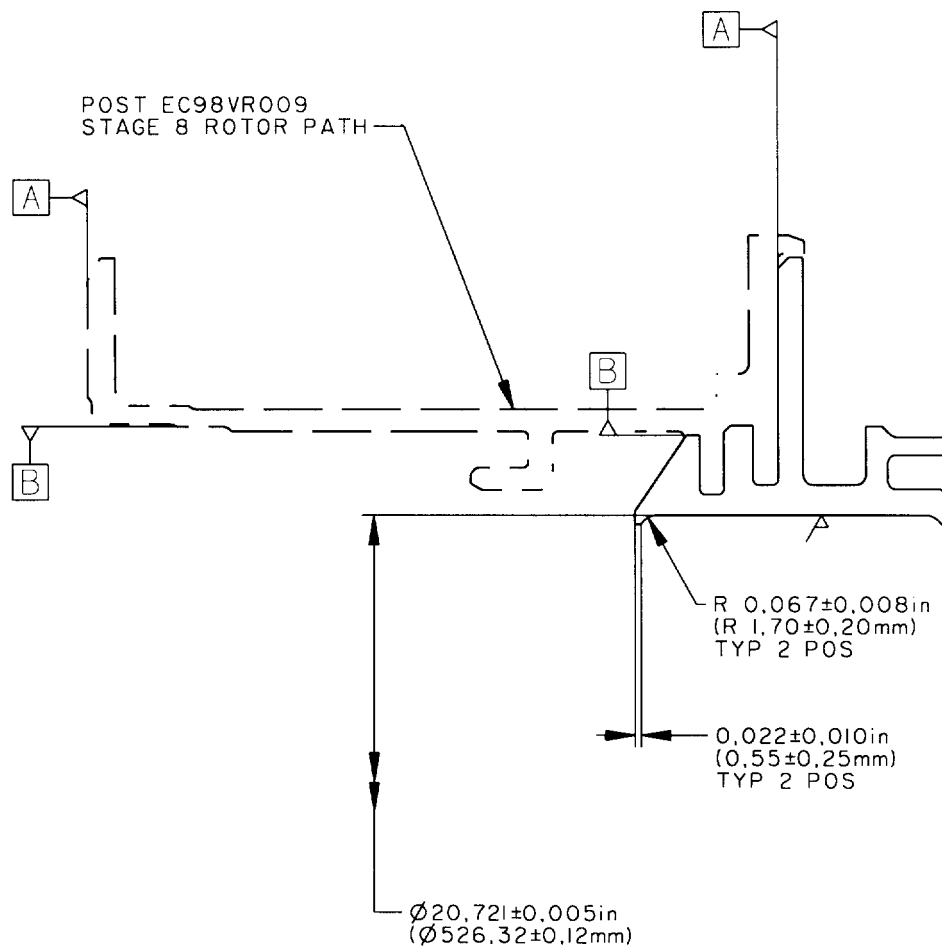
Reworking of existing stage 8 rotor path liners  
Fig.12

NOTE AT  
APPLY BOND COAT  $0.004 \pm 0.001$  in ( $0.105 \pm 0.025$  mm) THICK, THEN APPLY WEARAWAY COATING IN ACCORDANCE WITH ACCOMPLISHMENT INSTRUCTIONS

NOTE AU  
SURFACE UNDULATIONS DUE TO PRODUCTION PROCESSES ARE ACCEPTABLE  
SEE MACHINING ASSEMBLY

| PROCEDURE | RELATED DATA |
|---|---|
| (h) Visually examine and measure the dimensions of the repaired area | See Fig.1, Fig.7 and Fig.12.<br>Use workshop inspection equipment |
