International Aero Engines SERVICE BULLETIN

ENGINE - FAN CASE REAR EXTENSION - INTRODUCTION OF ANTI-FRET COATING ON THE V-GROOVE

V2500-ENG-72-0371

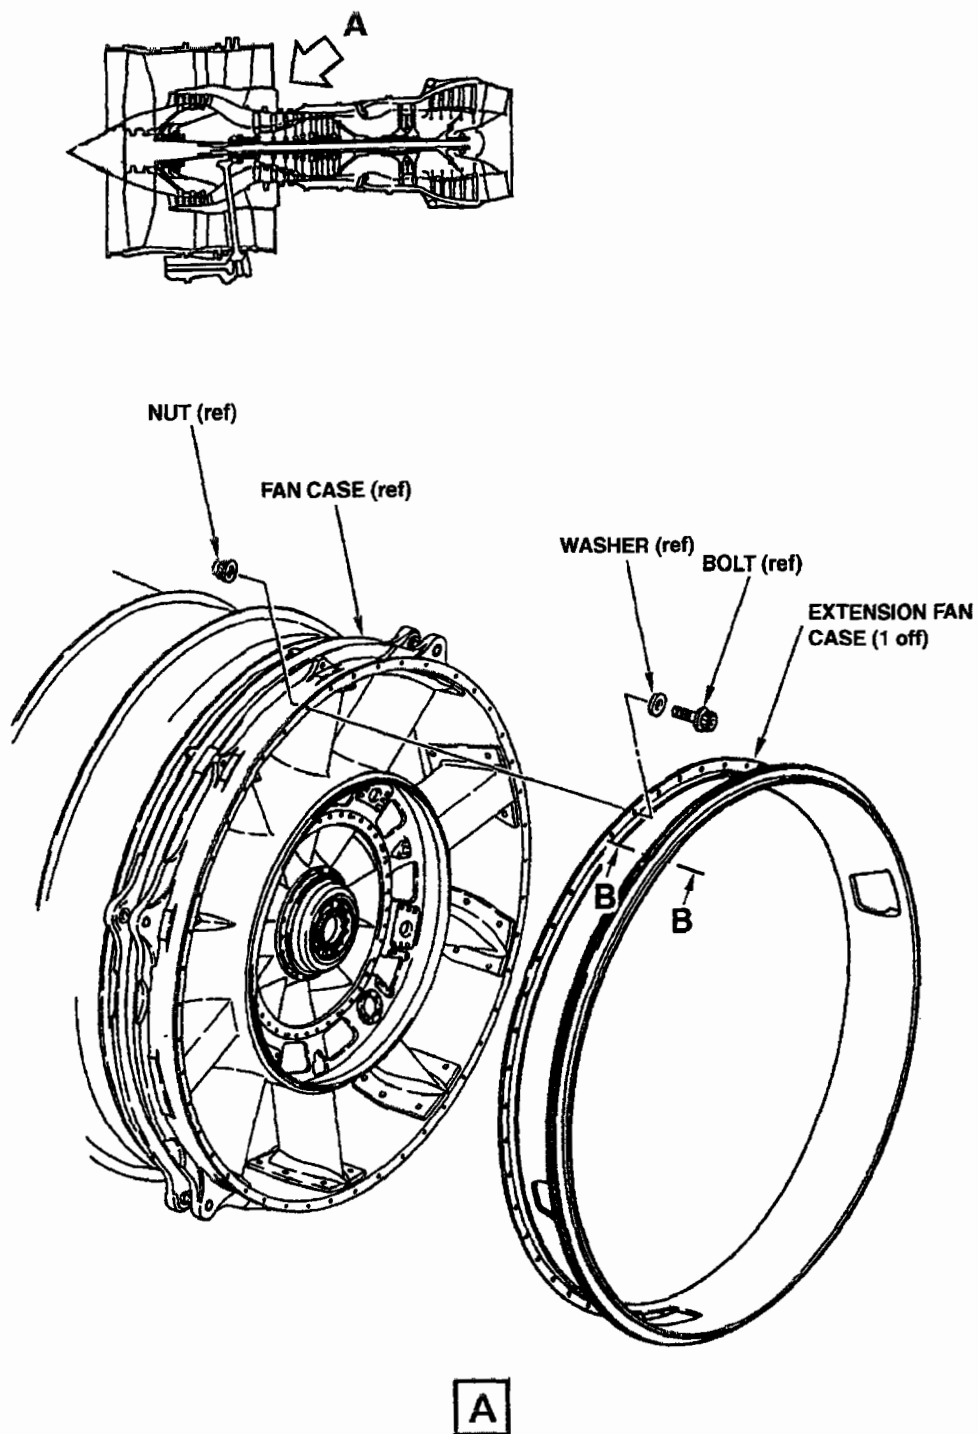
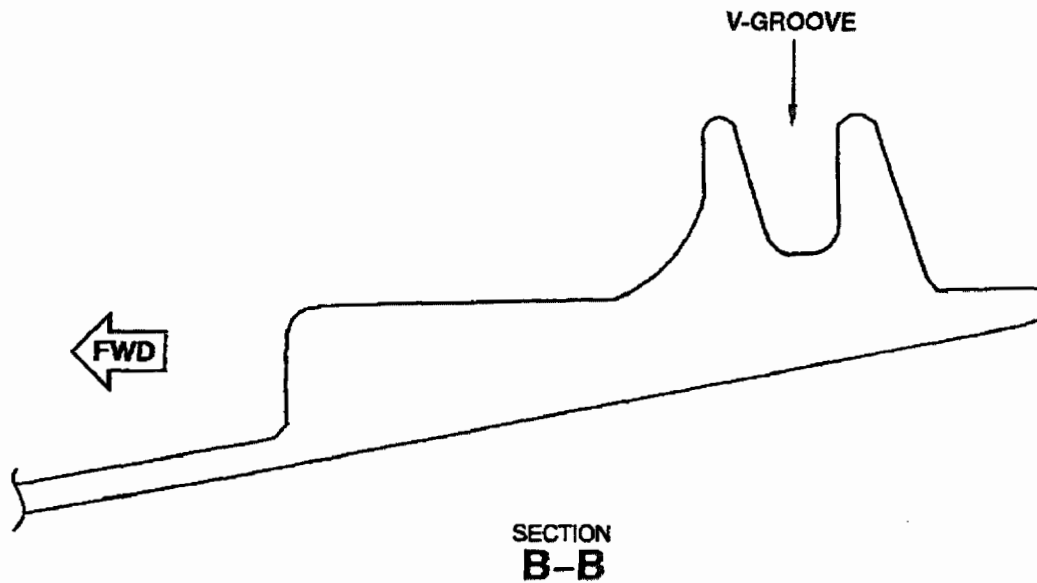
Location of V-groove of Extension Fan Case
Figure 1 (Sheet 1 of 2)

Cracks have been found on the V-groove on a small number of the Extension Fan Case on in service engines.

The cracks start from the fretting damage which is caused by rubbing between the V-groove and the V-blade on the Thrust Reverser.

The purpose of this Service Bulletin is to introduce the dry film lubricant on the V-groove surface to reduce extent of the fretting damage.
