**V2500-A1 PROPULSION SYSTEMS SERVICE BULLETIN**

**V2500-ENG-72-0372**

ENGINE – LP COMPRESSOR BLADES AND FILLERS – INTRODUCTION OF A REVISED WIDE CHORD FAN  
BLADE WITH DELETED ROOT STOP PIN AND REVISED FRONT AND REAR CHOCKING PADS

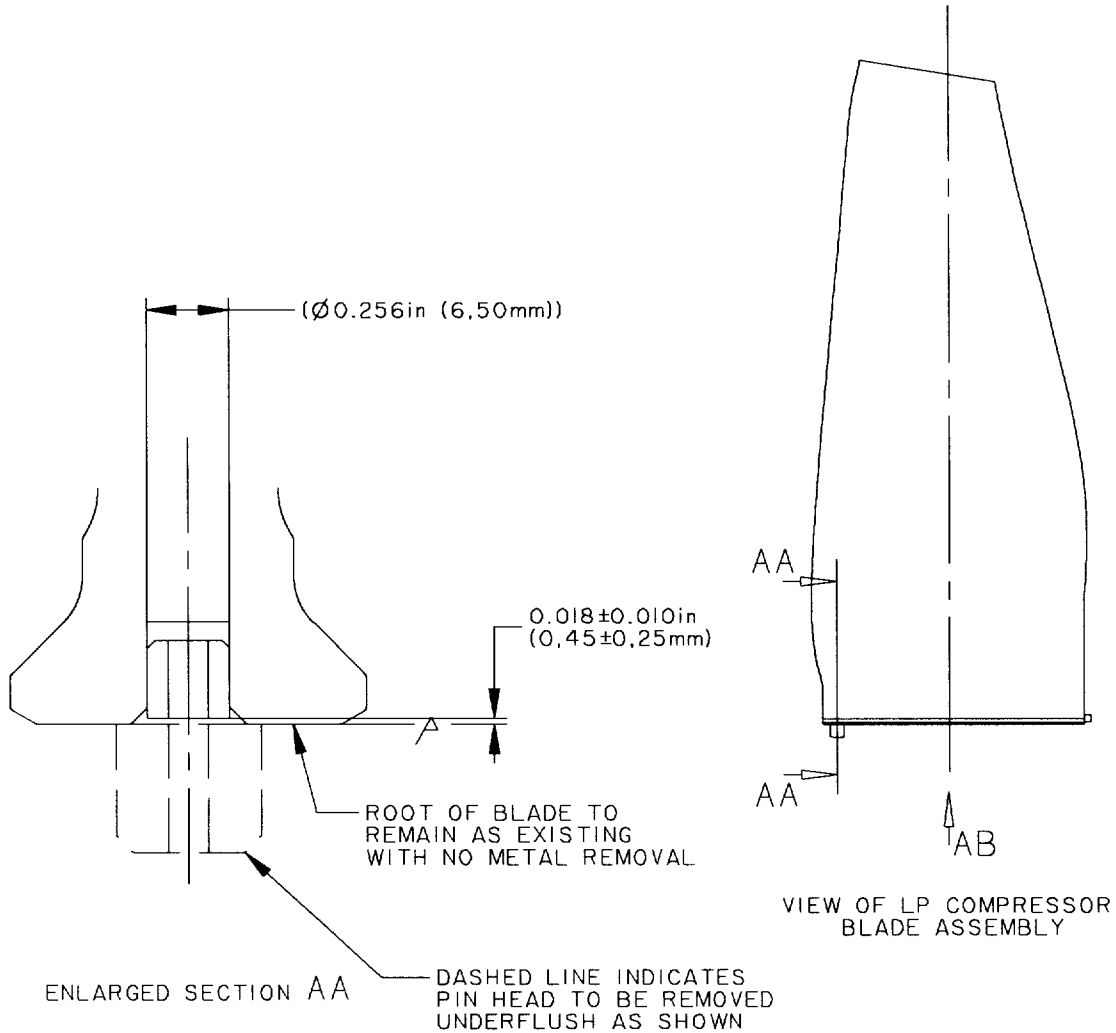
Detail of blade root rework  
Fig 1

Root pin to be removed underflush on the fan blade root to a depth of 0,20mm to 0,70mm. No existing material to be removed from the blade root. Remainder of pin to remain in blade root	Tooling		3R19555	Machining fixture	3R19556	Centralizing pin	3R19557	End mill	3R19558	Setting gauge
Tooling											
3R19555	Machining fixture										
3R19556	Centralizing pin										
3R19557	End mill										
3R19558	Setting gauge										
(3) Clean blade root	Refer to (EM) TASK 72-31-11-100-000. Use chemical cleaning equipment

MACHINE WHERE MARKED ✓  
MACHINE SURFACE FINISH TO BE 250 MICROINCHES (6,4 MICROMETRES)  
REMOVE ALL BURRS

PROCEDURE	RELATED DATA										
(1) Remove front and rear chocking pads from blade	Refer to (EM), 72-31-11-300-013, (Repair VRS1028)										
(2) Remove pin from blade root	Refer to Fig 1. Use radial arm drill.

Refer to Fig 1. Refer to Standard Practices Manual (SPM) TASK 70-21-01-220-501. Visually examine the blade root. Reject if blade root material has been removed or pin has been totally removed
