V2500-A5/D5 SERIES PROPULSION SYSTEMS SERVICE BULLETIN

This document transmits Revision 7 to Service Bulletin EV2500-72-0373

V2500-ENG-72-0373

ENGINE – HP COMPRESSOR STAGE 4 ROTOR BLADES – ULTRASONIC INSPECTION OF BLADE ROOTS
NON-MODIFICATION SERVICE BULLETIN

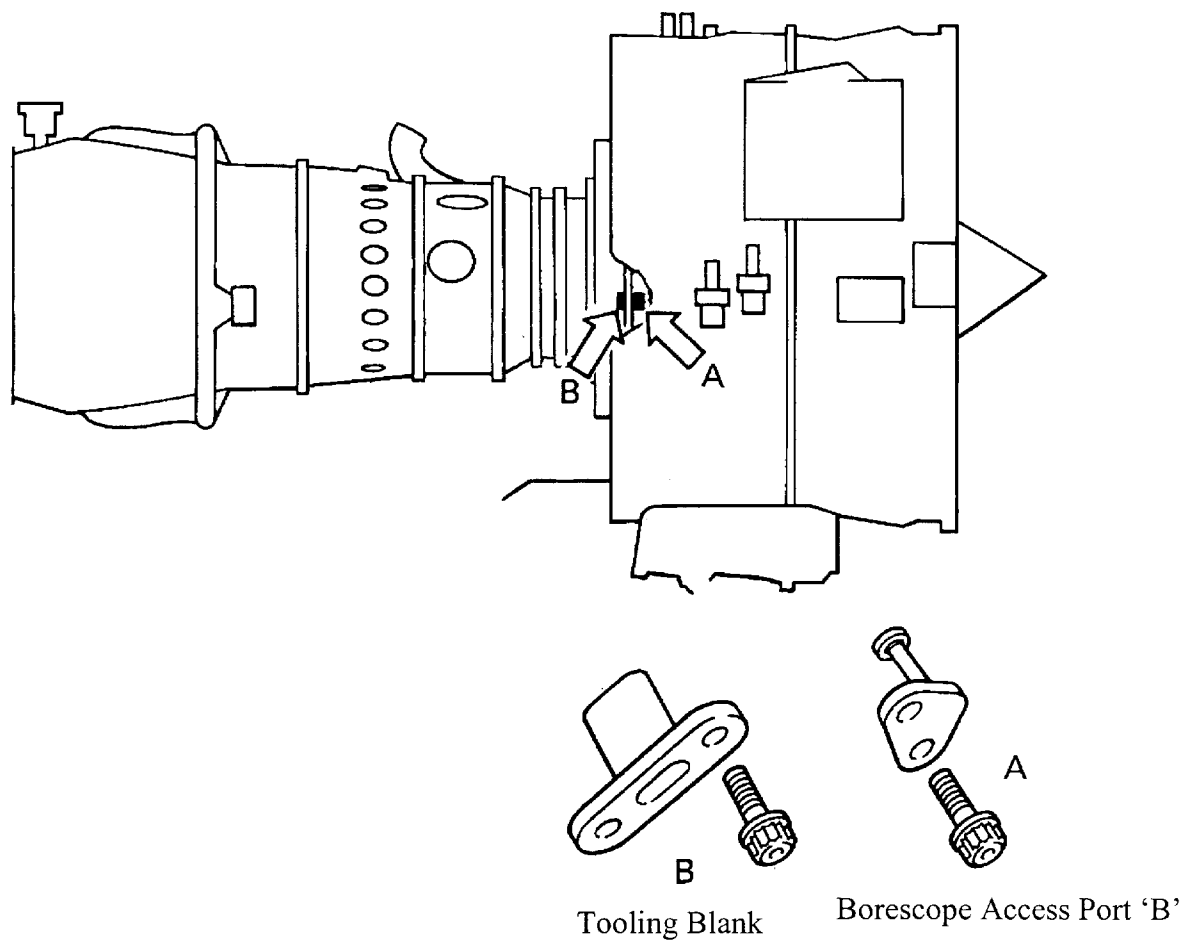
Access ports to be removed
Fig 1

(d) Borescope access port cover B (ATA 72-41-31, 01-100 part no. 6A2330) and the tooling blank immediately behind access port cover B (ATA 72-41-31, 01-120 part no. 6A1069) are the only access port covers that need to be removed. The clip holding the wiring harness to the pipe immediately in front of access port B will need to be loosened and the clip removed.

(c) Prepare the engine for borescope access – refer to AMM TASK 72-00-00. Refer to Figure 1.

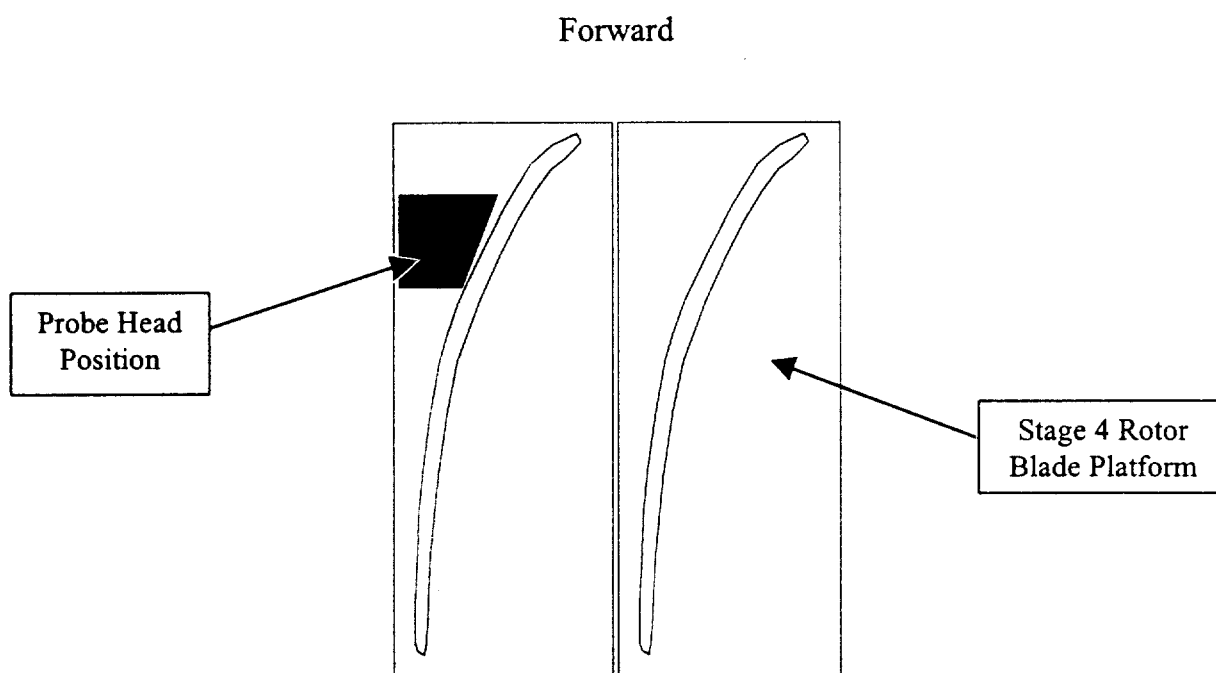
Correct position of ultrasonic probe relative to stage 4 blade platform
Fig 2

- (e) When the ultrasonic probe is in the correct position on the stage 4 rotor blade platform the location should be noted from the engine turning tool. An illustration of the correct probe position is given in Figure 2.
- (f) Continue inspection by rotating the ultrasonic probe out of the path of the stage 4 rotor blades. Then use the engine turning tool to move the HP rotor to the next blade position. Repeat until all 38 stage 4 rotor blades have been inspected or until a cracked blade is discovered.

- (a) Connect probe to ultrasonic flaw detector, adjust filters to the 5 to 10 MHz range and delay to zero.
- R (b) Position the probe on the leading edge platform of test piece IAE2R19752 and align probe edge with edge of the blade, refer to Figure 2.
- R (c) Identify large signal reflected from the bottom corner of the test piece IAE2R19752. Position this signal at division 8 on the timebase and adjust to 50% screen height. Increase gain by 12 dB and transfer the probe to test piece IAE2R19751 containing the 2,0 mm slot, identify the signal reflected from the slot.
- R (d) Adjust amplitude of this signal to 50% screen height and position monitor gate over signal, to aid identification. Increase gain by a further 6dB, the signal should now be full screen height.
- (e) Adjust width of monitor gate to 1.5 timebase divisions and position centrally over calibration signal.
