V2500-A5 PROPULSION SYSTEMS SERVICE BULLETIN

This document transmits Revision 2 to Service Bulletin EV2500-72-0379

V2500-ENG-72-0379

ENGINE – HP COMPRESSOR VSV SYSTEM INSPECTION NON-MODIFICATION SERVICE BULLETIN1. Planning InformationA. Effectivity

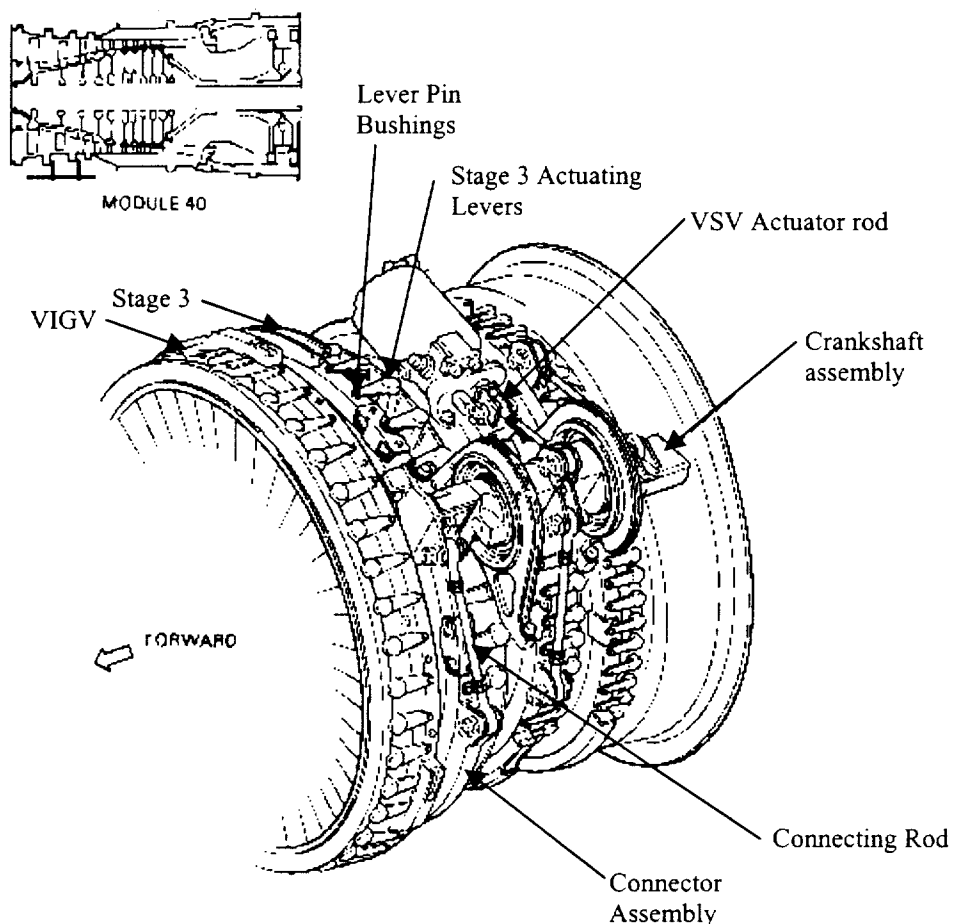
Figure 1 – VSV System

C. General condition of stage 3 VSV system (see Fig 1 and 2)

(1) Inspect the stage 3 VSV actuating levers and lever pin bushings (72-41-34, part number UP11069)

R (a) If a cracked lever is found - Replace lever, see AMM 75-32-42-401

R (b) If a bent lever is found - Replace lever within 50 cycles, see AMM 75-32-42-401

(c) If a broken lever is found - Reject engine

(2) Make sure crankshaft assembly is securely attached to front casings - If attaching bolts are found to be loose (EIPC 72-41-34, Fig 1 items 604 and 762) - Re-torque bolts to between 180 and 220lbf.in (2.03 and 2.48 m.daN)

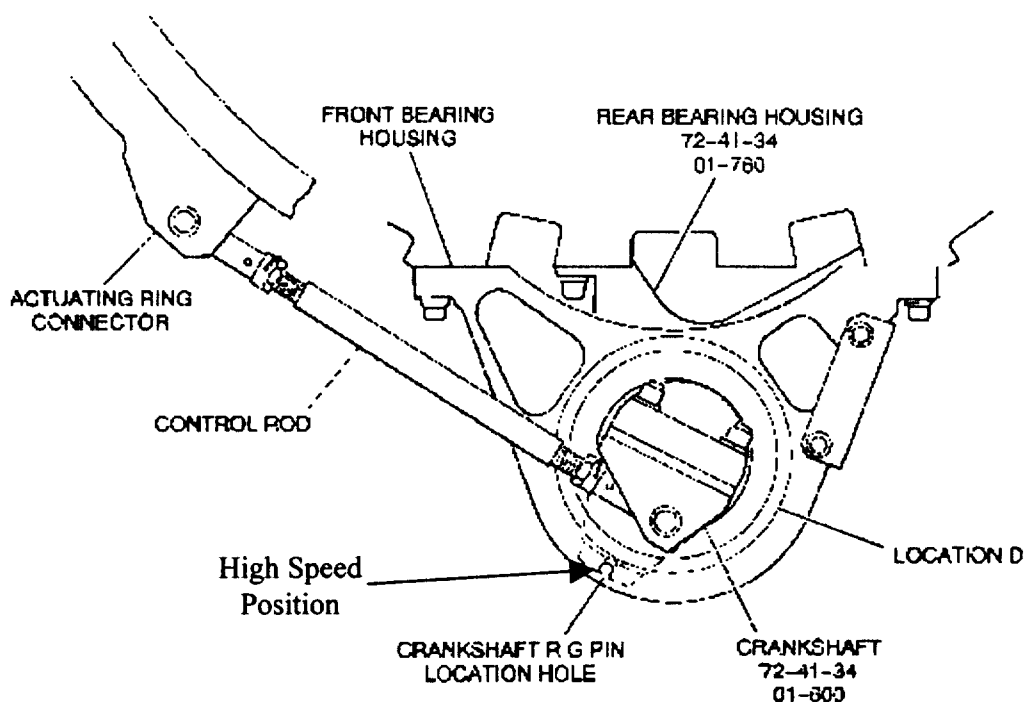
Figure 6 – Crankshaft Assembly

E. Check stage 3 VSV rigging (see Fig 6 and 7)

- (1) Check actuator/crankshaft rigging
 - (a) Set the VSV system to the high speed condition
 - (b) Insert rig pin (part number IAE1R18891) into the actuator ram
 - (c) Attempt to insert rig pin (part number IAE1R18254) through the rig pin hole in the front bearing housing and the crankshaft
 - (d) If rigging is out by more than half but less than one hole – Re-rig the actuator within 50 cycles, see 3.L.

- (e) If the pin cannot be inserted and the rigging is out by greater than one hole – Re-rig the actuator within 50 cycles, see 3.L. – Accomplish Service Bulletin V2500-ENG-72-0373 within 50 cycles

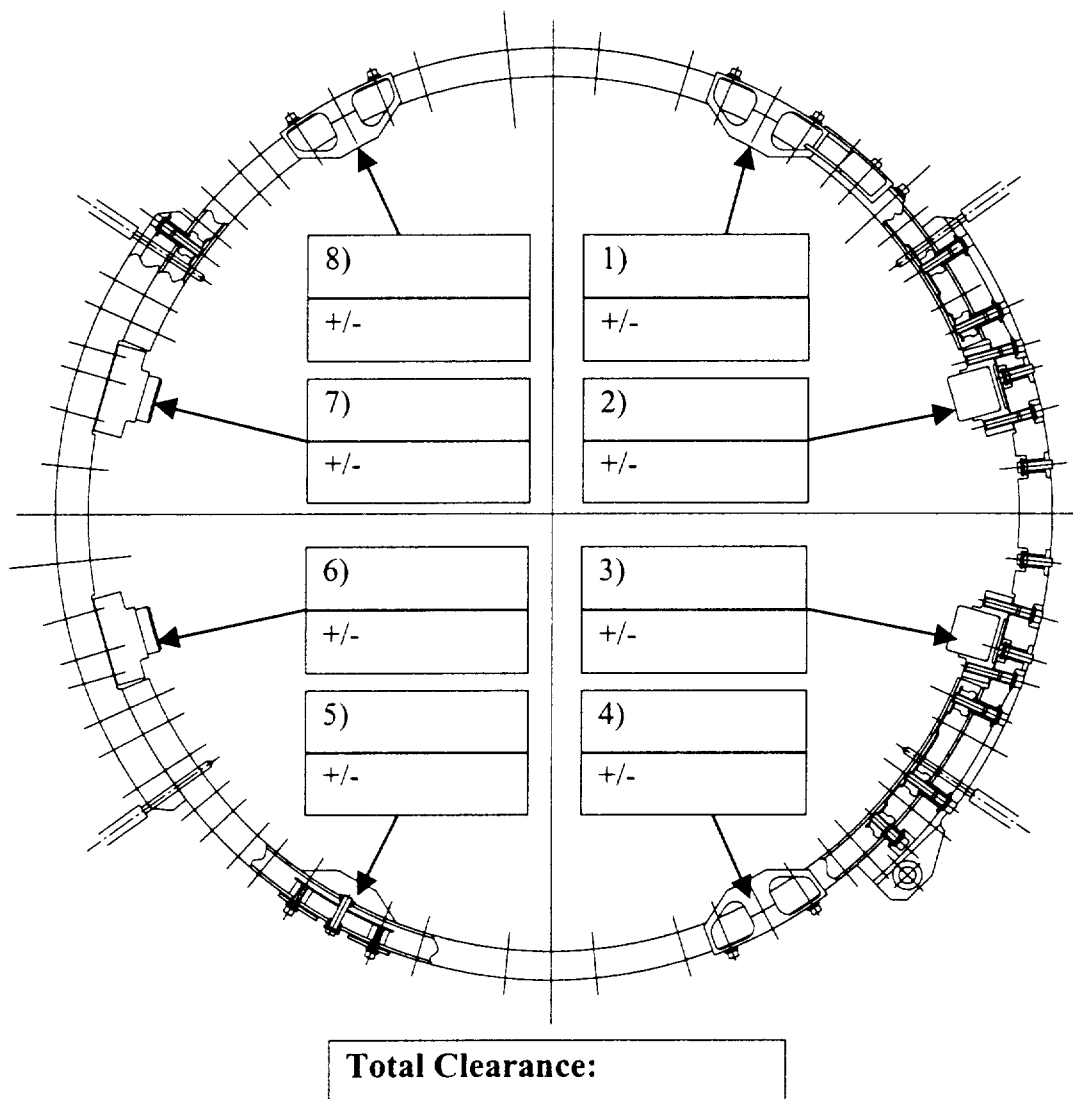
3.G. 3.J. – Stage 3 pad clearances (if required)
(Indicate change in size of shim installed, as required, in box provided)
Fig 10

- (4) If the total pad clearance exceeds 2,00mm (0.079in.) but is less than 2,40mm (0.094in.) – Re-shim the centralising/compensating pads within 50 cycles, see 3.J.
- (5) If the total pad clearance exceeds 2,40mm (0.094in.) – Re-shim the centralising/compensating pads, see 3.J. – Accomplish Service Bulletin V2500-ENG-72-0373 within 50 cycles
- (6) Remove all feeler gauges and rig pins
