## V2500-A1/A5/D5 SERIES PROPULSION SYSTEMS SERVICE BULLETIN

# V2500-ENG-72-0384

ENGINE - LP COMPRESSOR BLADES AND FILLERS - INTRODUCTION OF A REVISED LP COMPRESSOR  
BLADE WITH METCO 58 - REWORK

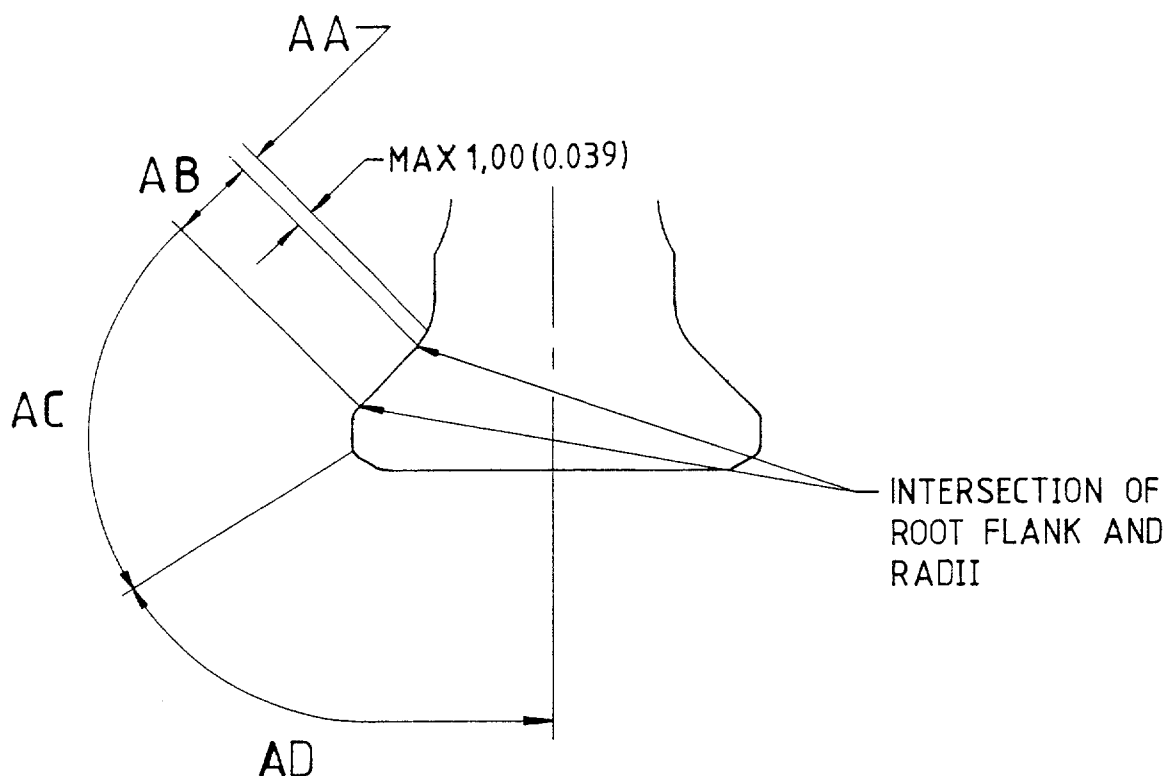
LP compressor blade view at AE  
 Fig 2

GRIT BLAST ZONES AA AND AB TO THE INSTRUCTIONS  
 METAL SPRAY TO BE APPLIED TO ZONE AB TO THE  
 INSTRUCTIONS WITH A RUNOUT INTO ZONE AA  
 OVERSPRAY IS ACCEPTABLE WITHIN ZONE AC AS A NATURAL  
 RUNOUT BUT NOT ACCEPTABLE WITHIN ZONE AD

| (6) Shot peen the blade root | Refer to Figs 1 and 2<br>Refer to Engine Manual, TASK 72-31-11-300-024, (Repair VRS1723)<br><br><u>NOTE:</u> VRS1723 is a source demonstrated repair |
| (7) Mask the blade | Refer to Figs 1 and 2<br>Refer to SPM TASK 70-34-01-340-001. Put suitable masking on the areas not to be abrasive blasted and metal sprayed.<br><br><u>NOTE:</u> It is important to make sure the masking is positioned correctly |

- (8) Abrasive blast the blade  
Refer to Figs 1 and 2  
Refer to SPM TASK 70-34-01-340-001.  
Abrasive blast the area to be metal sprayed at 20 to 25 psi. Use pressure pot abrasive blasting equipment. Keep a nozzle to part distance of at least 76mm (3in.). Make sure the blasting cabinet is thoroughly cleaned and the abrasive medium changed before blasting each set of fanblades (22 off). Use Co-Mat 05-002 abrasive blast media. Use abrasive blasting equipment

- (9) Renew blade masking if necessary  
Refer to Figs 1 and 2.  
Refer to SPM TASK 70-34-01-340-001
- (10) Apply metal spray coating to blade dovetail root working flanks  
Refer to Figs 1 and 2  
Refer to SPM TASK 70-34-01-340-501, SUBTASK 70-34-01-340-005. Use CoMat 03-261 (Metco 58NS) metal spray powder - copper, nickel, indium. Apply the metal spray to a finished thickness of 0,10 to 0,15mm and leave in the 'as sprayed condition'. Use 3R19551 rotating metal spray fixture and test piece holder - 1 off. Use metal spray equipment

- (12) Inspect the metal sprayed coating  
Refer to Figs 1 and 2  
Refer to SPM TASK 70-34-01-340-501, SUBTASK 70-34-01-340-005  
Make sure the metal sprayed coating has been correctly applied. Make sure the thickness of the sprayed coating is within the limits given by measuring the coating thickness on the metal spray test pieces

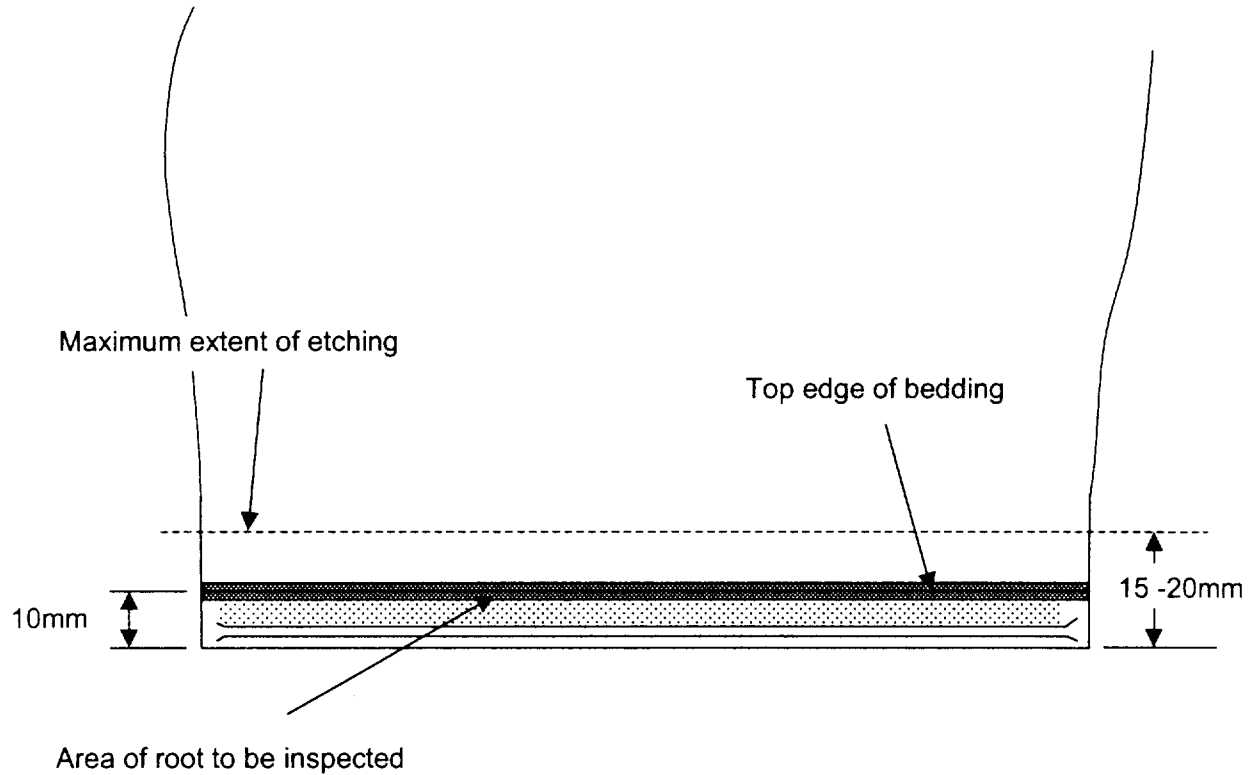
Area to be inspected  
Fig 7

This technique covers the inspection of V2500 fan blade roots for top edge of bedding cracking in the region shown in Appendix 2 Fig 7.

A. Reject any blade exhibiting a crack like feature running axially along the root in the inspected region

B. Reject any blade exhibiting a 'scar' or crater-like feature
