V2500-A5 SERIES PROPULSION SYSTEMS NON-MODIFICATION SERVICE BULLETIN

This document transmits Revision 7 to Service Bulletin EV2500-72-0386

V2500-ENG-72-0386

ENGINE – LP COMPRESSOR FAN BLADES – DOVETAIL ROOT FLANK ULTRASONIC INSPECTION AND
APPLICATION OF DRY FILM LUBRICANT (ROOT FRETTING/WEAR – SCARRING) NON-MODIFICATION
SERVICE BULLETIN

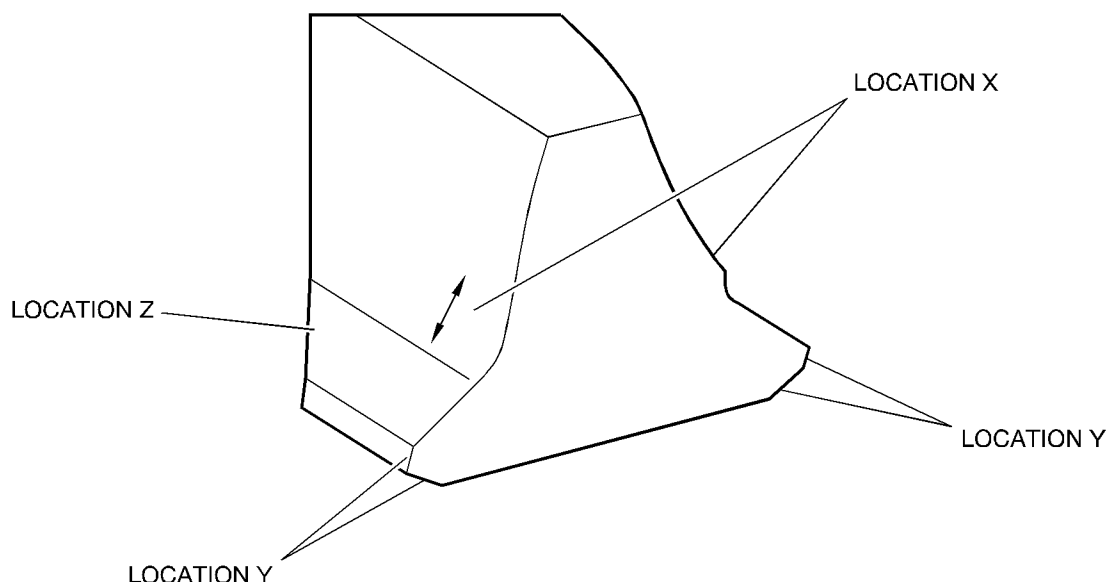
Removal of excess Dry Film Lubricant (DFL)
Fig.3

CAUTION 1: On post SB 72-0375 and post SB72-0384 (Metco 58 coated root) fan blades it is essential not to "scotchbrite" the fan blade bedding surface (Location Z) as this will have a detrimental effect to the coating.

CAUTION 2: On post SB 72-0375 and post SB72-0384 (Metco 58 coated root) fan blades it is important not to damage the fan blade bedding surface (Location Z) when using a scraper

- 1) At the ultrasonic reject indication locations, on either the concave or the convex flanks, remove any excess Dry Film Lubricant (DFL) by lightly rubbing with 'Scotchbrite' using CoMat No 05-125 to 05-127 in the following areas:
 - above the top edge of the bedding (location X)
 - at the lower corner of the root where the ultrasonic probe locates (location Y)

- 2) If excessive DFL is present, at location X and/or Y that cannot be removed by lightly rubbing with 'Scotchbrite' it is permissible to remove this using a non metallic scraper and then remove any loose residual DFL using 'Scotchbrite'

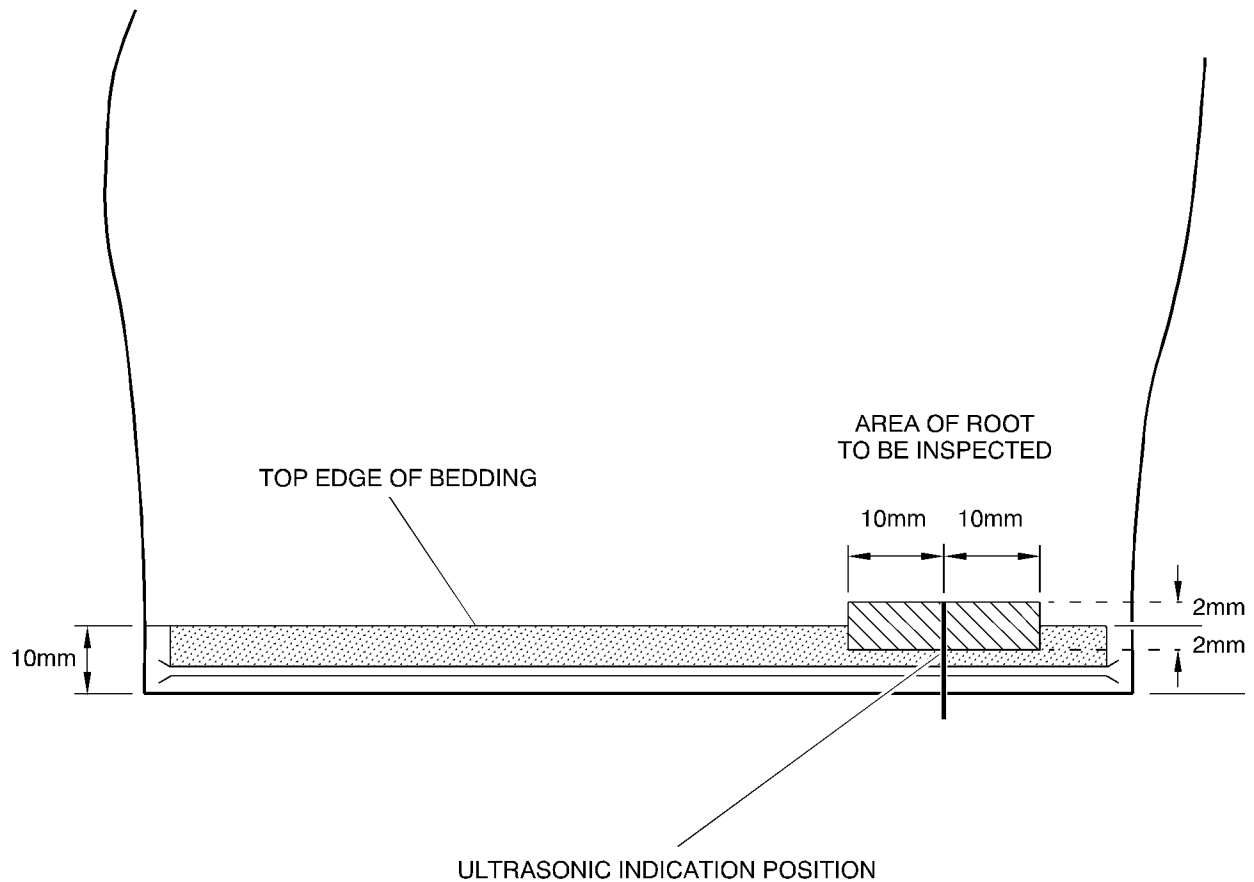
Inspection areas
Appendix 2, Fig.1

This technique covers the additional binocular inspection of V2500 fan blade roots for possible top edge of bedding cracking, detected by ultrasonic inspection as shown in Appendix 2, Figure 1.

(1) Reject any blade exhibiting a crack-like feature running axially along the root in the inspected region.

(2) Reject any blade exhibiting a 'scar' or crater-like feature.
