V2500-A1/A5/D5 SERIES PROPULSION SYSTEMS SERVICE BULLETIN

MODIFICATION SERVICE BULLETIN - ENGINE - LP COMPRESSOR - IMPROVED REPAIR PARTS FOR ACOUSTIC LININGS OF FAN CASE

V2500-ENG-72-0392

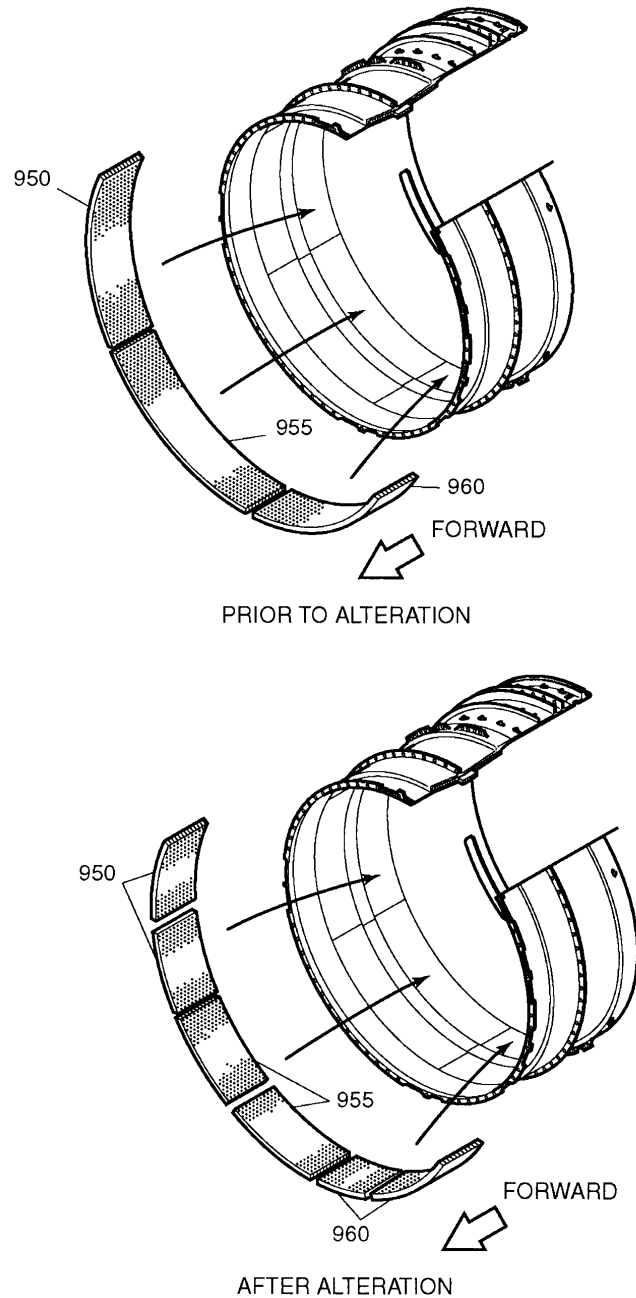
- (i) To change the adhesive for perforated skin end of acoustic lining.
- (ii) To decrease circumferential length of acoustic lining to a half of current parts.
- (iii) To increase the quantity of acoustic lining to 12 from 6 for each engine.
- (iv) To provide a water drainage feature and eliminate possibility of incorrect installation.

Repair Parts for Acoustic area - Before and after alteration
Figure 1

- (1) The part introduced by this Service Bulletin must be fitted as a complete location set to increase reliability. This Service Bulletin configuration partitions an old part into two small parts. If old configuration lining became damaged, each one can be removed and replaced with two new configuration linings.
