V2500-D5 PROPULSION SYSTEMS SERVICE BULLETIN

This document transmits Revision 2 to Service Bulletin EV2500-72-0393

ENGINE - HP COMPRESSOR VSV SYSTEM INSPECTION - NON-MODIFICATION SERVICE BULLETIN

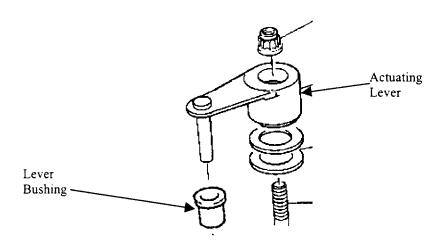
Figure 1 – VSV System

- C. General condition of stage 3 VSV system (see Fig 1 and 2)
 - (1) Visually inspect the stage 3 VSV actuating levers and lever pin bushings (72-41-34, part number UP11069)

- (a) If a cracked lever is found Replace lever, see AMM 75-31-02
 - (b) If a bent lever is found Replace lever within 50 cycles, see AMM 75-31-02
 - (c) If a broken lever is found Reject engine

- (d) If less than 22 bushings are found missing/incomplete Replace bushings within 50 cycles, see 3.H.
 - (e) If more than 22 of the bushings are found missing/incomplete Replace bushings within 50 cycles, see 3.H. - Accomplish Service Bulletin V2500-ENG-72-0373 within 50 cycles

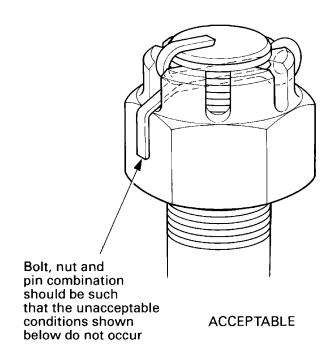
R R Installation of split cotter pin Fig 11

<u>CAUTION</u>: ENSURE THAT COTTER PIN IS CORRECTLY FITTED. REFER TO FIGURE 11

Prongs too long — causes fatigue failure

Head and upper prong not firmly seated against bolt

Split cotter pin more than half its diameter above the nut slots

Prong bent around castellations of nut

UNACCEPTABLE CONDITIONS

Ensure that castellated nut EIPC 72-41-34, Fig 1, item 230, is secured with split cotter pin EIPC 72-41-34, Fig 1, item 228.
