V2500-A1/A5 SERIES PROPULSION SYSTEMS SERVICE BULLETIN

This document transmits Revision 1 to Service Bulletin EV2500-72-0394

V2500-ENG-72-0394

ENGINE – PROVIDE NEW LOOP CLAMP BRACKET FOR USE WITH NON AT RISK FUEL MANIFOLDS

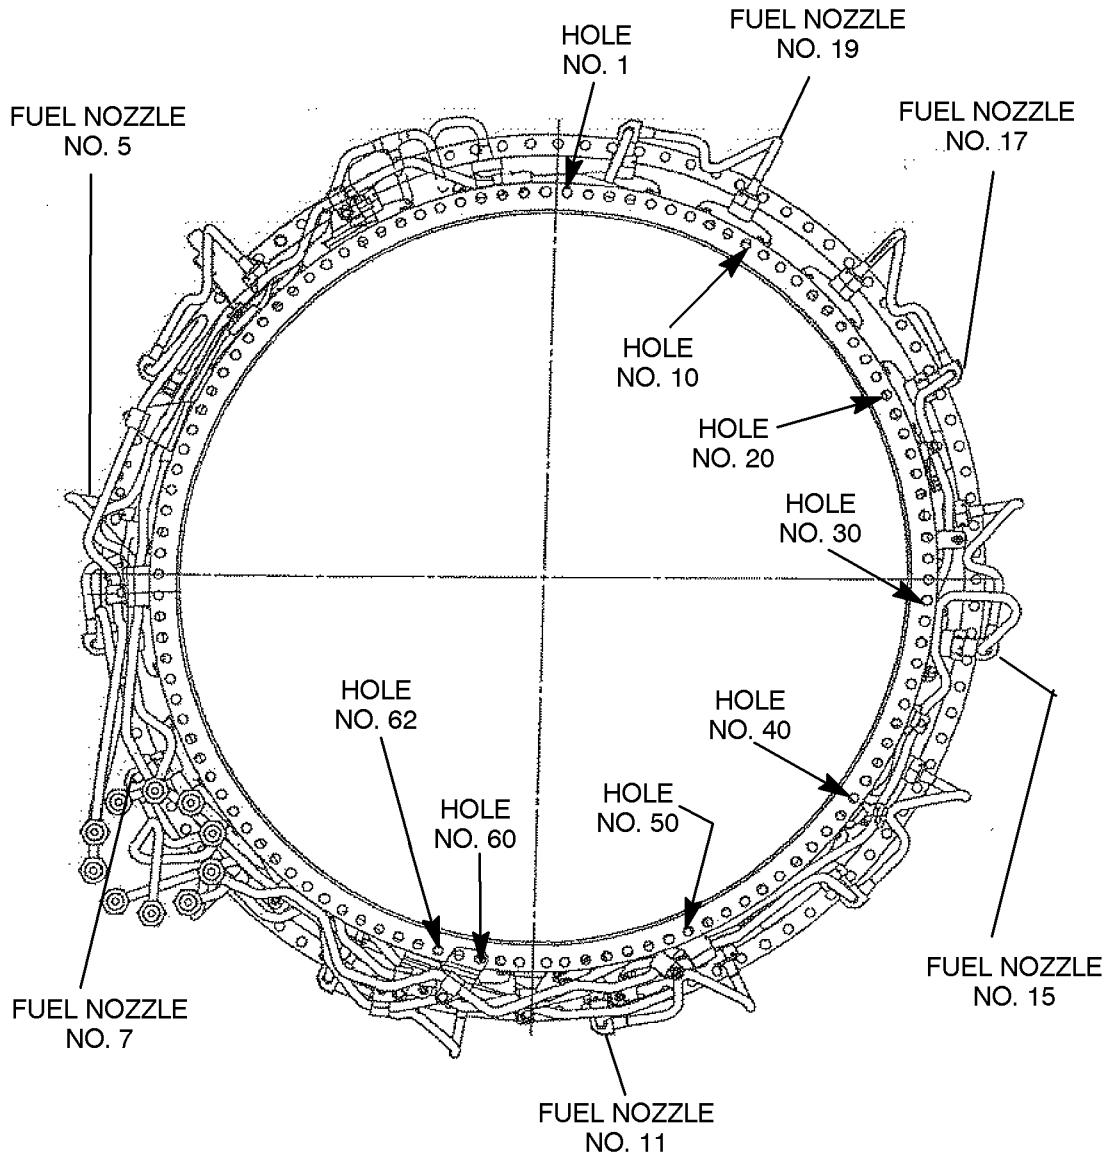
Flange K
Fig 1

During engine assembly, it was noted there is a close clearance condition between the fuel manifold part number 2A3264-01 with an adjacent tube clamp bolt head located on bracket part number 2A3389.

Replace bracket part number 2A3389 at hole 62 and 63 (as viewed facing rearward counting clockwise from the 12 o'clock position, see figure 1) with a redesigned bracket featuring a bent tab to provide additional bolt clearance.

- (1) Remove the existing bracket part number 2A3389 as follows:
 - (a) Locate the bracket on K flange at bolt holes 62 and 63. See Figure 1 for location of the part.

- (a) Install the new bracket on K flange at bolt holes 62 and 63. See Figures 1 and 2.
 - (b) Torque the flange nuts by the procedure specified in reference (3), Engine Manual, Chapter/Section 72-00-42, Installation-01.

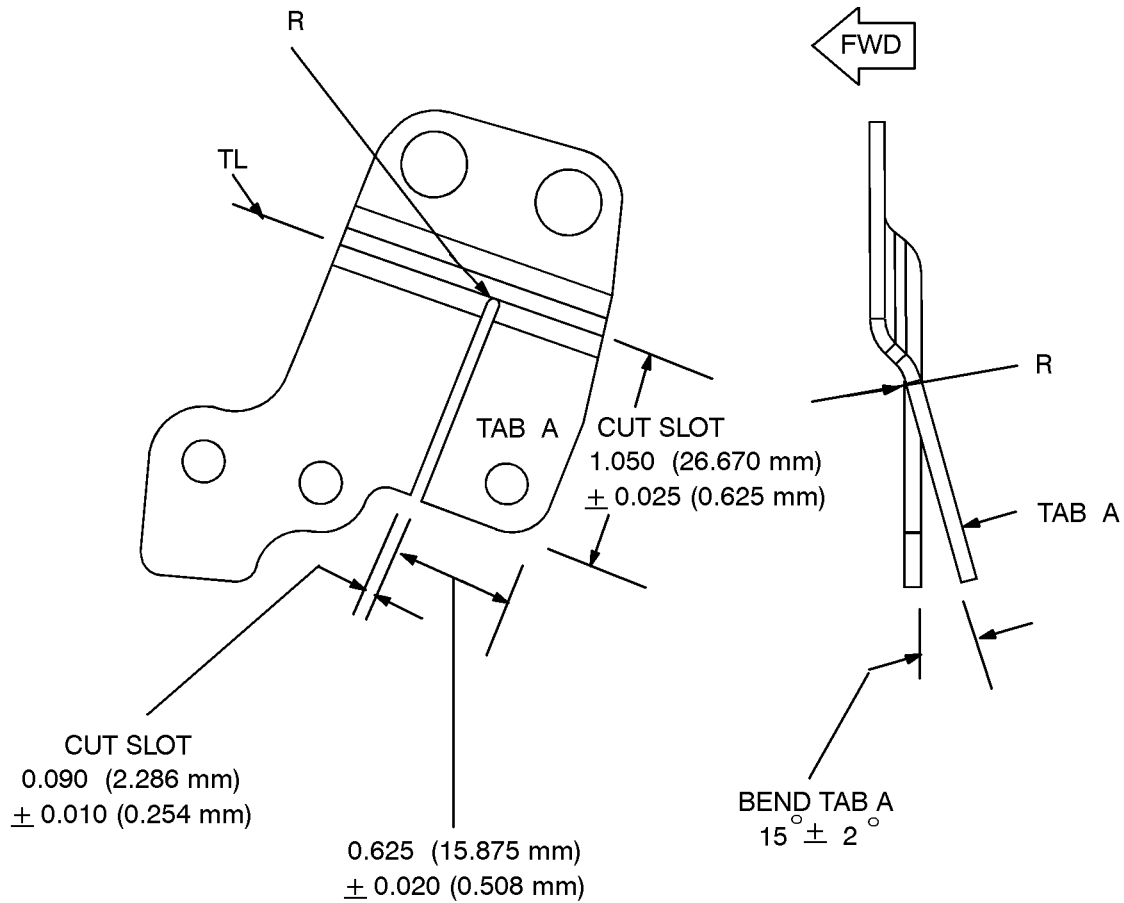
Bracket modification
Fig 3

MODIFY BRACKET 2A3389 AND IDENTIFY TO 2A3553

- (2) Rework the bracket part number 2A3389 as follows:
 - (a) Produce a slot 1.050 inch (26.670 mm) long (+/- 0.025 inch (0.625 mm)), by 0.090 inch (2.286 mm) wide (+/- 0.010 inch (0.254 mm)) in the bracket. The slot shall be parallel to the right edge of the bracket. The right edge of the slot shall be 0.625 inch (15.875 mm) (+/- 0.020 inch (0.508 mm)) from the right edge of the bracket. The end of the slot shall feature a 0.045 inch (1.143 mm) radius (+/- 0.005 inch (0.127 mm)). See Figure 3.

- (b) Bend back (toward engine rear) 15 degrees (+/- 2 degrees), the portion of the bracket to the right of the slot. See Figure 3.
 - (c) Inspect the bracket per VIS 517.

- (d) Identify the reworked bracket to part number 2A3553 in accordance with reference 3 the V2500 Standard Practices/Processes Manual, 70-00-00.
- (3) Assemble the new bracket part number 2A3553 as follows:
