V2500-A1 SERIES PROPULSION SYSTEMS SERVICE BULLETIN

V2500-ENG-72-0397

ENGINE – MAIN GEARBOX ASSEMBLY – INSPECTION OF THE SCAVENGE PUMP DRIVE GEAR ASSEMBLY
– NON-MODIFICATION SERVICE BULLETIN

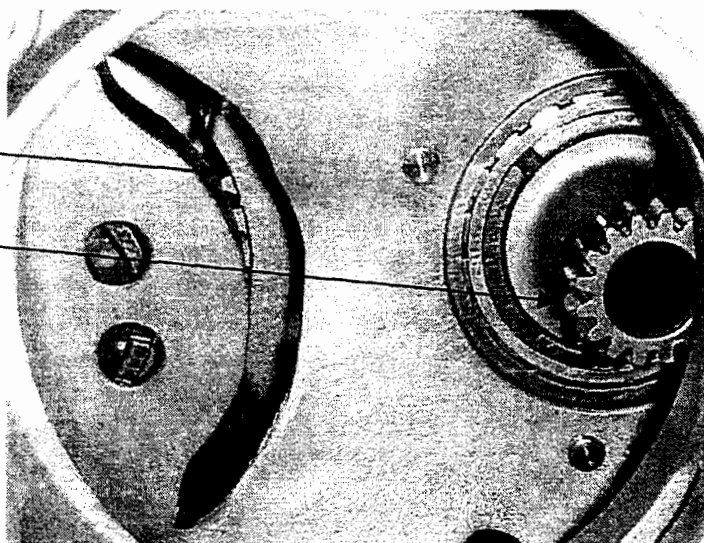
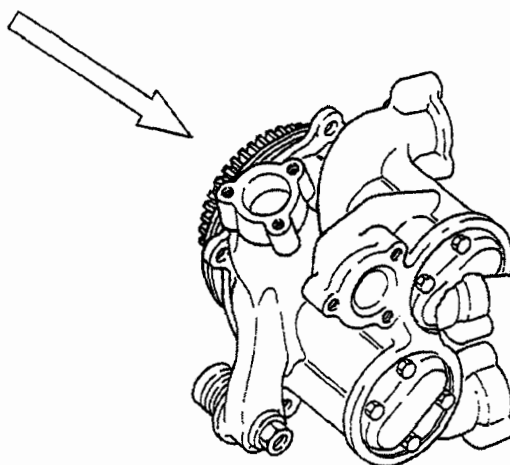
Gear Locations
Fig 1

61 teeth spur gear

16 teeth spur gear

VIEW with Scavenge Pump Removed.
Scavenge Drive Gear Assembly (72-60-26, 01-140) installed

SCAVENGE OIL PUMP DRIVE
GEAR

79-22-41, 01-300

- R (1) Examine the condition of the drive gear (79-22-41, 01-300) on the oil scavenge pump. Refer to Fig 1 and 2.
- (a) If required, use a 5x magnifying lens and observe the contact area of the gear teeth.

- R (2) Examine the condition of the oil scavenge drive gear assy (72-60-26, 01-140) of the main gearbox. Refer to Fig 1, 2 and 3.
- R (a) If required, use a 5x magnifying lens and inspect the 16 teeth spur gear.

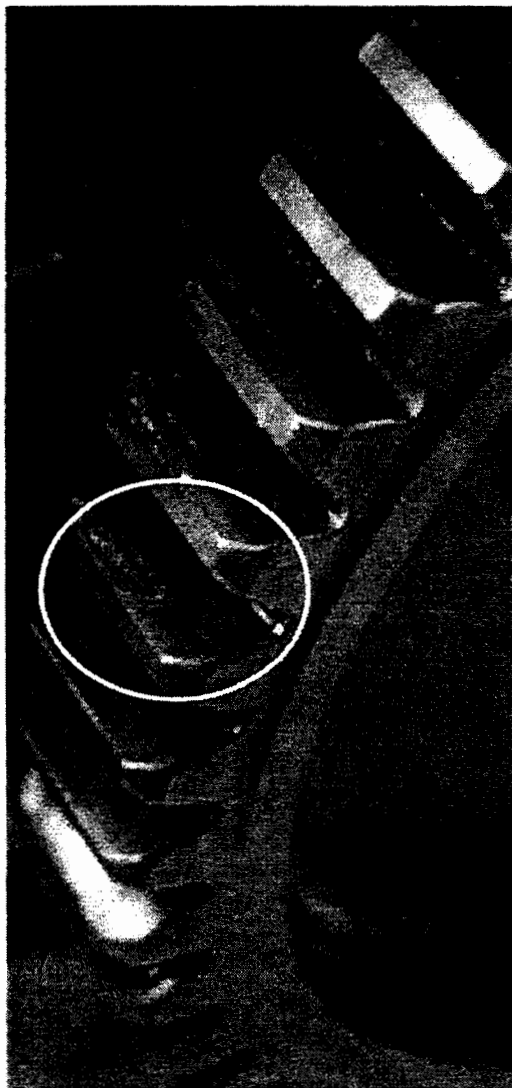
Fig 2

There have been two In Flight Shut Downs (IFSD) resulting from the fracture of the scavenge pump drive gearshaft. Investigation shows the fractures were caused by abnormal loading. An indication of abnormal loading is micro-pitting on the gear teeth of the scavenge pump drive gearshaft that drives the scavenge pump.

Micro-pitting gives the gear tooth a frosted, matte or grey stained appearance under magnification, the surface appears to be covered with very fine pits.

Wear/micro-pitting on the oil scavenge drive gear (79-22-41, 01-300), reject condition

- R (b) If micro-pitting is found outside the limits defined in part 3.D. replace the gear, as detailed in CMM TASK 79-22-41-060-401.
- (c) Make sure the scavenge pump complies with SIL 158 soft time recommendation.

(1) If micro-pitting is observed over more than 10 percent of the whole area of the gear teeth, reject the gear.

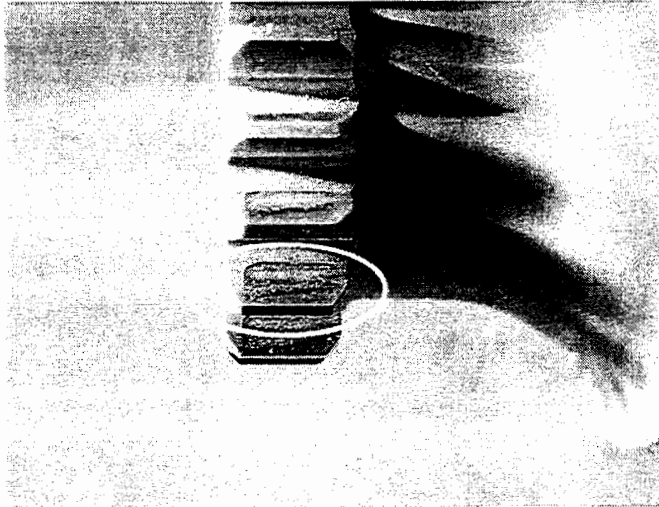
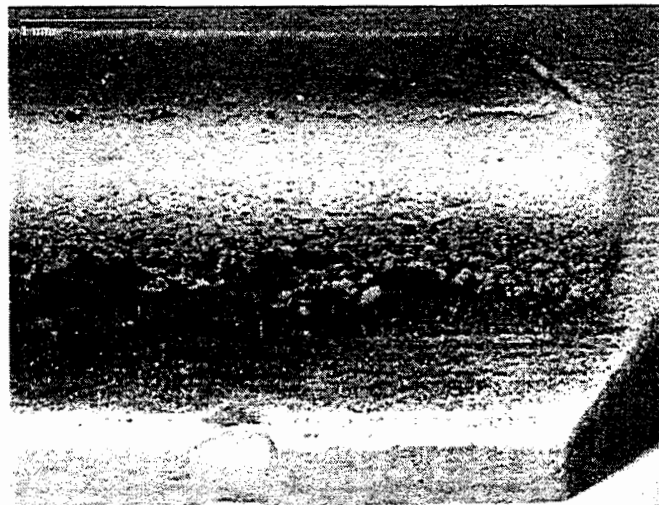
Scavenge drive gear assembly, Z16 spur gear, reject micro-pitting condition
Fig 3

Example of Micropitting
(visual examination, surface appears to be covered with very fine pits)

- (b) If micro-pitting is found outside the fly-on limits defined in part 3.D. replace the whole assembly as detailed in 3.C.(3).
- R (c) If no micro-pitting is found on the 16 teeth spur gear, then continue with the inspection that follows.

(2) If micro-pitting is found over less than 10 percent of the whole contact area of the gear teeth, the gearbox may be acceptable for a further 150 hours service operation.
