V2500-A5 PROPULSION SYSTEMS SERVICE BULLETIN

This document transmits Revision 3 to Service Bulletin EV2500-72-0399

V2500-ENG-72-0399
Transmittal - Page 1 of 2

ENGINE – PROVIDE A NEW 2ND STAGE TURBINE ROTOR BLADE RETENTION CONFIGURATION

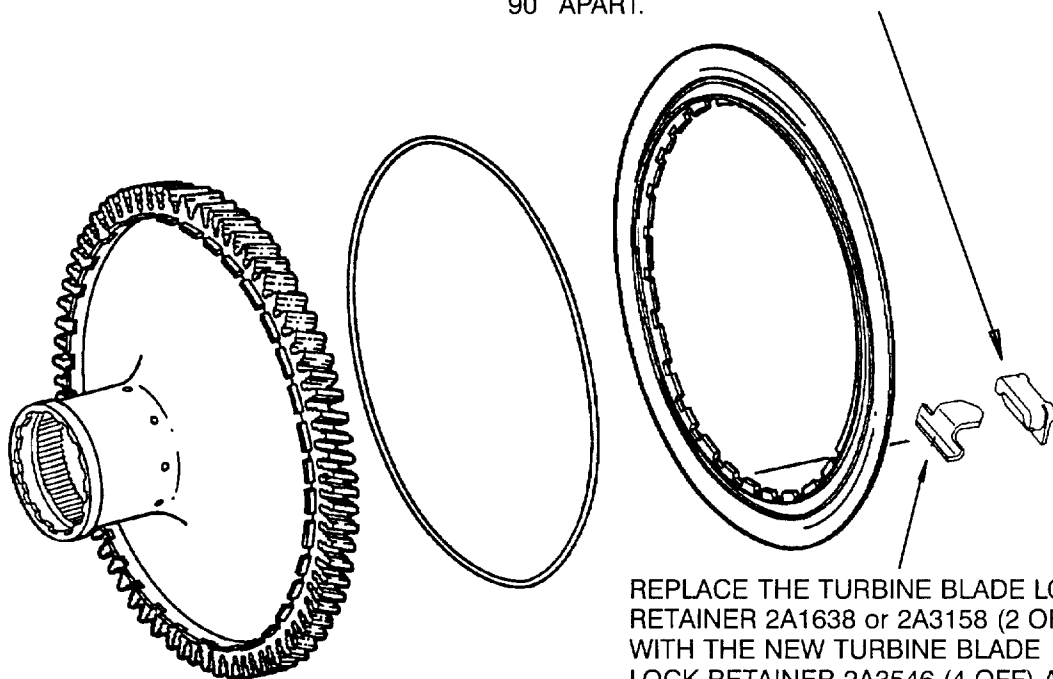
Location of the stage 2 turbine blade lock retainers
Fig 1

REPLACE THE HPT LOCK 2A1097 (2 OFF) WITH THE NEW TURBINE BLADE LOCK RETAINER 2A3545 (4 OFF) AT FOUR SLOT LOCATIONS 90° APART.

REPLACE THE TURBINE BLADE LOCK RETAINER 2A1638 or 2A3158 (2 OFF) WITH THE NEW TURBINE BLADE LOCK RETAINER 2A3546 (4 OFF) AT FOUR SLOT LOCATIONS 90° APART.

- (a) Select 4 slot locations 90 degrees apart for Retainer/Lock installation. (See Figure 1).
 - (b) Install 2nd Stage High Pressure Blade Lock Retainers, P/N 2A3546 four (4) off and Turbine Blade Locks, P/N 2A3545 four (4) off.
