## V2500-A1/A5/D5 PROPULSION SYSTEMS SERVICE BULLETIN

# V2500-ENG-72-0401

ENGINE – PROVIDE NICKEL PLATING ON THE NUMBER 4 CARBON SEAL HOUSING PILOT DIAMETER

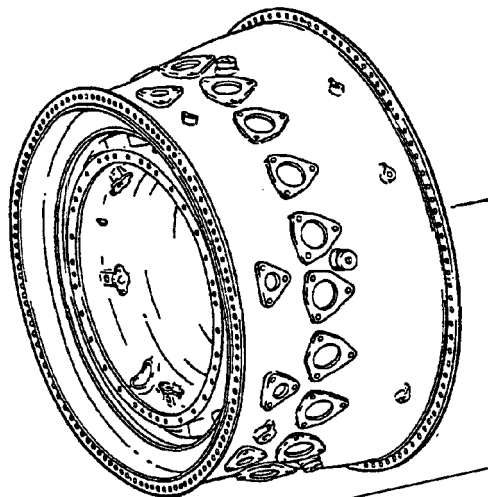
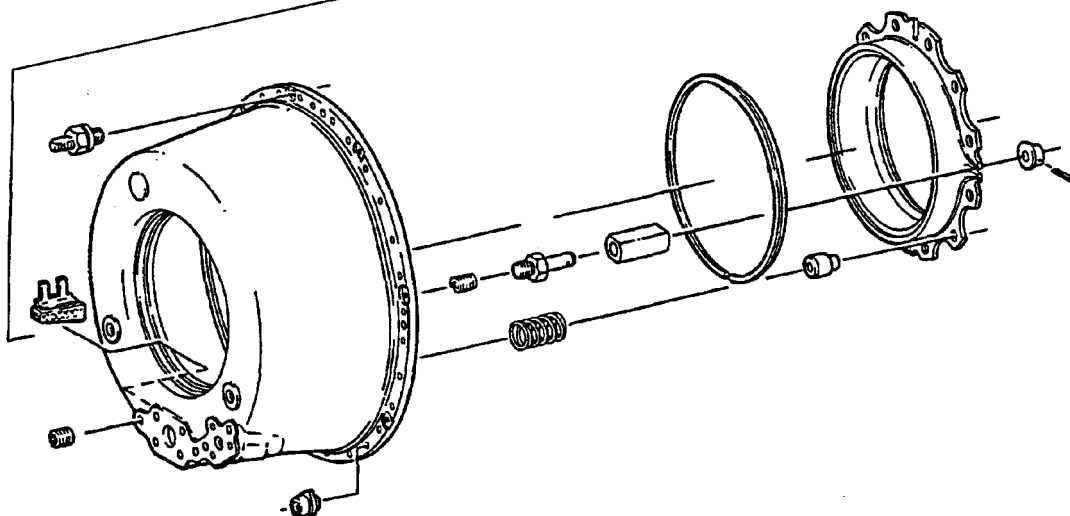
Engine - No.4 bearing front seal assembly  
Fig 1

Multiple engine teardown inspections at overhaul were carried out and revealed abnormal fretting wear on the Front Carbon Seal Housing pilot diameter. This problem is believed to be a contributing factor to lose oil at sub-idle condition as part of number 4 compartment oil loss into High Pressure Turbine (HPT) investigation.

- (2) For V2500-A1/A5 Engines.
  - (a) Replace the No. 4 Bearing Support Assembly, PN 2A2833 with 2A3537.
    - (i) When you assemble the No. 4 Bearing Front Seal Assembly, PN 2A3538 or 2A3581 install the No. 4 Bearing Seal Support Assembly PN 2A3537 (1 off) by the procedure given in Reference (6), Chapter/Section 72-42-33, Assembly. Refer to Figure 1.

- (i) When you assemble the No. 4 Bearing Front Seal Assembly, PN 2A3538 or 2A3581 install the No. 4 Bearing Seal Support Assembly PN 2A3537 (1 off) by the procedure given in Reference (6), Chapter/Section 72-42-33, Assembly. Refer to Figure 1.
- (ii) Identify the 2A2930 or 2A3525 No. 4 Bearing Front Seal Assembly as 2A3581 or 2A3538 respectively by the procedure given in Reference(4), Chapter/Section 70-09-00 Marking of Parts.
- (iii) Install the No. 4 Bearing Front Seal Assembly, PN 2A3538 or 2A3581 by the procedure given in Reference (6) Chapter/Section 72-42-30, Assembly
