## V2500-A5/D5 PROPULSION SYSTEMS SERVICE BULLETIN

# V2500-ENG-72-0403

ENGINE – HP COMPRESSOR SHAFT – INTRODUCTION OF REVISED HP COMPRESSOR REAR SHAFT  
ASSEMBLY WITH NO.4 BEARING LOCATION COATING (A5 & D5 MODELS)

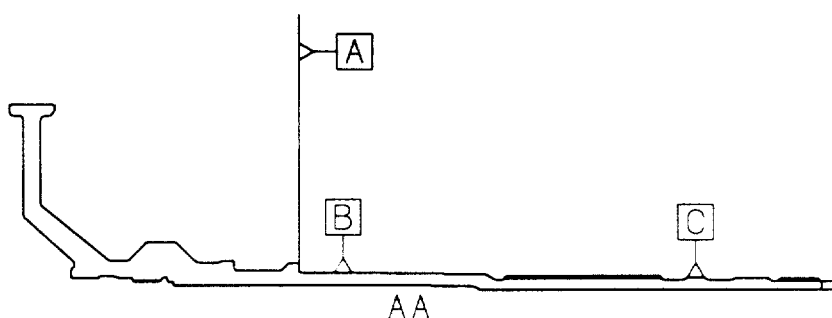
Rework of HP compressor rear shaft  
Fig 1

Wear has been observed on the HP Compressor rear shaft and the inner race of the No.4 bearing. In extreme cases this may result in the fit between the components exceeding acceptable limits.

R This is attributed to the variation in thermal expansion of components throughout the flight cycle, causing movement of the bearing inner ring relative to the shaft, resulting in fretting.

(2) Existing HP Compressor rear shaft assemblies may only be reworked providing that the No.4 Bearing diameter (identified as ZONE AB) has not been repaired with Chromium Plate in accordance with repair VRS6509 – see Figs 1 and 2.

- (i) A recess is machined into the diameter of the shaft at the No.4 bearing location to a controlled depth of 0,076mm to 0,152mm, with a width sufficient to ensure the final run-out of applied coating is well beyond the front and rear faces of the bearing.

(b) A tungsten carbide cobalt coating is applied to the recess and machine ground back in order to maintain the current No.4 bearing location diameter.
