## V2500-A1 PROPULSION SYSTEMS SERVICE BULLETIN

This document transmits the Revision 1 of Service Bulletin V2500-ENG-72-0404.

ENGINE – HP COMPRESSOR SHAFT – INTRODUCTION OF REVISED HP COMPRESSOR REARSHAFT  
ASSEMBLY WITH NO.4 BEARING LOCATION COATING (A1 MODEL)

**V2500-ENG-72-0404**

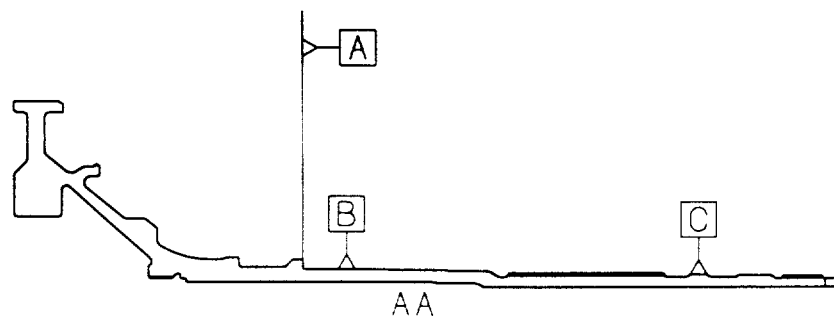
Rework of HP compressor rear shaft  
Fig 1

Wear has been observed on the HP Compressor rear shaft and the inner race of the No.4 bearing. In extreme cases this may result in the fit between the components exceeding acceptable limits.

R This is attributed to the variation in thermal expansion of components throughout the flight cycle, causing movement of the bearing inner ring relative to the shaft, resulting in fretting.

- (1) This Service Bulletin introduces an anti-fretage coating to the No.4 bearing location diameter of the HP compressor rear shaft assembly in order to minimise fretage and eliminate loss of fit between these two components.

- (a) A recess is machined into the diameter of the shaft at the No.4 bearing location to a controlled depth of 0,076mm to 0,152mm, with a width sufficient to ensure the final run-out of applied coating is well beyond the front and rear faces of the bearing.
- (b) A tungsten carbide cobalt coating is applied to the recess and machine ground back in order to maintain the current No.4 bearing location diameter.
- (2) Existing HP compressor rear shaft assemblies may only be reworked providing that the No.4 Bearing diameter (identified as ZONE AB) has not been repaired with Chromium Plate in accordance with repair VRS6509 – see Figs 1 and 2.
- (3) For effect on declared life see Time Limits Manual 5-10-01.

| <p>(b) Install the HP compressor rear shaft assembly on to the fixture and set to turn correctly</p> | <p>Refer to Fig 1 and Fig 2. Use a dial test indicator and standard workshop equipment. Make sure that datums A, B and C are set to turn correctly</p> |
| <p>(c) Grind the HP compressor rear shaft assembly</p> | <p>Refer to Fig 1 and Fig 2. Refer to approved vendor process</p> |

| <p>(10) Cold ferric chloride etch surface AB on the HP compressor rear shaft</p> | <p>Refer to Fig 1 and Fig 2. Refer to SPM TASK 70-11-39-300-503, SUBTASK 70-11-39-300-001. Use chemical cleaning equipment</p> |
| <p>(11) Visually examine surface AB on the HP compressor rear shaft</p> | <p>Refer to Fig 1 and Fig 2. Use X10 binoculars. Indications of defects are not permitted</p> |
| <p>(12) Do a local penetrant crack test on surface AB of the HP compressor rear shaft</p> | <p>Refer to Fig 1 and Fig 2. Refer to SPM TASK 70-23-05-230-501. Use CoMat 06-022 fluorescent penterant, with penetrant crack test equipment. Cracks are not permitted</p> |

| (14) Apply the metal spray hard coating to surface AB on the HP compressor rear shaft | Refer to Fig 1 and Fig 2. Refer to vendor approved process |
