DATE ~~R~~ Aug.20/02**V2500-A5/D5 PROPULSION SYSTEMS SERVICE BULLETIN**

**V2500-ENG-72-0405**  
 Transmittal - Page 1 of 2

ENGINE – PROVIDE NEW NUMBER FOUR BEARING FRONT AND REAR SEALS

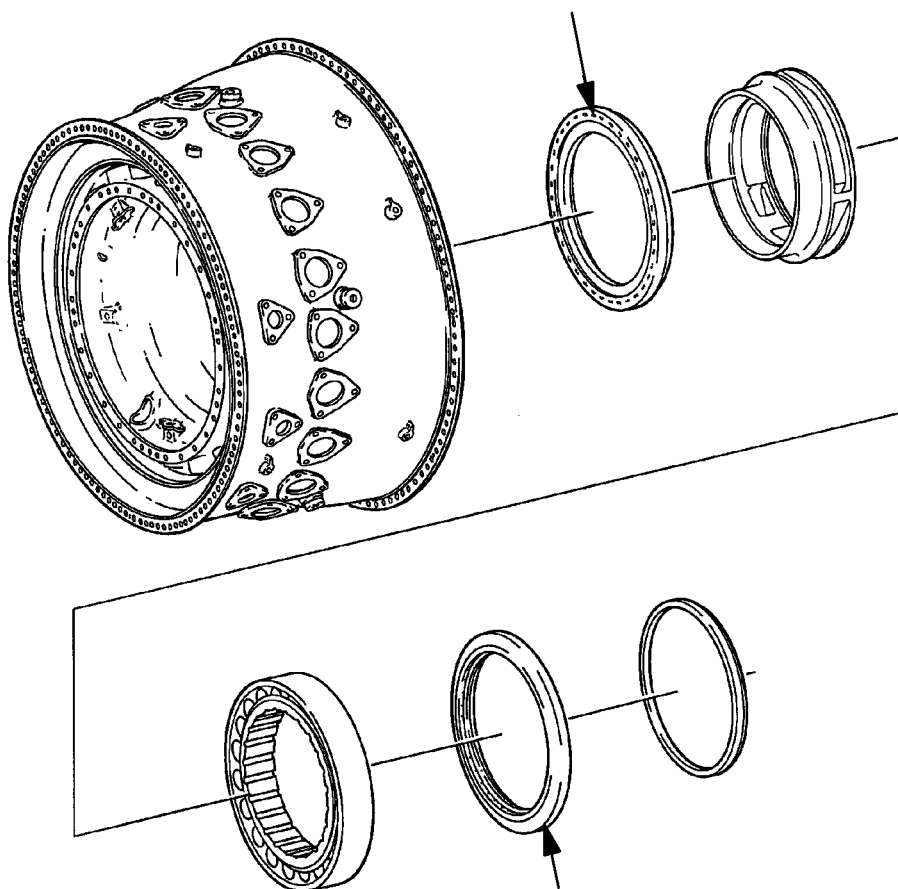
Front and rear seat No.4 bearing seal  
Fig 1

Black oil is being experienced on the V2500.

(a) Engines that operate in hot environments have been found to generate black oil.

(a) Redesign seal plates by relocating the oil pool drain exit hole orientation from axial to radial. This will improve cooling effectiveness and minimize generation of black oil.

REPLACE SEAT NO. 4 BEARING  
SEAL FRONT PN 2A0066 OR  
2A1998 WITH 2A3432

REPLACE SEAT NO. 4 BEARING  
SEAL REAR PN 2A0067 OR  
2A1999 WITH 2A3433
