DATE: **Aug.22/01****V2500-A1/A5/D5 SERIES PROPULSION SYSTEMS SERVICE BULLETIN**

This document transmits the Initial Issue of Service Bulletin EV2500-72-0408

V2500-ENG-72-0408

ENGINE – INTERNAL GEARBOX ASSEMBLY – FBC TROUBLESHOOTING AND TEARDOWN PROCEDURE –
NON-MODIFICATION SERVICE BULLETIN

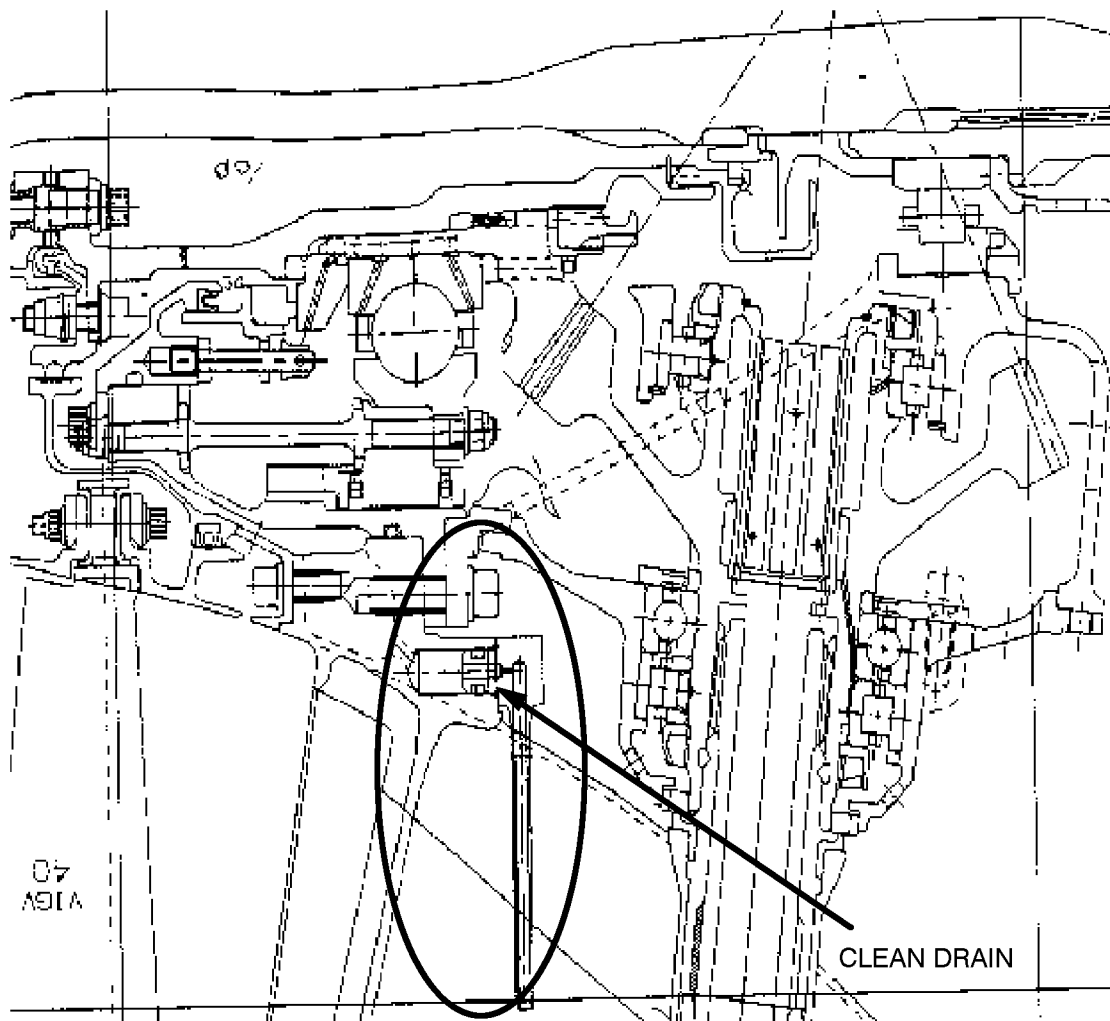
Intermediate case drain
Fig 1

- (b) Inspect drain hole at location No.6 from the engine cross section (See Figure 5) for blockage. If blocked, submit debris to IAE for analysis. Ensure drain hole is clear prior to reassembly (Pre SBE 72-0211 CMM 72-32-38-100-101, Post SBE 72-0211 EM 72-32-03-100-003). See Figure 1.

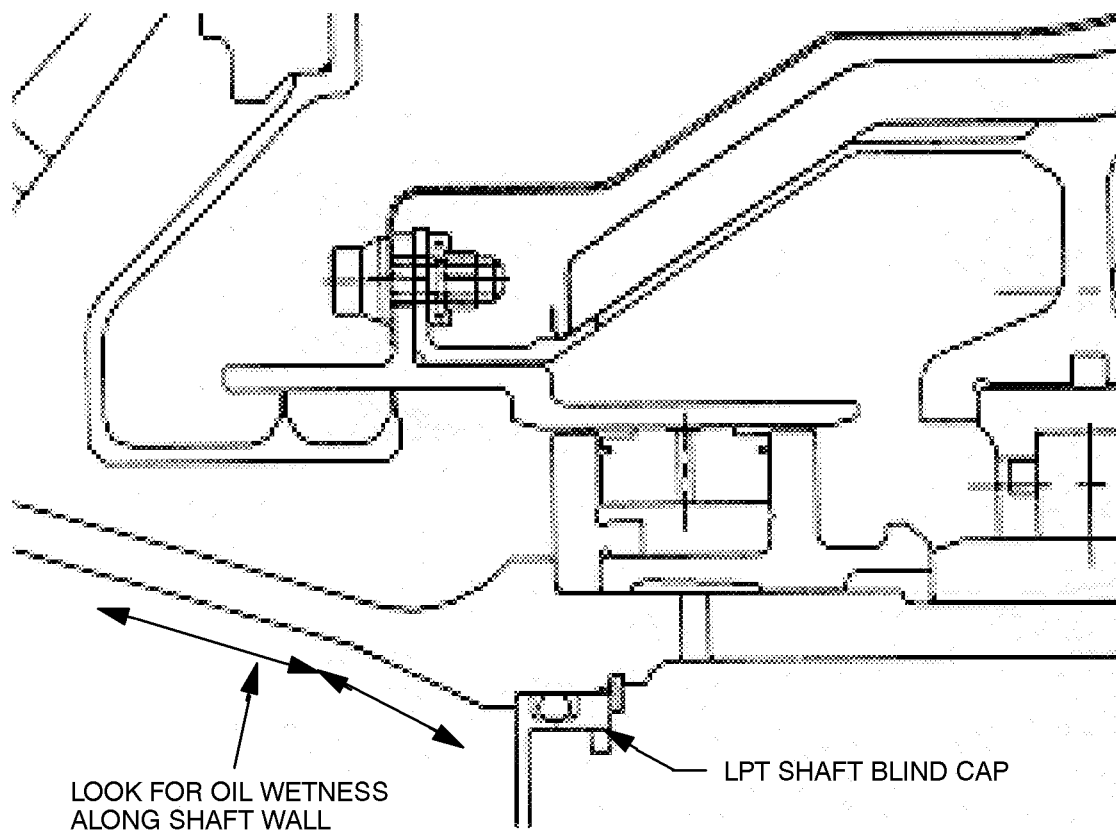
LPT shaft blind cap
Fig 2

- (1) On wing troubleshooting for the engine and aircraft to prevent unnecessary engine removal.
- (2) If engine oil consumption is greater than 0.3 qts/hr, follow All Operators Wire 1050, Issue 2. See Reference (4).
- (3) Is the number 5 bearing compartment LPT shaft blind cap leaking, determine after removal of the LPC spinner (AMM ATA 72-38-11, Page Block 401). If leakage found, replace seal and properly seat the blind cap (Airbus SIL21-029, Page Block 201, Environmental Control Systems decontamination procedure) (ATA 21-00-00).

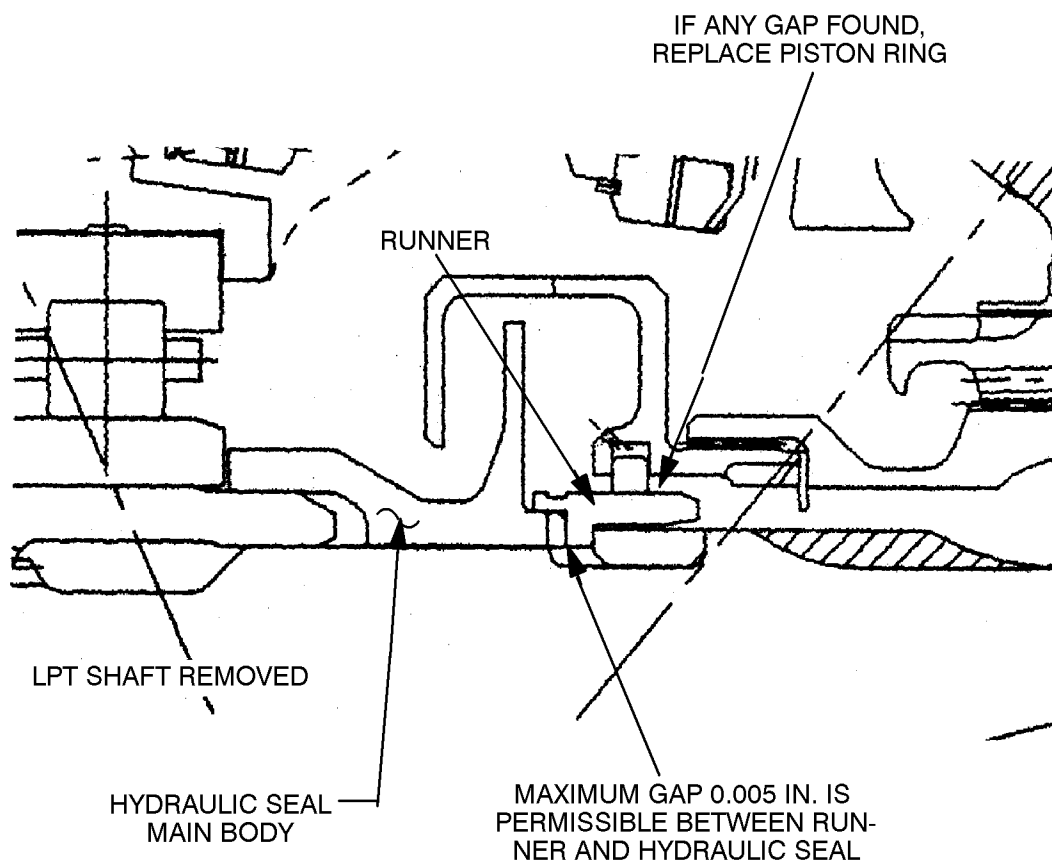
Hydraulic seal inspections for assembly problems
Fig 3

- (i) Take close up digital pictures of the piston ring and inside of the hydraulic seal, paying particular attention to any oil coking.
 - (ii) Disassemble piston ring of hydraulic seal and inspect for air gap in between runner and piston ring interface. Replace piston ring if gap is found. See Figure 3.

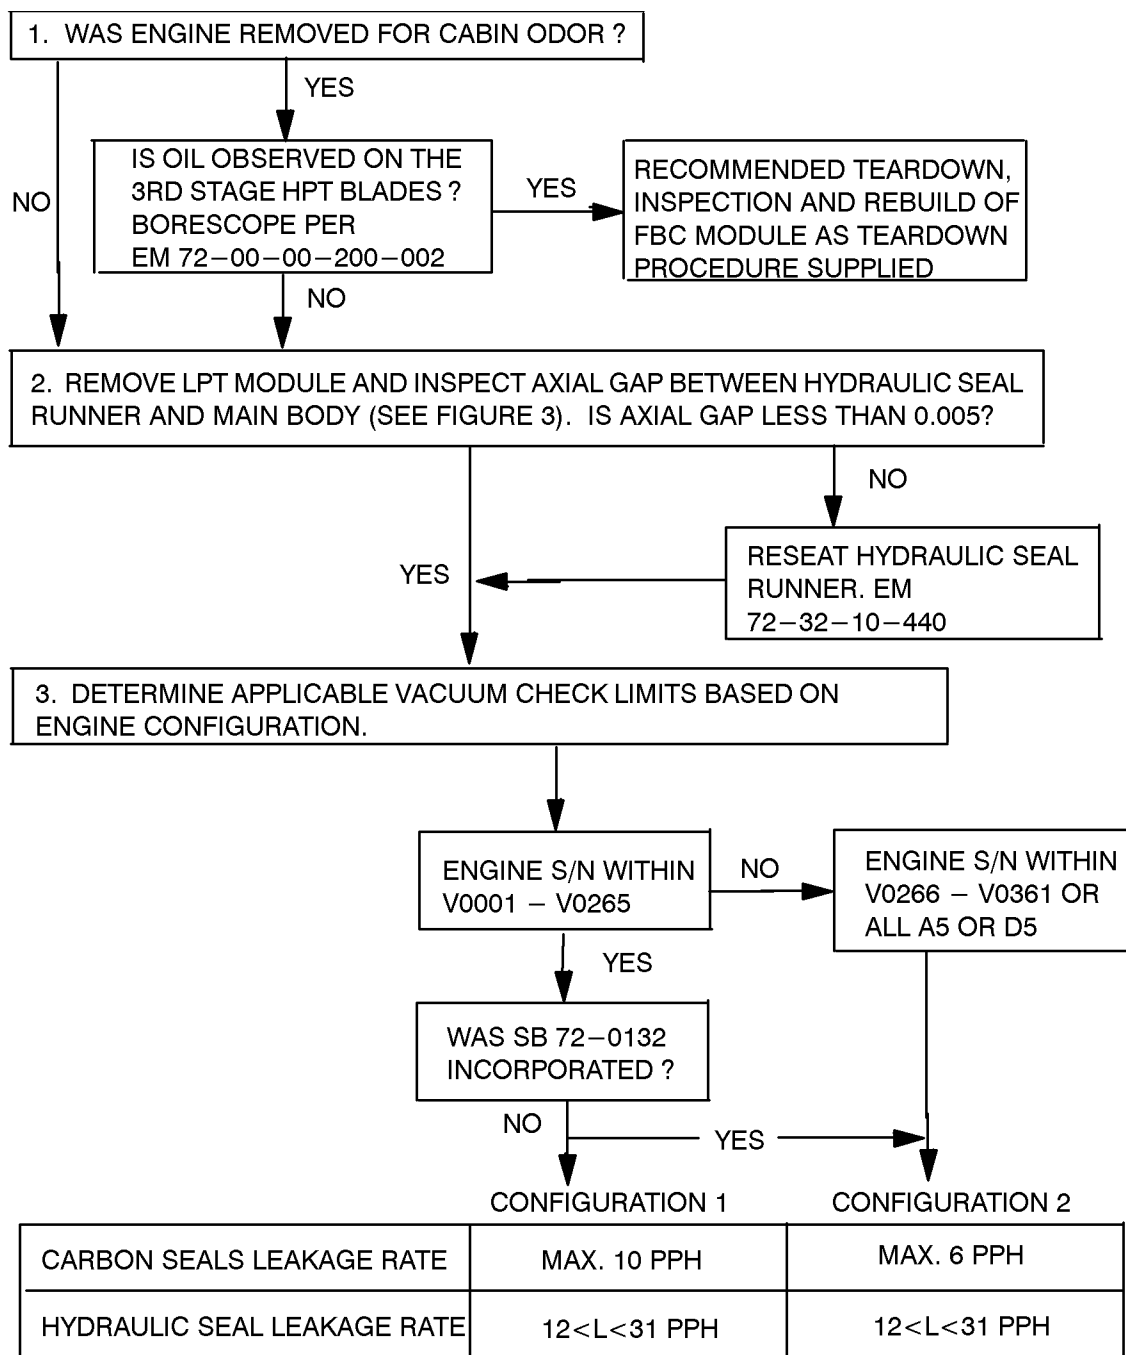
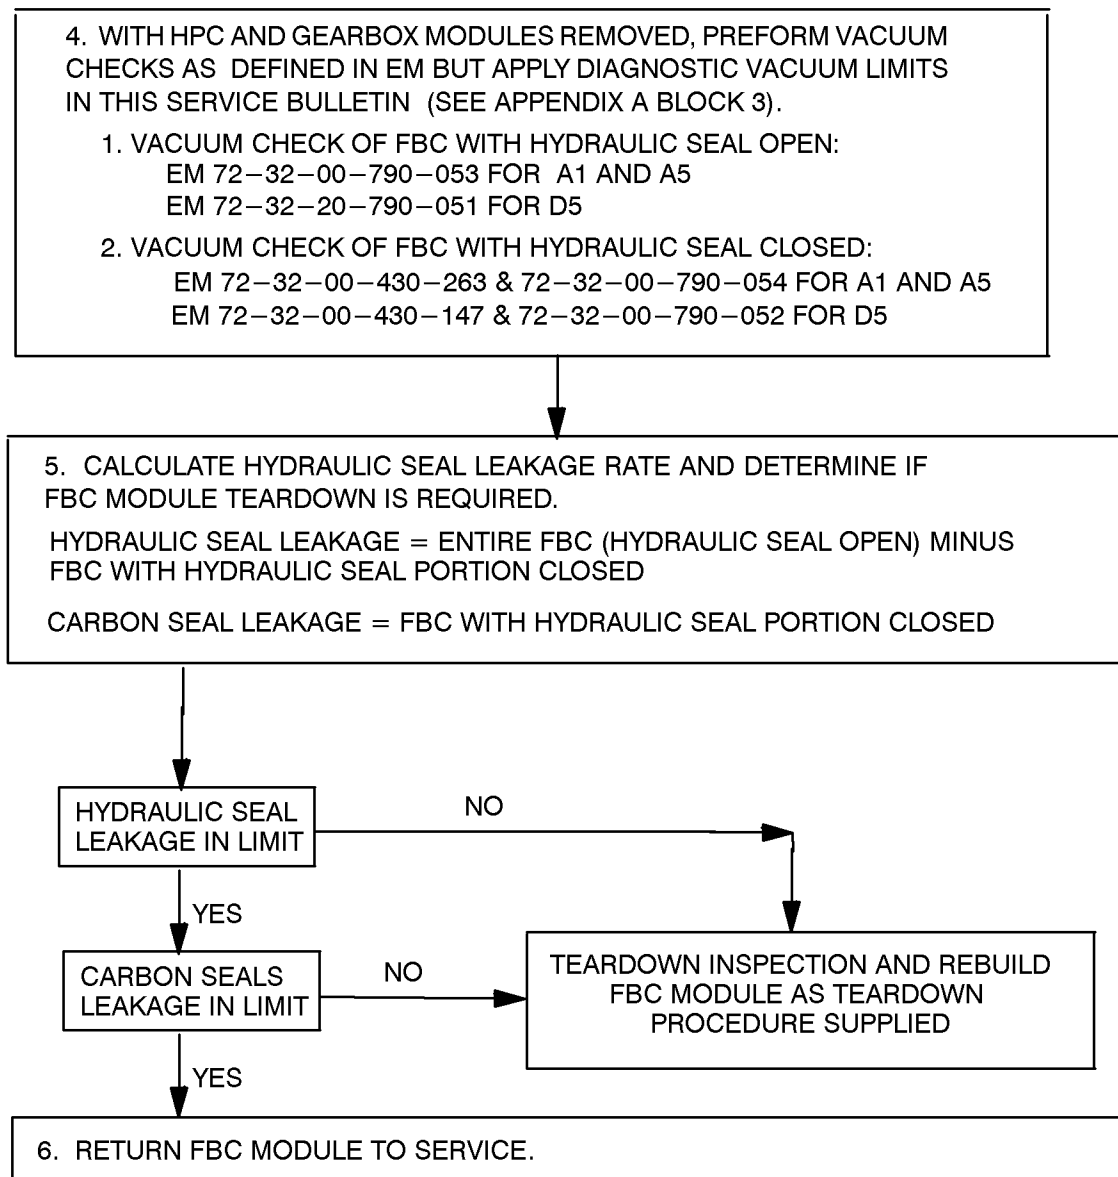
E8405
PWHTeardown decision flowchart (Appendix A)
Fig 4 (sheet 1)

- (1) Follow Teardown Decision Flowchart in Figure 4 – Appendix A. The results of all inspections to be recorded in Appendix B – Table 1, Part 1 and returned to IAE Technical Services via PSCOMM through local IAE representatives.

- (2) Front Bearing Compartment (FBC) teardown as required from flowchart in Figure 4 – Appendix A

NOTE: The FBC vacuum check limits defined in this NMSB are for diagnostic purposes only before disassembly of the FBC. The limits as defined in the EM at assembly are not affected (Ref. Step four (4) of Appendix A flowchart).

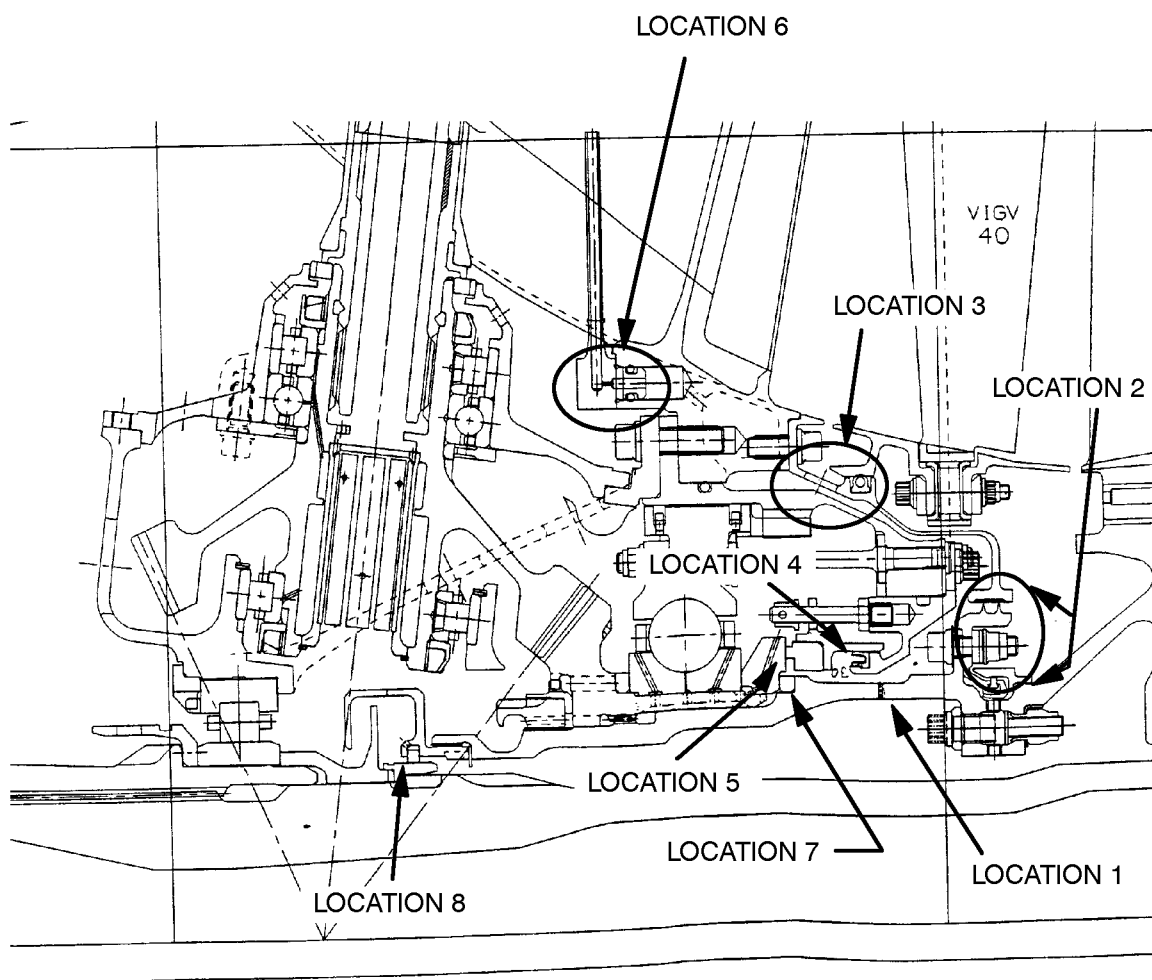
Engine inspection locations (Appendix C)
Fig 5

- (a) Take close up digital pictures at the following locations for any sign of oil staining or coking (See Figure 5 in Appendix C for more detail).

(i) Location No.1: Drain hole in HPC stub shaft (inside and outside).

(ii) Location No.2: Lab seal area both sides of case.

(iii) Location No.3: Hole exit to compressor area.

- (iv) Location No.4: Carbon seal/sealing ring interface.
- (v) Location No.5: Carbon seal sealing face.
- (vi) Location No.7: HPC adjusting spacer/seal plate interface.

- (c) Record breakaway torque for No.3 bearing nut per EM 72-32-20-040-001 (Record in Table 1).
- (d) Inspect for sign of oil leakage through the seal plate inner diameter and axial HPC adjusting spacer at location No.7 from the engine cross section. See Figure 5.

- 2. Verify for proper HPC adjusting spacer thickness per EM 72-32-20-440-001.
- (e) Visually inspect the piston ring of the hydraulic seal for any damage or evidence of leakage at location No.8 from the engine cross section (See Figure 5), (EIPC 72-32-19, Fig.01 Items 100-200). If any oil leakage found:

- (i) If any oil leakage is observed: Record in Table 1.
 - 1. Inspect contact surfaces of spacer and shaft shoulder for deformation. Replace and/or repair part if deformation is found.
