## V2500-D5 SERIES PROPULSION SYSTEMS SERVICE BULLETIN

# V2500-ENG-72-0409

ENGINE - LP COMPRESSOR FAN BLADES - DOVETAIL ROOT FLANK ULTRASONIC INSPECTION AND  
APPLICATION OF DRY FILM LUBRICANT (ROOT FRETTING/WEAR - SCARRING) - NON-MODIFICATION  
SERVICE BULLETIN

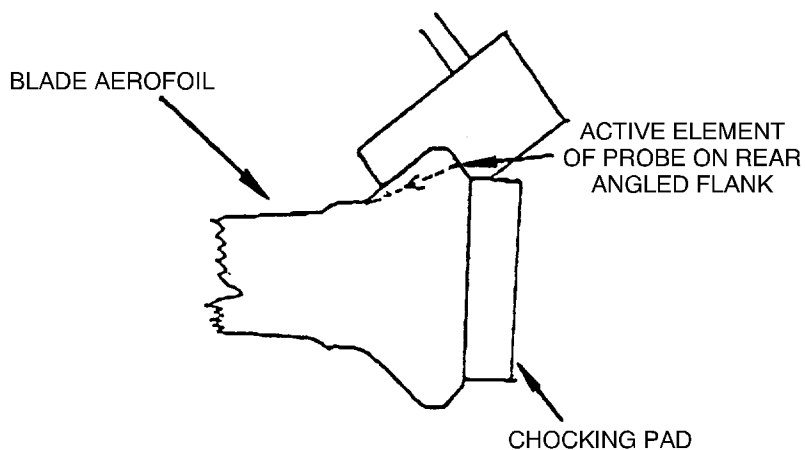
FIGURE 2

Schematic diagram showing position of probe on blade root flank  
Fig 2

- (3) Do an ultrasonic inspection on each of the fan blades
  - (a) Apply the couplant to the concave face of the blade root flank at the area to be inspected. Position the probe at the front of the concave blade root flank and move the probe along the first 2.4in. (60mm) of the chordal width of the blade root. (Refer to Fig 2)

- (e) Apply the couplant to the convex face of the blade root flank at the area to be inspected. Position the probe 1.77in. (45mm) from the front face of the blade root (immediately behind the front chocking pad if still installed) and move the probe along the next 4.33in. (110mm) of the chordal width of the blade root, terminating the inspection at 6.10in. (155mm) from the front face of the blade root (approximately 3.3in. (85mm) from rear face of the root)

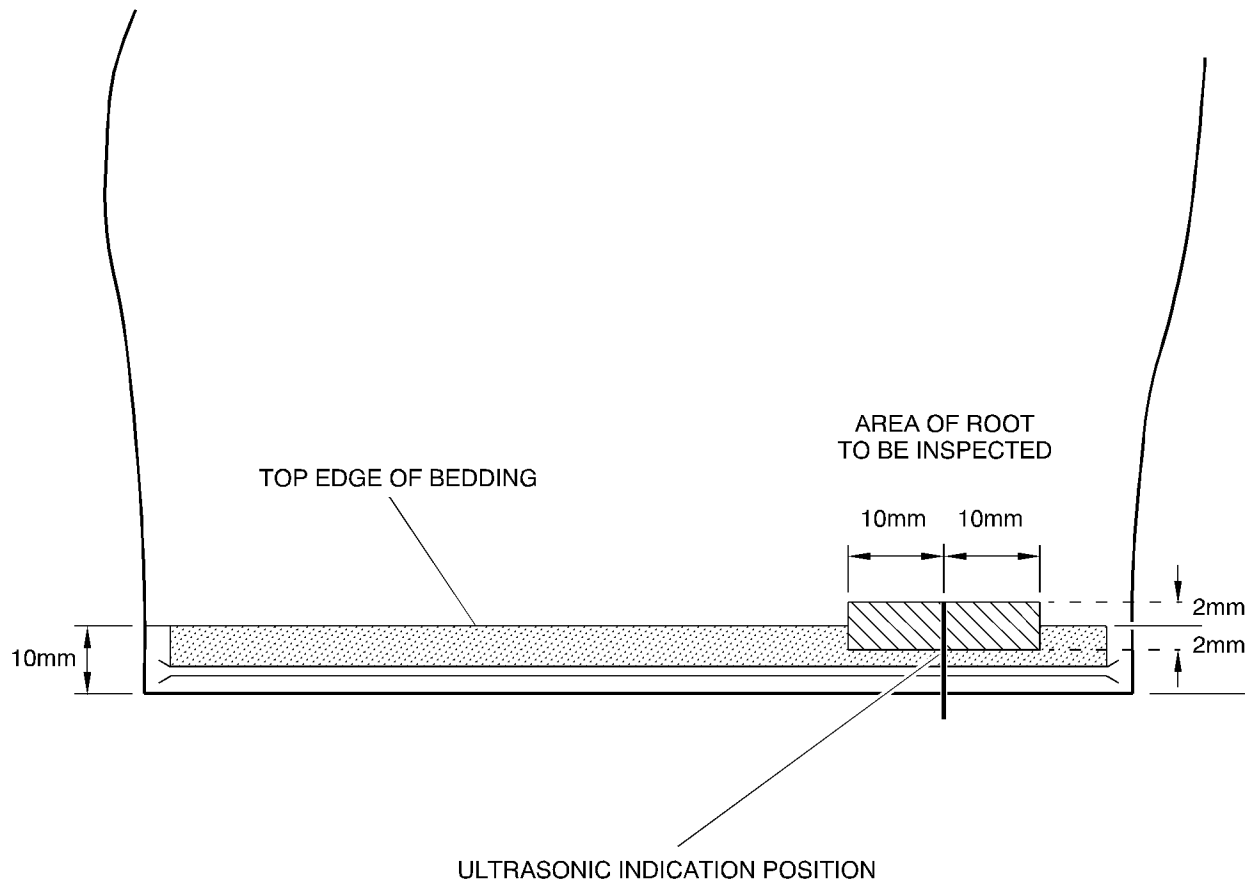
Inspection areas  
Appendix 2, Fig.1

This technique covers the additional binocular inspection of V2500 fan blade roots for possible top edge of bedding cracking, detected by ultrasonic inspection as shown in Appendix 2, Figure 1.

(1) Reject any blade exhibiting a crack-like feature running axially along the root in the inspected region.

(2) Reject any blade exhibiting a 'scar' or crater-like feature.

(2) Adjust lamp to optimum illumination position for highlighting top edge of bedding at ultrasonic indication position, as illustrated in Appendix 2, Figure 1.

(4) Slowly traverse along the blade, inspecting the top edge of bedding 10 mm. either side of the ultrasonic indication position, as shown in Appendix 2, Figure 1.
