V2500-A1/A5/D5 SERIES PROPULSION SYSTEMS SERVICE BULLETIN

This document transmits Revision 1 to Service Bulletin EV2500-72-0411

ENGINE – LP COMPRESSOR – INTRODUCTION OF HYDRAULIC SEAL WITH REVISED OIL DRAIN
FEATURE

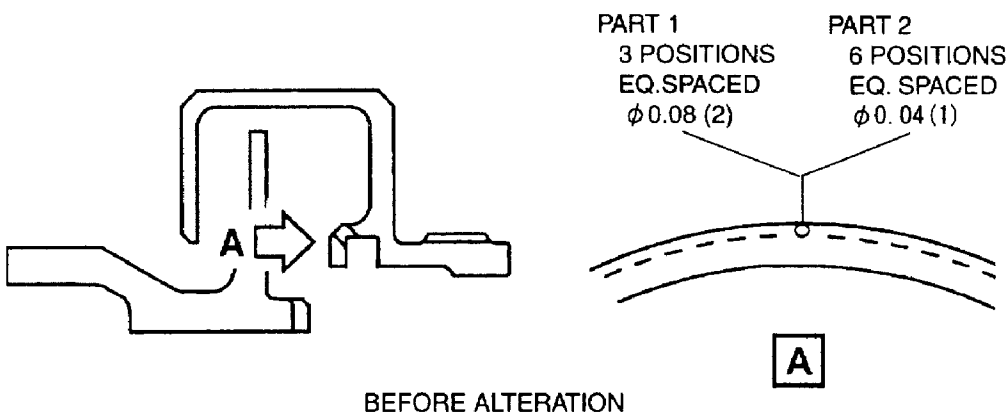
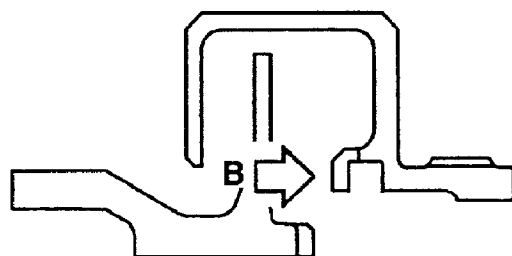
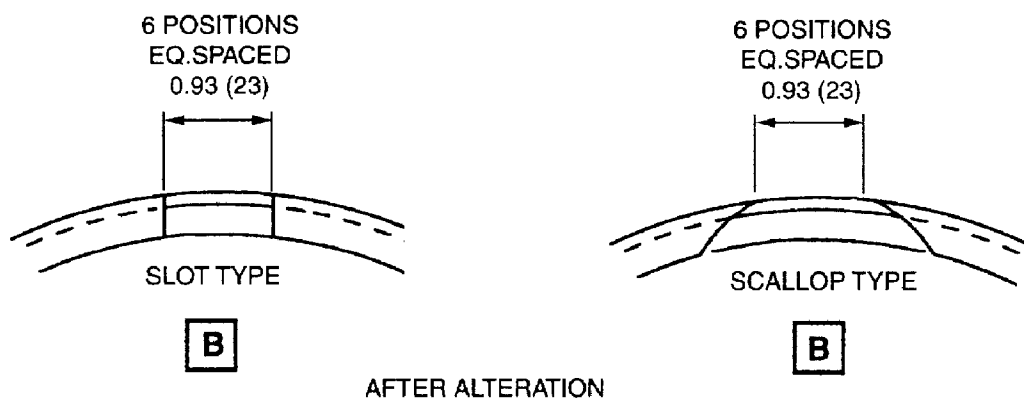
Before and after alteration of hydraulic seal
Fig.1

R (a) The oil drain feature at the side wall of hydraulic seal groove is
changed from holes to slots or scallops. Refer to Fig.1.

(b) The numbers of the oil drain feature are not changed. Refer to Fig.1.

R (c) The oil drain feature at the side wall of hydraulic seal groove is
changed from holes to slots or scallops. Refer to Fig.1.

(d) The numbers of the oil drain feature are changed from three to six.
Refer to Fig.1.

NOTE: THERE ARE TWO TYPE, SLOT TYPE OR SCALLOP TYPE
FOR OIL DRAIN FEATURE OF AFTER ALTERATION
