International Aero Engines

V2500-A5/D5 PROPULSION SYSTEMS SERVICE BULLETIN

V2500-ENG-72-0412

ENGINE - PROVIDE ADDITIONAL OIL DRAIN HOLE IN 2ND STAGE TURBINE AIR SEAL

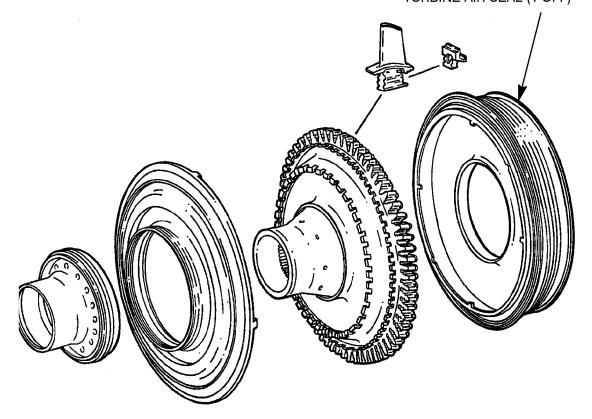
location of the stage 2 high pressure turbine air seals Fig ${\bf 1}$

During the oil loss ignition events on the V2500 it was found that there was a possibility of trapping oil in front of the 1-2 seal which if ignited could cause High Pressure Turbine (HPT) Rotor damage.

Oil leakage from the number 4 bearing compartment that pools in the HPT Rotor could ignite during operation and cause HPT distress.

Incorporate an oil drainage feature (hole) in front of the 1-2 seal to allow any accumulated oil to properly drain from this cavity prior to ignition.

- (1) Install the 2A3596 Stage 2 High Pressure Turbine Air Seal when you assemble the High Pressure Turbine Rotor And Stator Assembly by the procedure given in Reference (7) or (8), Engine Manual, Chapter/Section 72-45-00, Assembly. See Figure 1.
- (2) When you assemble the new High Pressure Turbine Rotor and Stator Assembly identify it by the procedure given in Reference (9), Chapter/Section 70-09-00 Marking of Parts.
- (3) Recording Instructions
 - (a) A record of accomplishment is required.

INSTALL THE 2A3596 STAGE 2 HIGH PRESSURE TURBINE AIR SEAL (1 OFF)
