V2500-A1/A5/D5 PROPULSION SYSTEMS SERVICE BULLETIN

V2500-ENG-72-0415
Transmittal - Page 1 of 3

ENGINE – PROVIDE NEW FRONT AND REAR NUMBER 4 BEARING DUCTS WITH OIL DRAIN HOLES

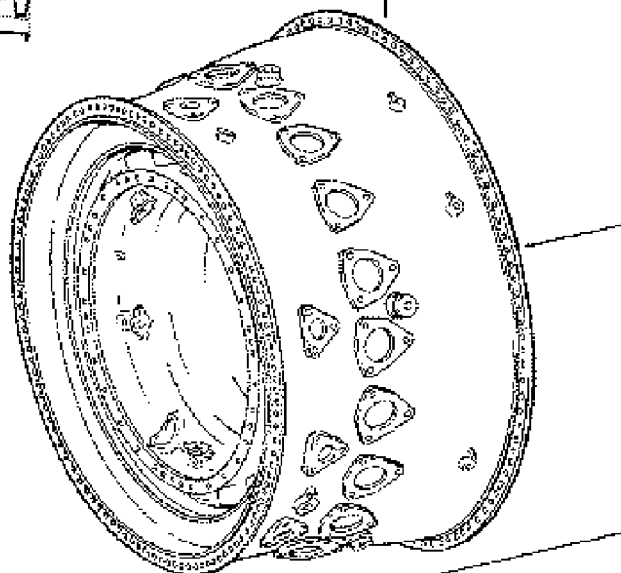
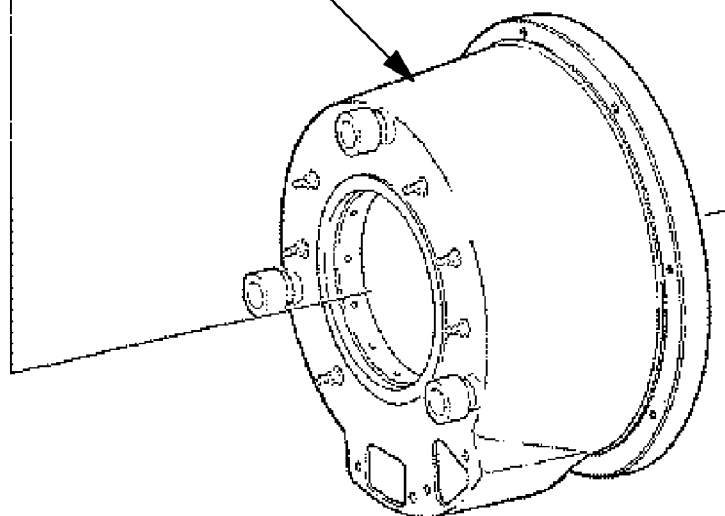
Duct Assembly, Cooling Air, No. 4 Bearing Front
Figure 1 (Sheet 1)

- (1) **Problem:** In the event of oil loss accumulated out of the number 4 bearing compartment, the oil could be ignited at engine high power condition and cause detrimental heat distress damage to HPT parts. Multiple engine tear-down inspections revealed that the front and rear cold buffer cavities were found with evidence of oil wetness/coking deposits.

REPLACE DUCT 2A2257-01
OR 2A0892-01 WITH DUCT
2A3810-01 OR 2A0892-001
RESPECTIVELY
