**V2500-A1/A5/D5 PROPULSION SYSTEMS NON-MODIFICATION SERVICE BULLETIN**

**V2500-ENG-72-0419**  
Transmittal - Page 1 of 2

NON-MODIFICATION SERVICE BULLETIN – ENGINE – NO. 4 COMPARTMENT OIL LOSS INVESTIGATION  
AND TROUBLESHOOTING GUIDE

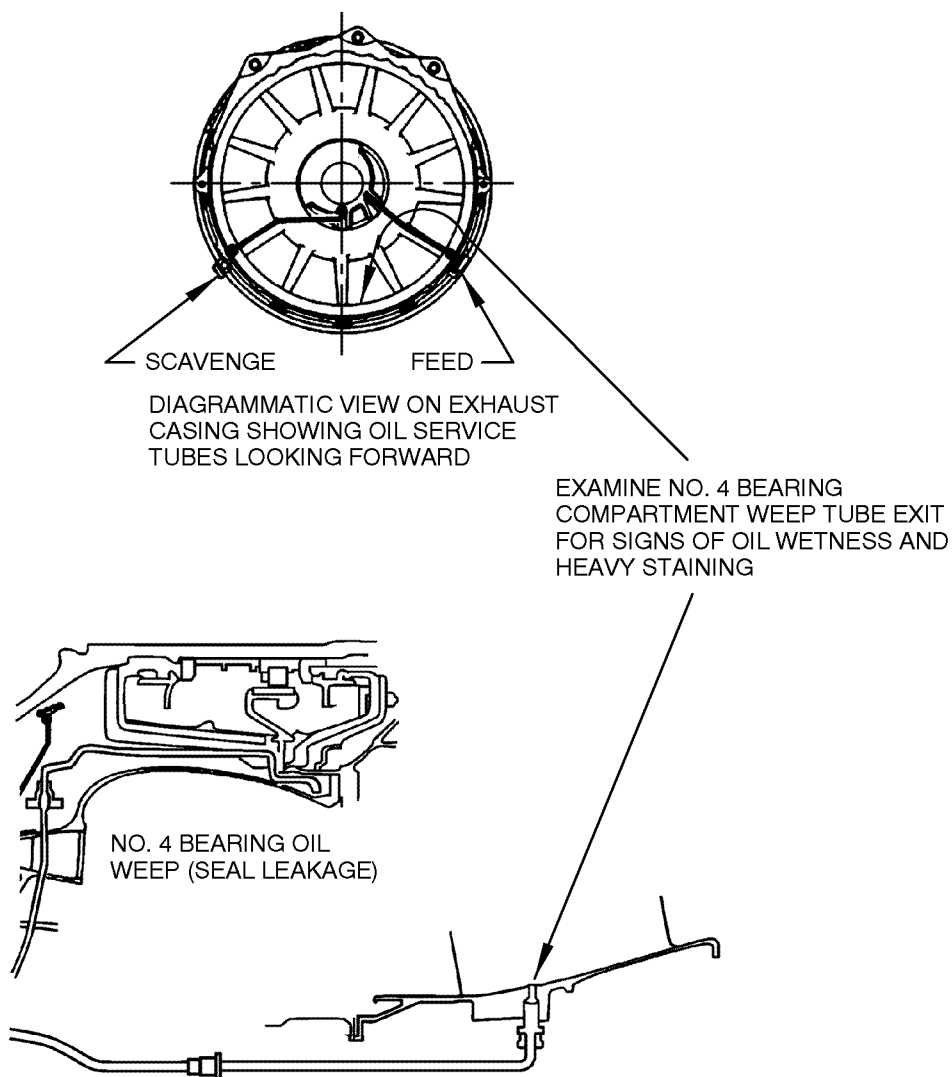
Bearing Compartment Weep Tube Exit At TEC  
Figure 1

- (a) Confirmation of oil loss from No.4 compartment indicated by oil wetness at weep tube exit located at bottom of the TEC (See Figure 1). Record in Table 1 Appendix B actual findings if abnormal wetted and stained surfaces are evident. If determination is uncertain contact IAE Technical Services via the Field Representative for further instructions (Take a digital photo).
- (b) If engine oil consumption is greater than 0.3 QTS/HR, follow All Operators wire 1050 issue 2 (See Reference 7).
- (c) If "ENG 1 (2) BEARING 4 OIL SYS – HI PRESS" (A1/A5) or "EOAP:ENG SYS FAIL?" (D5) faults persist then carry out this NMSB.
- (d) Perform Borescope inspection per Non-Modification Bulletin V2500-ENG-72-0349 and V2500-ENG-72-0430.

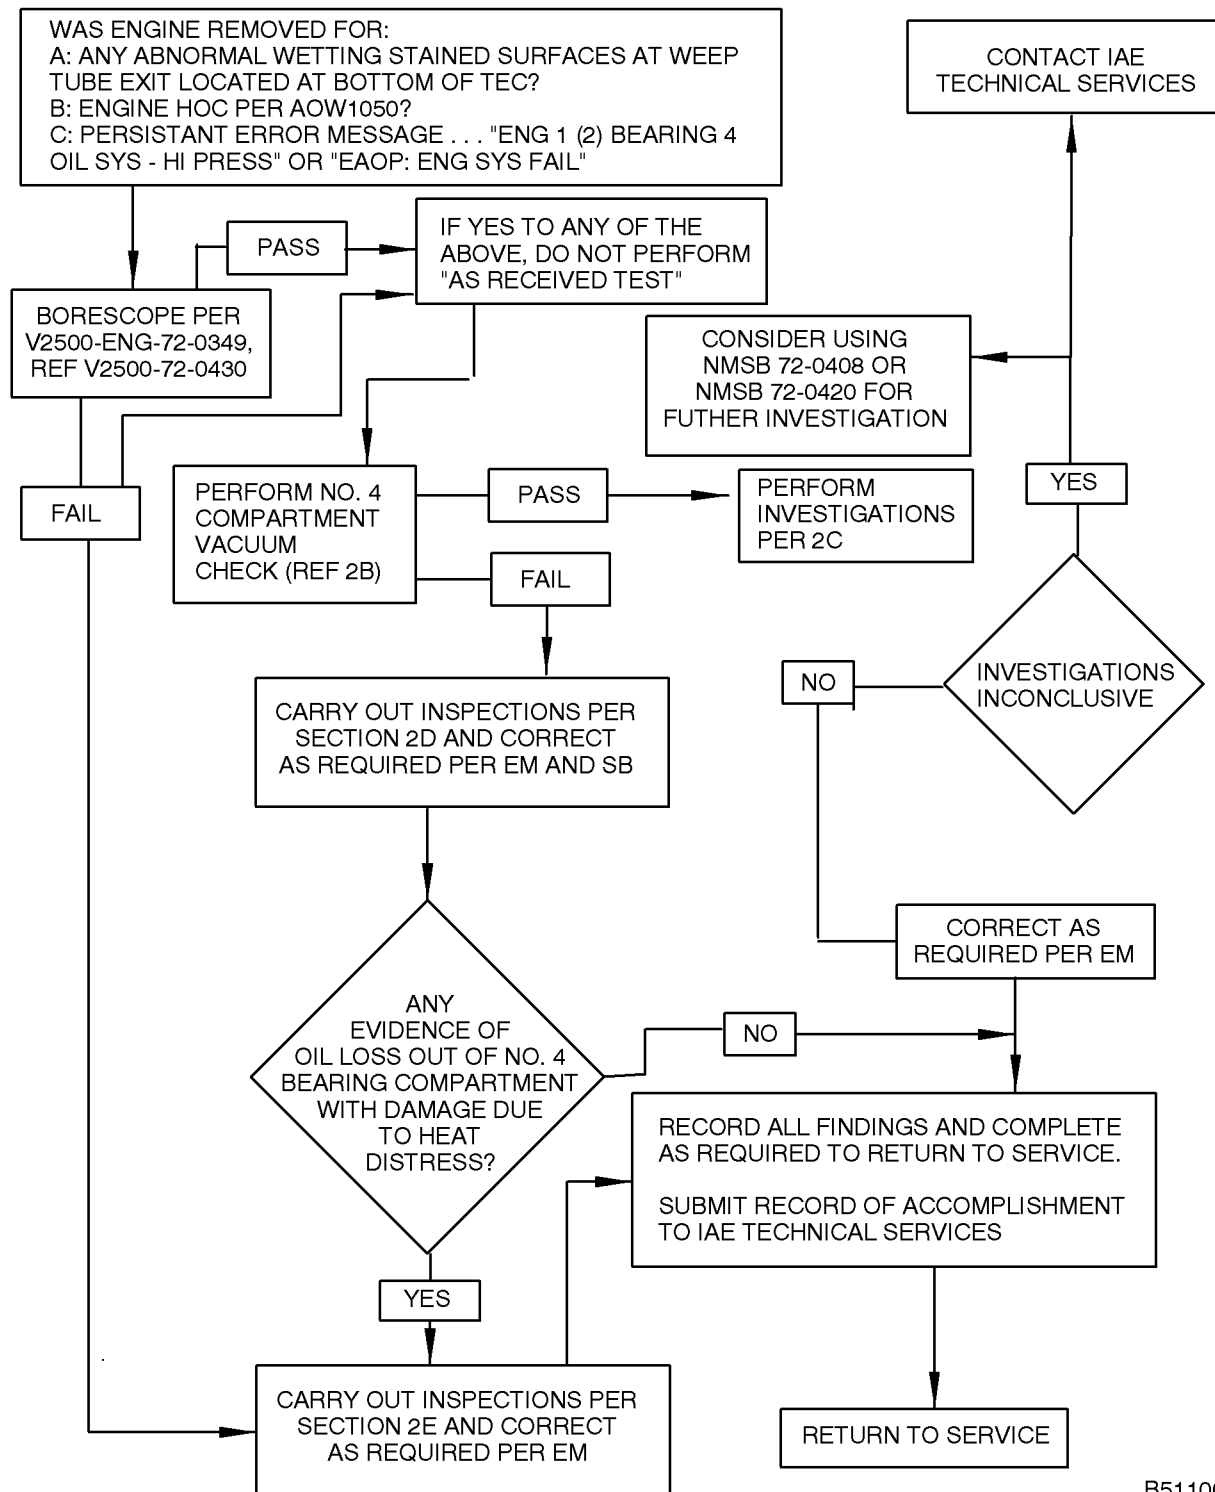
Trouble Shooting Flow Chart  
Figure 2Aug.30/02  
Aug.30/02

- (a) Follow the Troubleshooting flow in Appendix A (See Figure 2) and carry out the following inspections as required. Record and return findings to IAE Technical Services via PSCOMM through the local field representative.
