DATE ~~R~~ Sep.20/02**V2500-A1/A5/D5 PROPULSION SYSTEMS NON-MODIFICATION SERVICE BULLETIN**

V2500-ENG-72-0420

NON-MODIFICATION SERVICE BULLETIN – ENGINE – NO. 5 COMPARTMENT OIL LOSS
TROUBLESHOOTING PROCEDURE AND PROPOSED CORRECTIVE ACTIONS

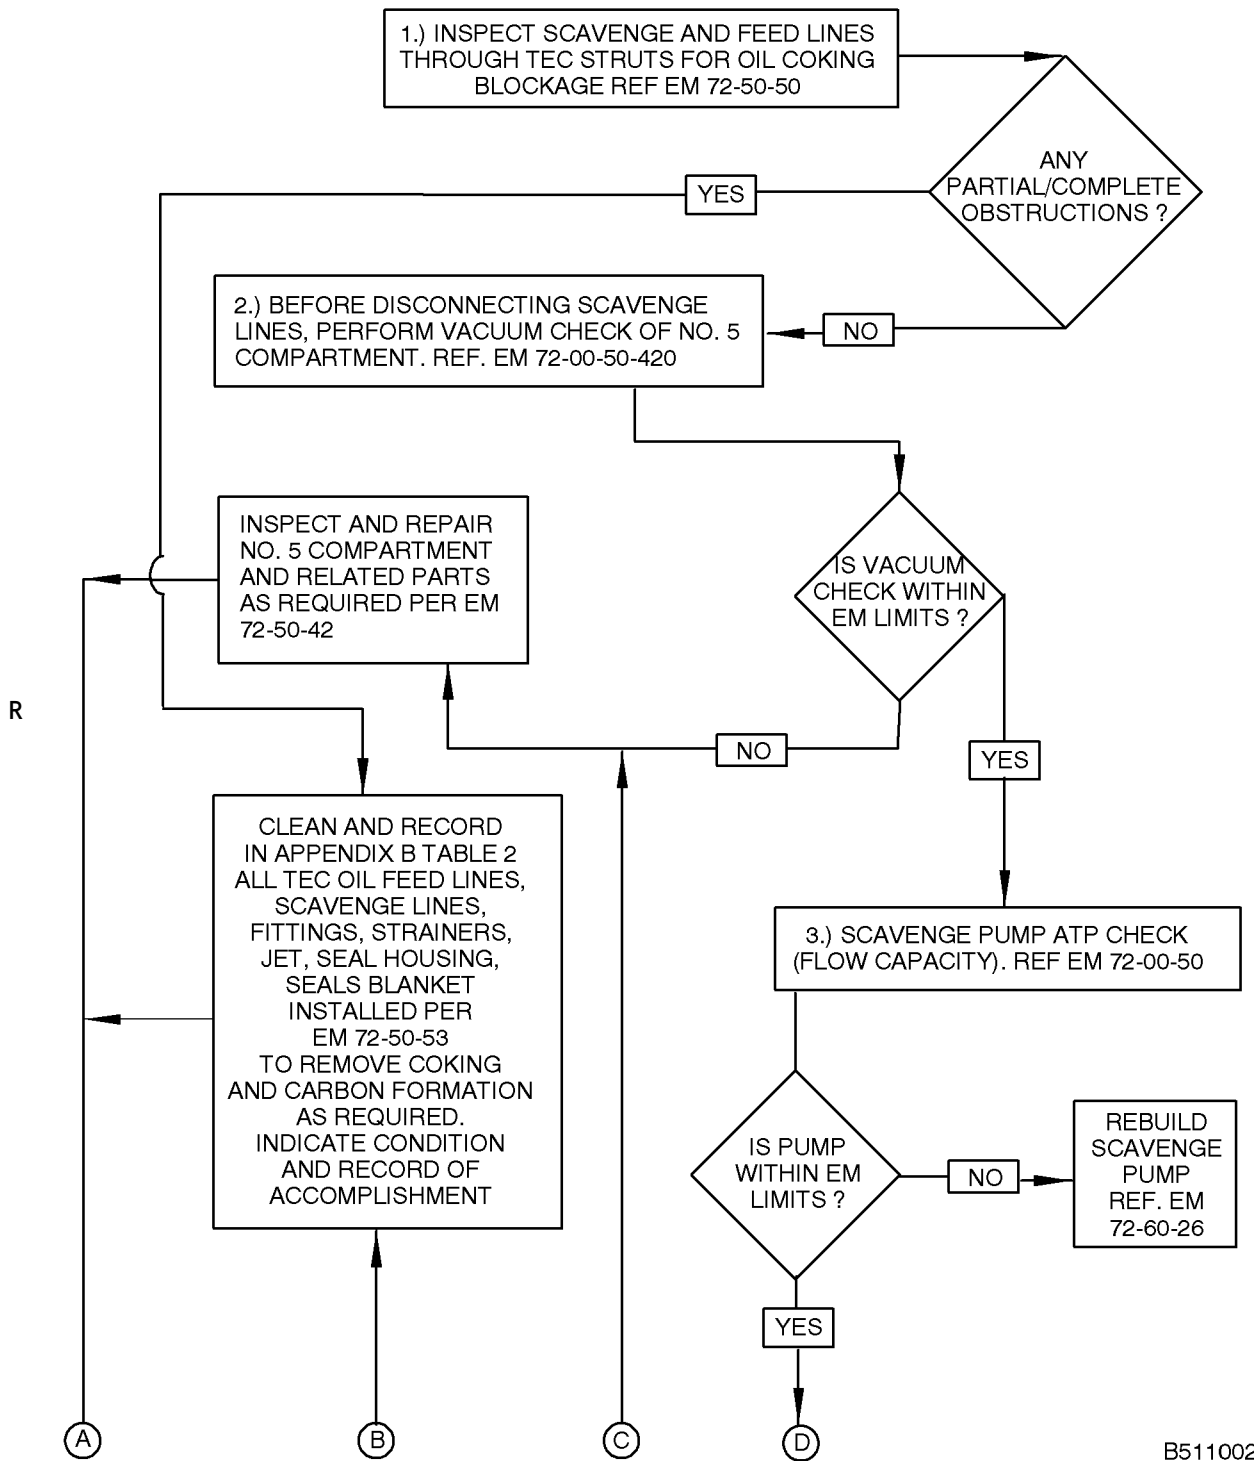
No.5 Compartment Trouble Shooting Chart
Figure 1 (Sheet 1)

A number of engines have been removed from service for oil leakage from the No. 5 Bearing Compartment that resulted in tail pipe smoke event and/or in some cases, resulting in a high oil consumption engine. This leakage can be observed as oil wetting on the lower TEC struts and trailing edge of the LPT blades.

- (a) Follow troubleshooting Process Flow chart in Figure 1 Appendix A. Record the results of all inspections in Appendix B Tables I and II and return tables via PSCOMM to IAE Technical Services through the local IAE representative.
