**International Aero Engines****RR-DERBY**

DATE: **Apr.30/02****V2500-A5 SERIES PROPULSION SYSTEMS NON-MODIFICATION SERVICE BULLETIN**

This document transmits the Initial Issue of Service Bulletin EV2500-72-0423

ENGINE - LP COMPRESSOR FAN BLADES - DOVETAIL ROOT FLANK ULTRASONIC INSPECTION (HIGH STRESS EVENT) - NON-MODIFICATION SERVICE BULLETIN

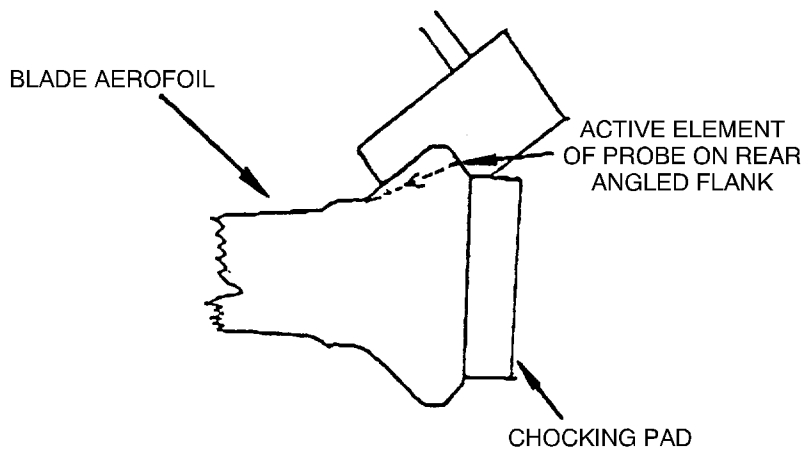
Schematic diagram showing position of probe on blade root flank
Fig.2

- (b) Monitor the signal very carefully as you move the probe over this area
 - (c) Reject the blade if a signal greater than 60 percent screen height is produced between the 4.5 and 5.5 division lines on the time base

- (e) Monitor the signal very carefully as you move the probe over this area
 - (f) Reject the blade if a signal greater than 60 percent screen height is produced between the 4.5 and 5.5 division lines on the time base

- (3) Do an ultrasonic inspection on each of the fan blades
 - (a) Apply the couplant to the concave face of the blade root flank at the area to be inspected. Position the probe at the front of the leading edge of the concave blade root flank and move the probe along the first 2.4in. (60mm) of the chordal width of the blade root. (Refer to Fig 2)

- (d) Apply the couplant to the convex face of the blade root flank at the area to be inspected. Position the probe at 1.77in. (45mm) from the front face of the blade root (immediately behind the front chocking pad, if still installed) and move the probe along the next 4.33in. (110mm) of the chordal width of the blade root, terminating the inspection at 6.10in. (155mm) from the front face of the blade root (approximately 3.3in. (85mm) from the rear face of the root)

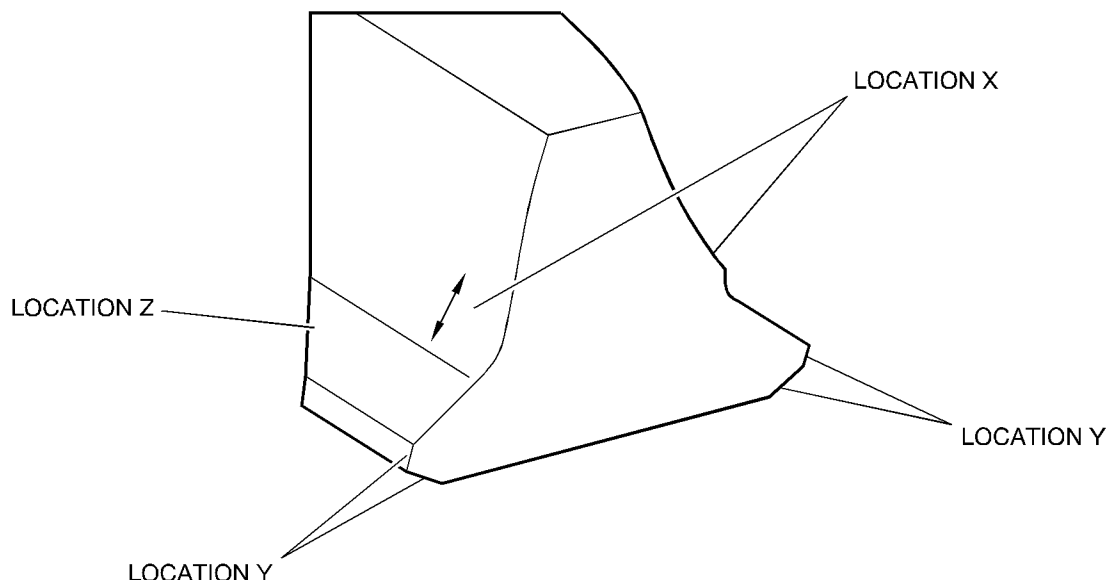
Removal of excess Dry Film Lubricant (DFL)
Fig.3

CAUTION 1: On post SB 72-0375 and post SB72-0384 (Metco 58 coated root) fan blades it is essential not to "scotchbrite" the fan blade bedding surface (Location Z) as this will have a detrimental effect to the coating.

CAUTION 2: On post SB 72-0375 and post SB72-0384 (Metco 58 coated root) fan blades it is important not to damage the fan blade bedding surface (Location Z) when using a scraper

- (g) Subsequently to the above, if excess dry film lubricant is still present at the ultrasonic reject indication position on the blade root flank in the areas X and Y defined in Fig.3, remove this by lightly rubbing with Scotchbrite (using CoMat 05-125 to 05-127). Repeat the ultrasonic check as in (a), (b), (d) and (e) above. Reject the blade if a signal greater than 60 percent screen height is still present between the 4.4 and 5.5 division lines on the time base

- 1) At the ultrasonic reject indication locations, on either the concave or the convex flanks, remove any excess Dry Film Lubricant (DFL) by lightly rubbing with 'Scotchbrite' using CoMat No 05-125 to 05-127 in the following areas:
 - above the top edge of the bedding (location X)
 - at the lower corner of the root where the ultrasonic probe locates (location Y)

- 2) If excessive DFL is present, at location X and/or Y that cannot be removed by lightly rubbing with 'Scotchbrite' it is permissible to remove this using a non metallic scraper and then remove any loose residual DFL using 'Scotchbrite'
