V2500-A5/D5 PROPULSION SYSTEMS NON-MODIFICATION SERVICE BULLETIN

This document transmits Revision 2 to Service Bulletin EV2500-72-0427

V2500-ENG-72-0427

NON MODIFICATION SERVICE BULLETIN – ENGINE – NO. 5 SCAVENGE TUBE LOT NUMBER M268050S1
IDENTIFICATION AND REPLACEMENT OF

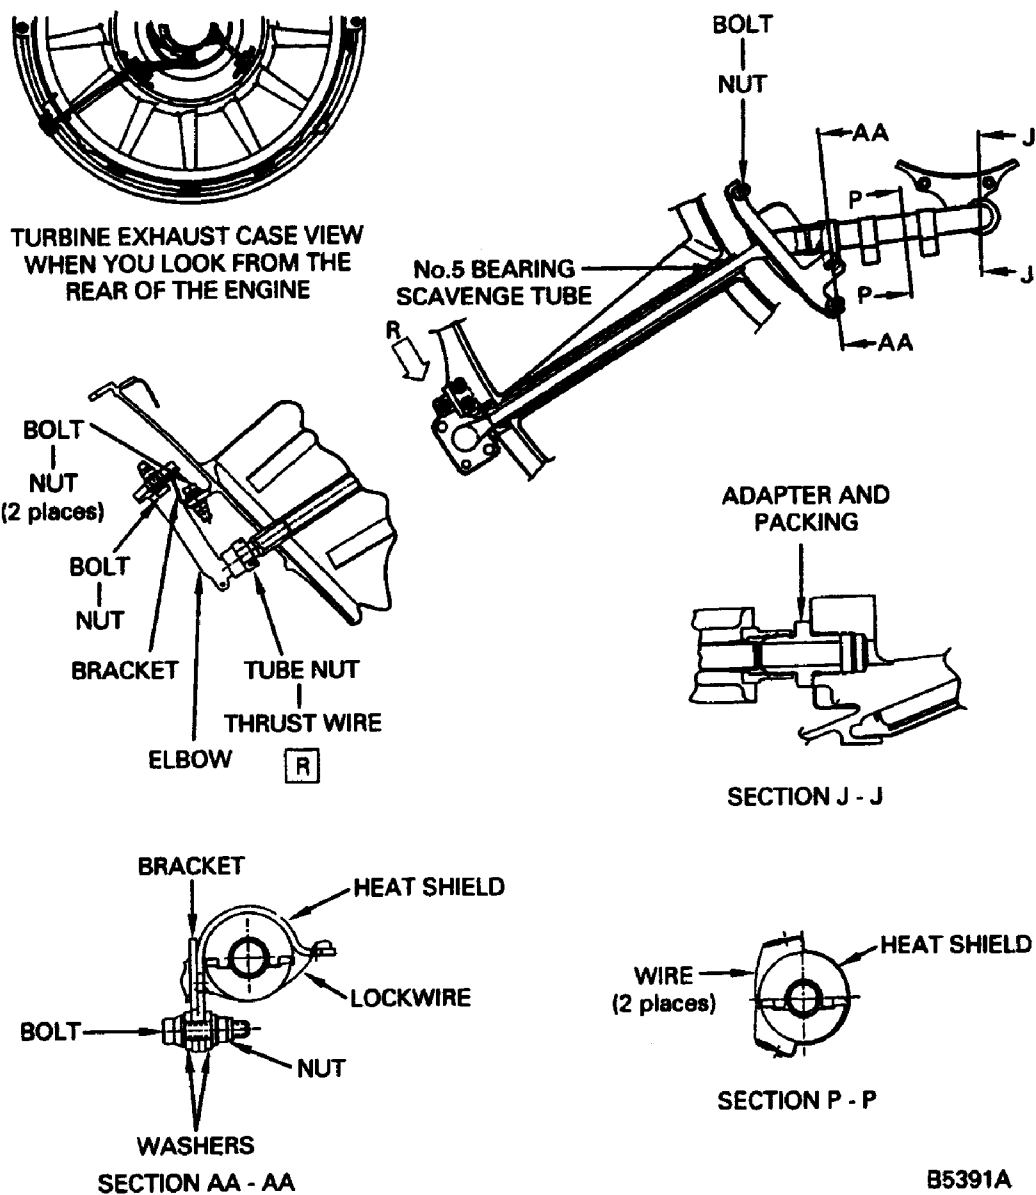
Remove the No.5 Bearing Scavenge Tube
Figure 1

- (1) Problem: There is a quality escape involving 2A3092-01 No. 5 Scavenge Tubes from production.
- (2) Evidence: A batch of 5 tubes with the lot number M268050S1 were inadvertently shipped to the TEC producer after having been rejected; failing x-ray inspection due to incomplete brazing. Three (3) tubes were found with oil leakage at prior to engine delivery and replaced. The two (2) remaining tubes with incomplete braze on the ferrule with batch lot number M268050S1 are suspect in the engines specified in the effectivity section.
- (3) Objective: Locate and replace the suspect tubes.

- (b) Disassembly instructions: Remove the No.5 Bearing Scavenge Tube. Reference EM 72-50-50-040-001 and Figure 1.

- (i) Remove the bolts and nuts that attach the bracket to the oil scavenge tube and to the rear external flange of the turbine exhaust case. Remove the bracket.
- (ii) Disconnect the scavenge tube nut at the elbow at external opening incase. Remove the elbow.
- (iii) Remove the thrust wire from the tube nut at the external opening in the case. Remove the tube nut and discard the thrust wire.
- (iv) Release the nut that attaches the oil scavenge tube and the heat shields to the inner bracket. Remove the nut, washers and bolt.
- (v) Remove the lockwire that attaches the two heat shields to the scavenge tube and remove the two heat shields.

- (vi) Remove the two bolts and nuts that attach the inner bracket to the inner support of the turbine exhaust case. Remove the bracket. Release the tube nut from the inner adapter on the exhaust case. Remove the adapter from the inner support of the turbine exhaust case.
