V2500-A5/D5 SERIES PROPULSION SYSTEM NON-MODIFICATION SERVICE BULLETIN

This document transmits the Initial Issue of Service Bulletin EV2500-72-0428

V2500-ENG-72-0428

**NON MODIFICATION SERVICE BULLETIN – ENGINE – HPT STAGE 2 BLADE INSPECTION FOR SURFACE
IMPERFECTIONS ON AIRFOIL****1. Planning Information****A. Effectivity****(1) Airbus A319**

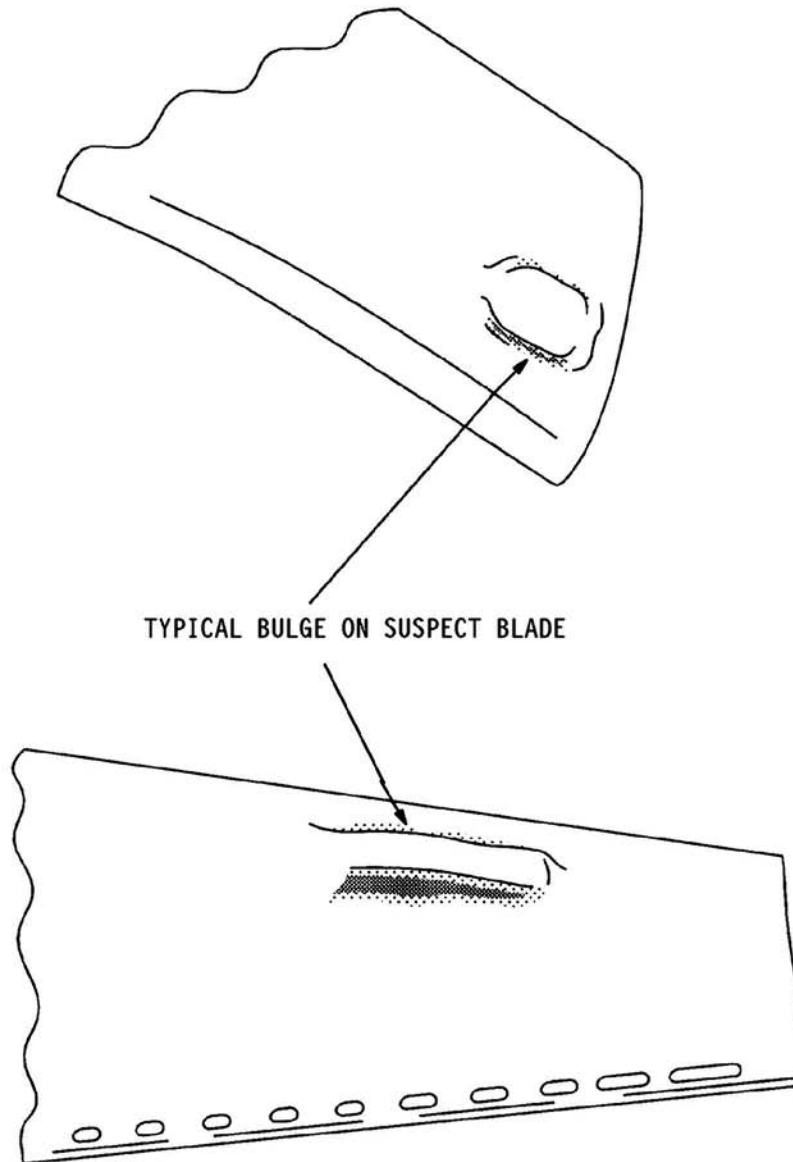
TYPICAL HPT STAGE 2 SUSPECT BLADE
Figure 1

- (1) Problem: HPT stage 2 blades were manufactured with surface imperfections (raised material) on the airfoil. Blade(s) with these surface defects were found to have internal cracks. Any cracking in blades may propagate and result in a fracture of a piece of the blade airfoil.

- (b) Inspect blades for surface imperfections with a visual inspection and carefully examine parts with hand for raised material. Run fingers over the concave and convex sides of the airfoil feeling for protrusions on the airfoil. The surface imperfection is an area of the airfoil on either the concave or convex side, which has a slight bulge or bump. The typical location for the slight bulge is from 50% span to the tip, on the concave and convex sides. See Figure 1.
- (c) If blades with surface imperfections are found they must be replaced. IAE Technical Services must also be notified via field representative.

- (a) Replace all blades with surface imperfections in accordance with the Engine Manual. See reference 3. and 4. , Task 72-45-30-040-001-C00)
