V2500-A1/A5 SERIES PROPULSION SYSTEM SERVICE BULLETIN

This document transmits the Initial Issue of Service Bulletin EV2500-72-0429

ENGINE – LP COMPRESSOR – INTRODUCTION OF A SMALLER DIAMETER WASHER

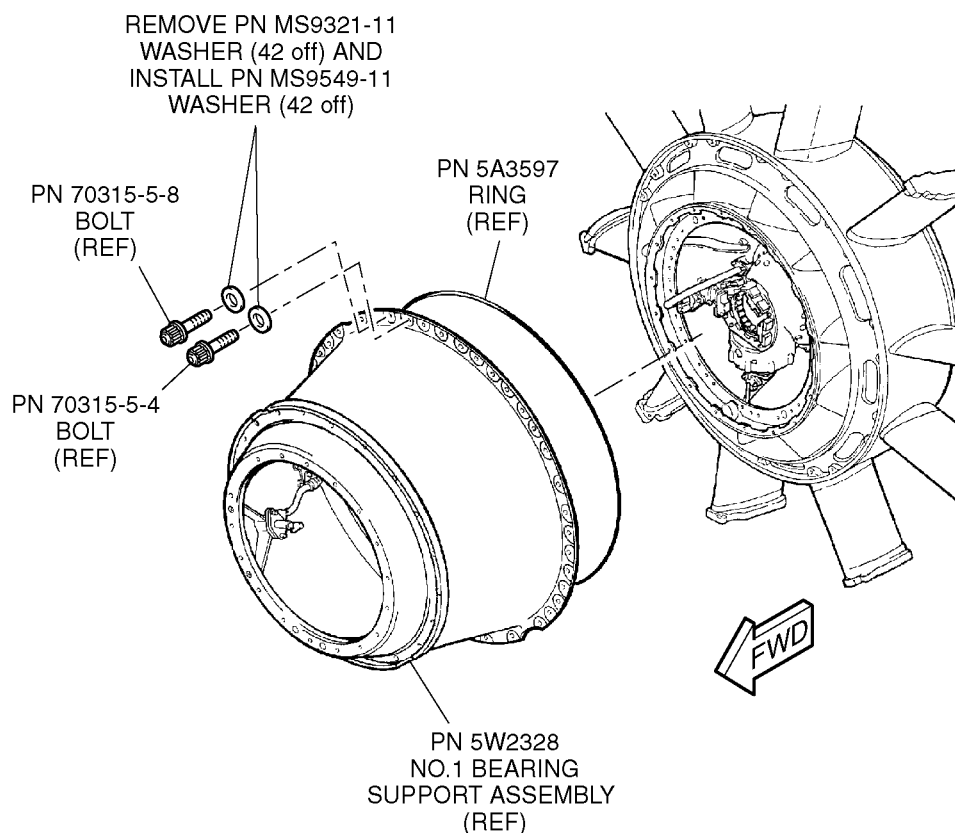
Location of the Washer that connects the No.1 Bearing Support to the Fan Frame
Figure 1

There is some possibility that the washer is not seated on the front surface of the rear flange with counter bore hole. The diameter of selected washer is almost same as the diameter of counter bore.

Smaller size washer will be introduced. It is not appropriate to increase the diameter of counter bore, because there will be less material at outer area of the flange. This feature of counter bore has designed for introduction of aluminium support by SBE72-0391.

The washer MS9549-11 with smaller outer diameter will provide appropriate clearance to the counter bore instead of current washer MS9321-11.

The nominal outer diameter of washer has been changed from 0.625inch (15,875 mm) to 0.562inch (14,275 mm).

Install the new MS9549-11 washer (42 off) to the No.1 bearing support assembly by the procedure given in reference (1), Engine Manual (E-V2500-1IA), 72-32-00, Assembly-05
