## V2500-A1 PROPULSION SYSTEMS SERVICE BULLETIN

# V2500-ENG-72-0430

ENGINE - HIGH PRESSURE TURBINE FIRST STAGE DISK METERING PLUG REPLACEMENT

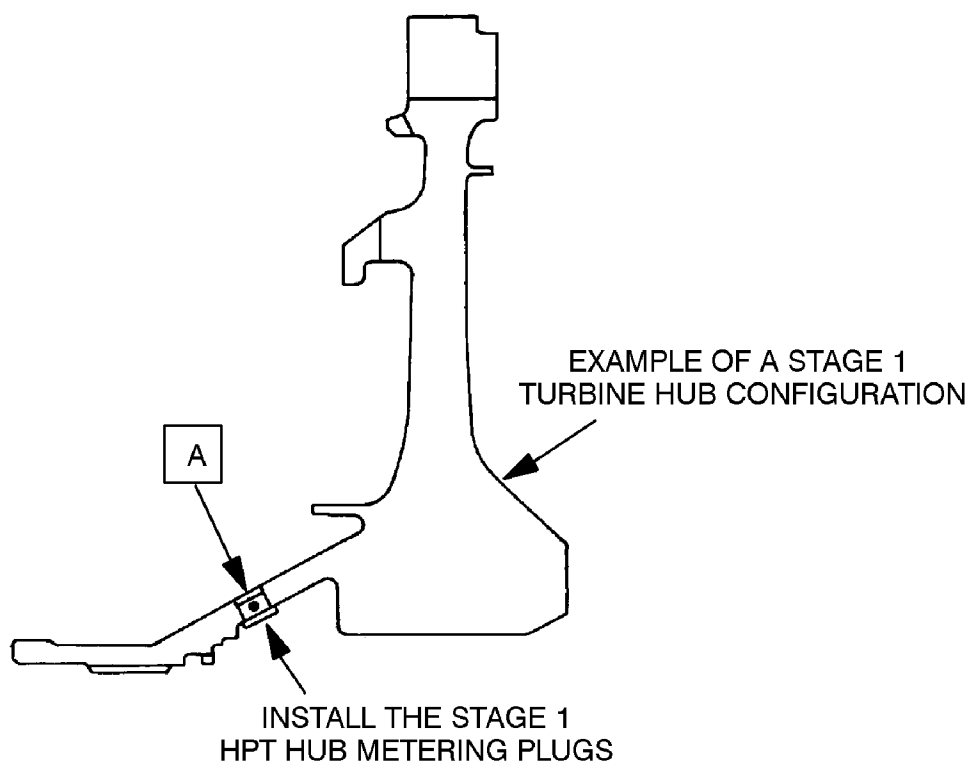
Location of Metering Plug in Hub Assembly Turbine Stage 1  
Figure 1

- (1) Problem: There have been occurrences of Metering Plug fracturing in production engines. The debris from the fractured Metering Plug can migrate into the Number 4 Bearing Compartment Rear Carbon Seal area. The debris can erode the Rear Carbon Seal until the Seal fractures which then releases a large quantity of oil and subsequently the oil can ignite. Ignition can cause HPT damage.

- (2) Background: The cause of the Metering Plug to fracture is due to High Cycle Fatigue. The unloaded Metering Plug tang starts to vibrate and may eventually fracture.

ALL FOUR TANGS MUST  
PROTRUDE THROUGH  
DISK AS SHOWN

TYPICAL  
METERING PLUG  
INSTALLED IN DISK

- (2) Measure the Metering Plug holes in the Turbine Hub.
  - (a) If the hole diameter is between 0.377 in. (9.576 mm) and 0.383 in. (9.728 mm) accept and record the dimensions.

- (b) If the hole diameter is between 0.384 in. (9.754 mm) and 0.387 in. (9.830 mm) accept part for select fit only and record the dimension.
  - (c) If A. or B. does not apply, perform one of the following:

- (ii) If more than one hole does not meet requirements in A. or B. contact IAE.
- (3) If all fits are acceptable, use IAE tool P/N IAE1P16494 or IAE1P17763 or other suitable drift to install and seat all 12 (or 11 depending on requirements reference 2. C. (1)) new stage 1 Metering Plugs through the rear bore of the hub into the inner diameter holes of the stage 1 Turbine Hub. Make sure the rear side of the Metering Plug tab touches the outer diameter surface of the Hub. See Figure 1.
