V2500-A1/A5/D5 SERIES PROPULSION SYSTEMS SERVICE BULLETIN

ENGINE – PROVIDE NEW NUMBER 4 BEARING INNER WEEP TUBE AND OUTER WEEP MANIFOLD

V2500-ENG-72-0434

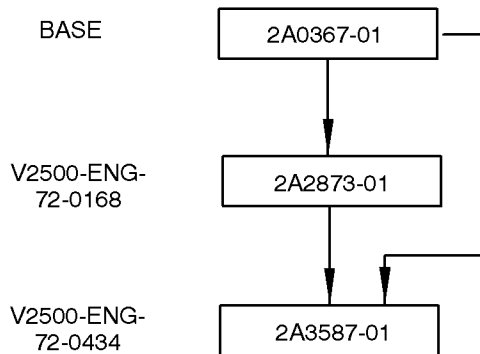
Chart 1

FAMILY TREE – TUBE ASSEMBLY NO.4 BEARING COMPARTMENT
