**International Aero Engines
NON-MODIFICATION
SERVICE BULLETIN**

ENGINE –INSPECTION OF HPC STAGE 6 METCO 313 ROTOR PATH CONDITION AFTER INACTIVE PERIOD WITHOUT ADHERENCE TO AMM STORAGE PROCEDURES ON AIRCRAFT WITH BOTH ENGINES POST ENG SB 72-0235 AND PRE ENG SB 72-0369

V2500-A5/D5 SERIES PROPULSION SYSTEM NON-MODIFICATION SERVICE BULLETIN

This document transmits Revision 2 of Non-Modification Service Bulletin V2500-ENG-72-0437

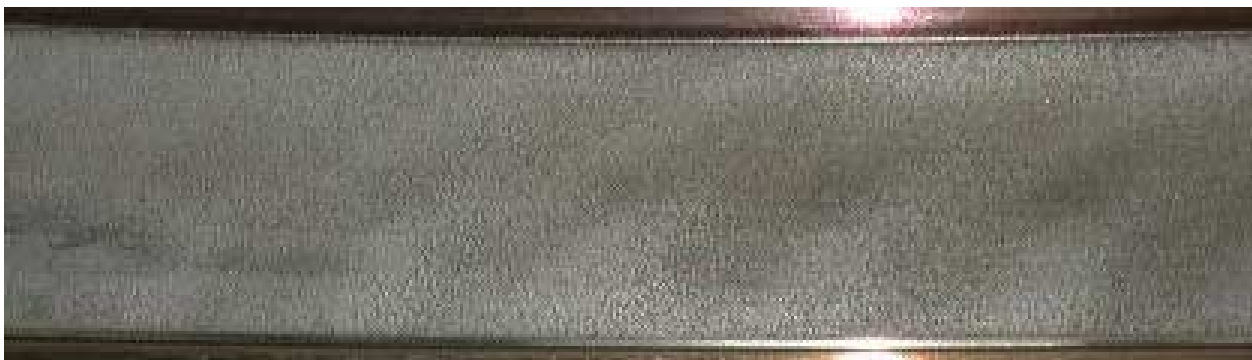
- A. Lining material sound and grey in colour or with light surface deposits, white in colour (Refer to Fig 1) – Acceptable.
- B. Missing topcoat not exposing basecoat. Remaining topcoat sound, without blistering or flaking (Refer to Fig 2) – Acceptable.

Fig 1 – Uniformly sound topcoat surface

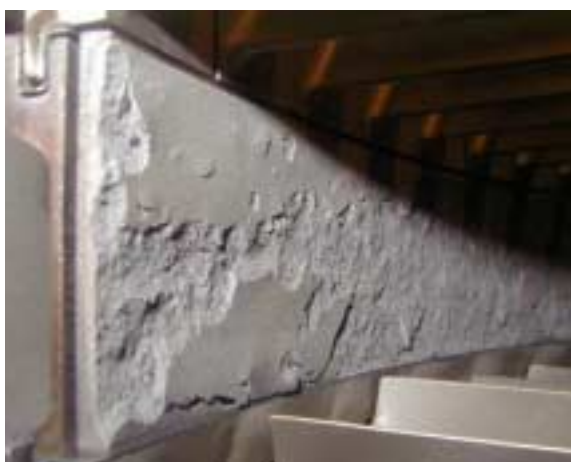
Fig 2 – Missing topcoat not exposing basecoat

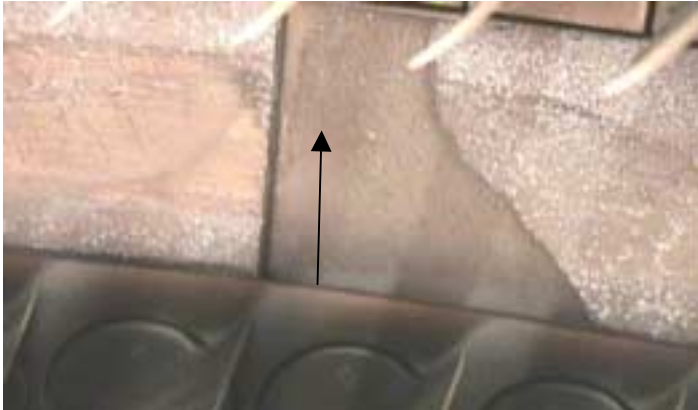
- C. Missing topcoat exposing basecoat (Refer to Fig 3). Any areas of missing top coat up to 1 in² (645 mm²) each – Acceptable. Any areas of missing topcoat more than 1 in² (645 mm²) each – Unacceptable.

Fig 3 – Missing topcoat exposing basecoat

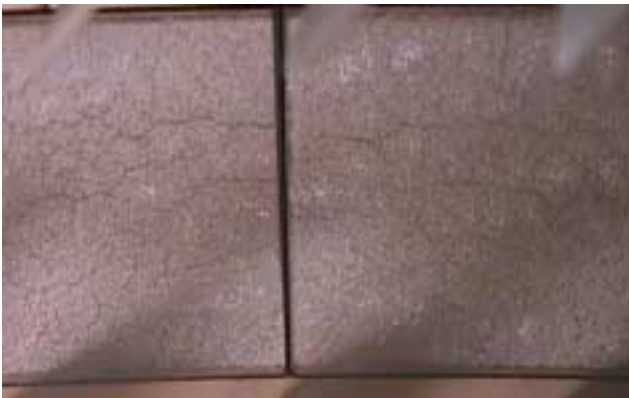
- D. Surface craze cracks with no missing material or lifting (Refer to Fig 4) - Acceptable. Large, open cracks – Unacceptable.
- E. Surface corrosion resulting in topcoat, lifting, blistering, bulging or swelling (Refer to Fig 5) – Unacceptable

Fig 4 – Cracking of topcoat surface

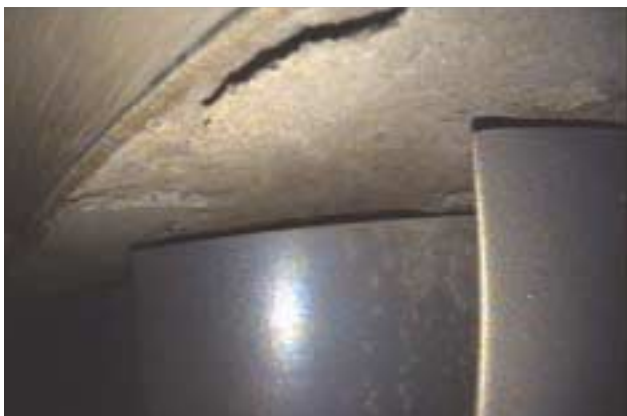
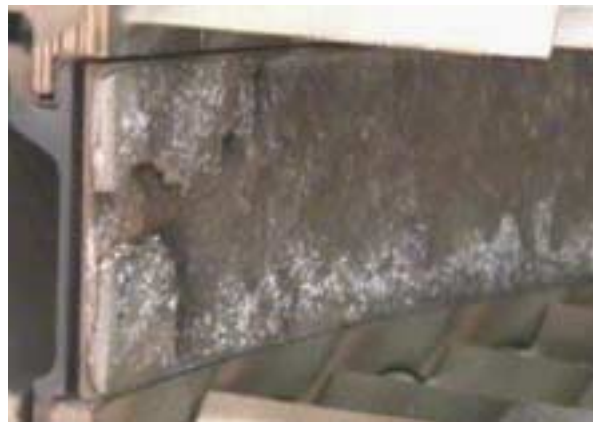
Fig 5 – Examples of corrosion related, lifting, blistering, bulging or swelling of topcoat surface

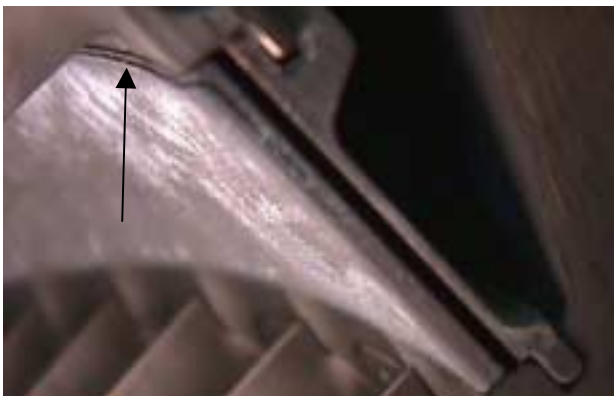
- F. Lifting/delamination. If there is evidence of delamination between the topcoat and bondcoat interface (Refer to Fig 6) up to 1” (25 mm) circumferentially – Acceptable. More than 1” (25 mm) circumferentially – Unacceptable

Fig 6– Delamination of topcoat/bondcoat interface
