DATE **Feb.10/03**
V2500-A1/A5/D5 SERIES PROPULSION SYSTEM SERVICE BULLETIN

V2500-ENG-72-0439

ENGINE - NO. 4 COMPARTMENT STRAINER IMPROVEMENT

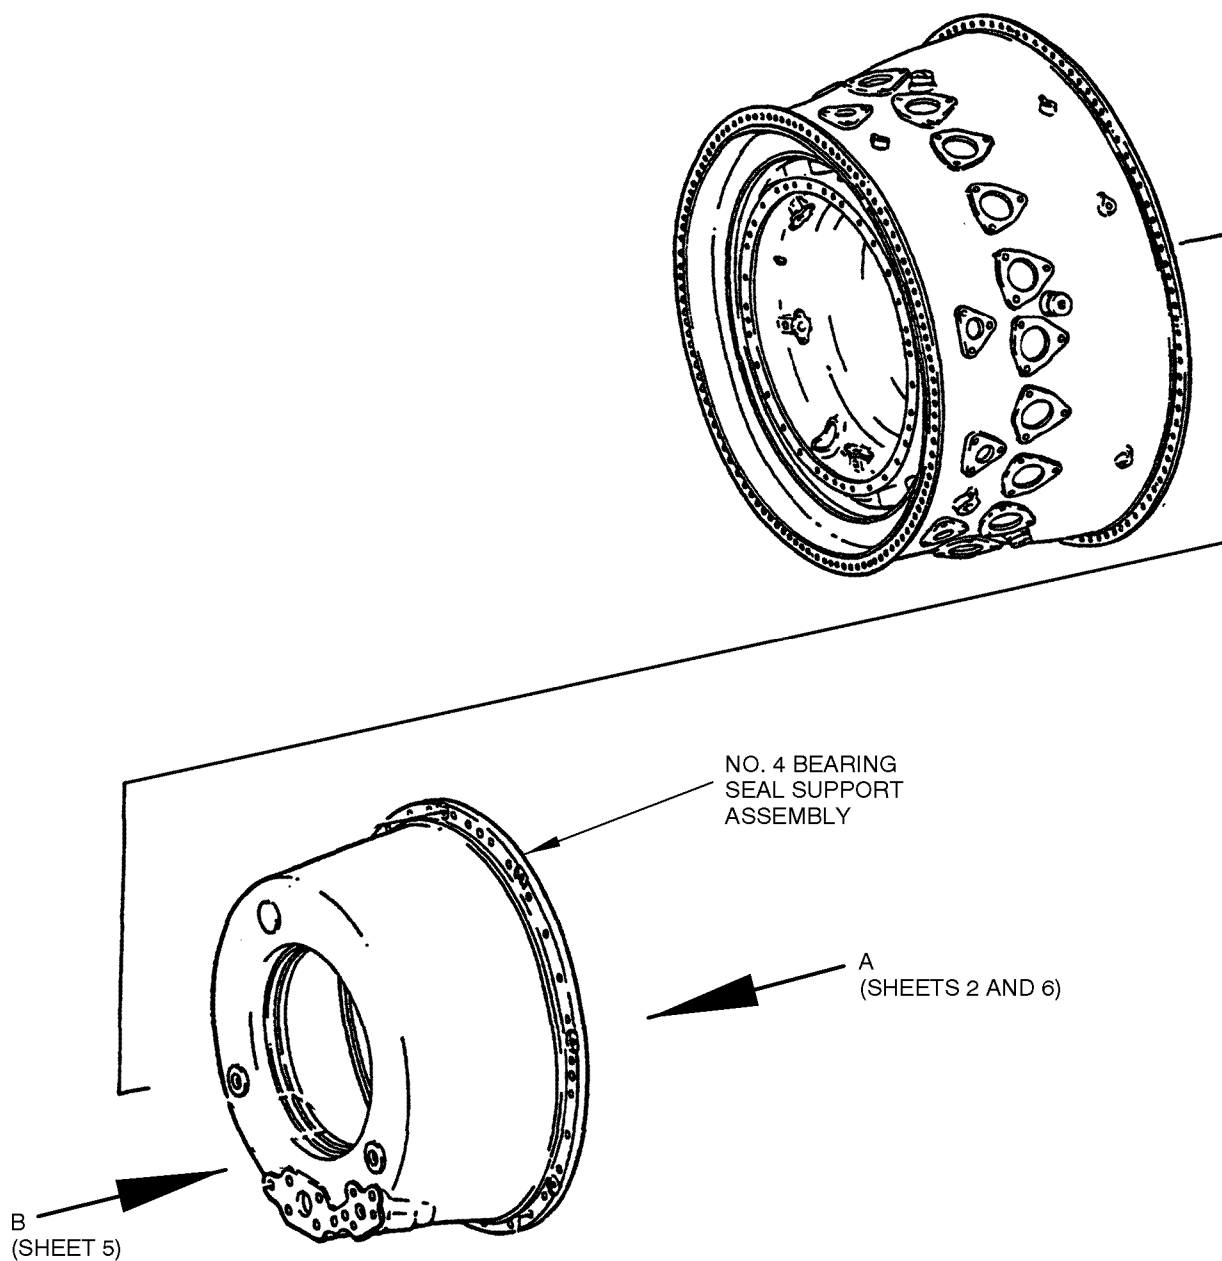
Location of the No.4 Bearing Seal Support Assembly
Figure 1, Sheet 1

- (1) Condition: Multiple events were found with oil loss from No. 4 bearing compartment and subsequent heat distress damage to High Pressure Turbine (HPT) compartments. Root cause investigation determined that oil loss occurred as a result of No. 4 bearing compartment flooding during extended sub-idle operation.

- (2) Background: Rig testing and oil system analysis showed that the No. 4 bearing compartment had insufficient sub-idle flow capacity to scavenge oil and prevent No. 4 compartment flooding. The compartment exit restriction was determined to be a contributing factor to compartment flooding.

R (6) Produce and deburr 10 holes in the No. 4 bearing seal support assembly. Refer to Figure 1, Sheet 1 for the location of the assembly. Refer to Figure 1, Sheets 2, 3, 4 and 6 for the location of the 10 holes.

- R (3) Produce and deburr 10 holes in the No. 4 bearing seal support assembly.
R Refer to Figure 1, Sheet 1 for the location of the assembly. Refer to
R Figure 1, Sheets 2 thru 4 for the location of the 10 holes.
