V2500-A5/D5 SERIES PROPULSION SYSTEMS SERVICE BULLETIN

ENGINE – ACTUATING MECHANISM HP COMPRESSOR VARIABLE VANES – INTRODUCTION OF A STAGE 4
AND 5 CONNECTOR BRACKET LOCATION DOWELS WITH REDUCED LENGTH – REWORK

V2500-ENG-72-0444

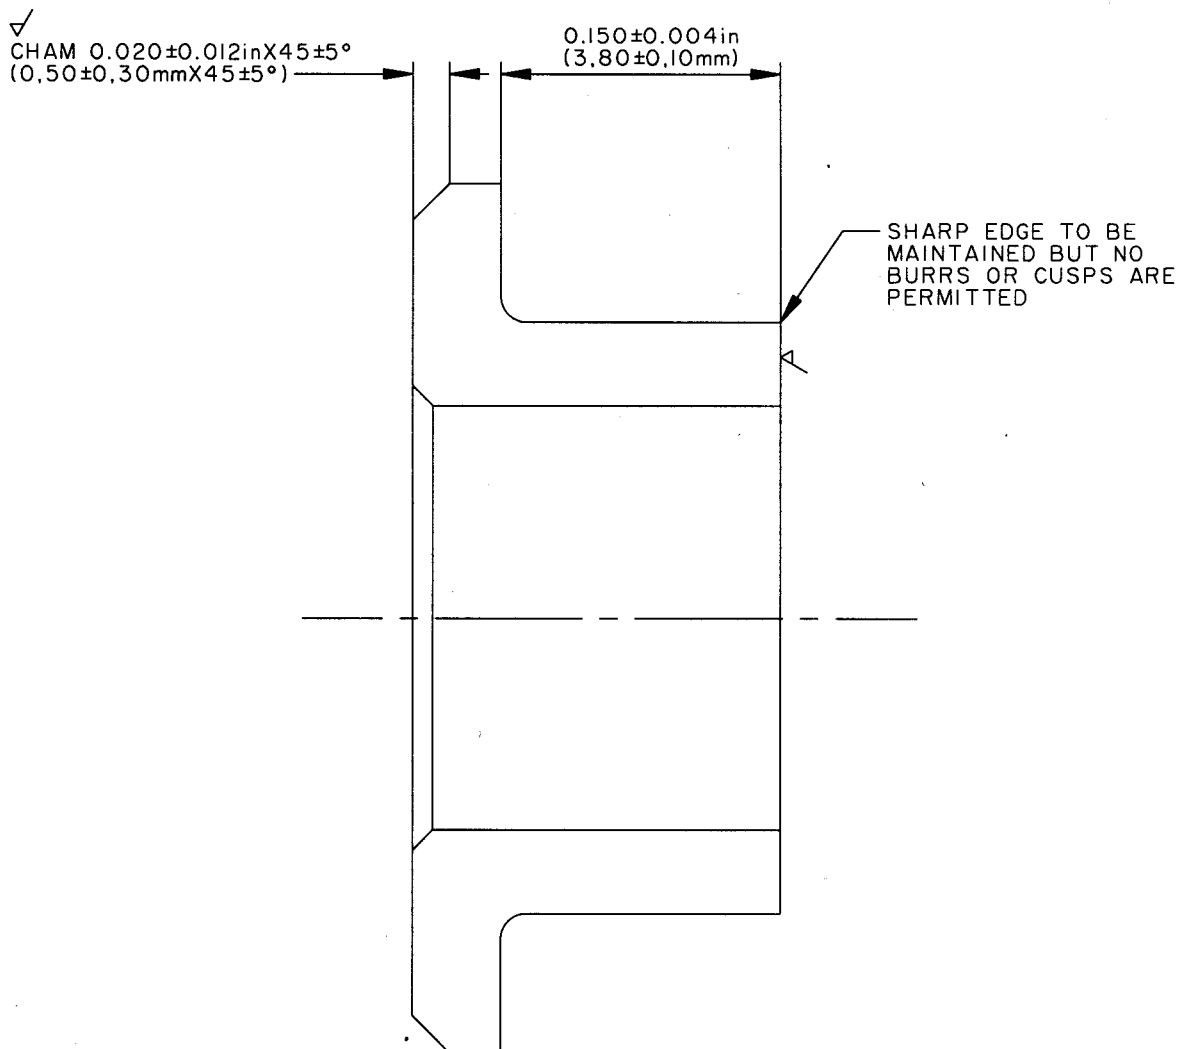
Rework of Dowel
Figure 1

Cracking of the Stage 4 and 5 VSV control rod brackets may occur. The problem has been attributed to the shank length of the locating dowel being too long. This causes fretting between the actuator bracket and the dowel, which in turn leads to fretting between the bracket and unison ring which results in high cycle fatigue.

- (a) A revised dowel is introduced, similar to the existing item except for a reduction in the maximum dowel shank length such that a minimum clearance of 0,1 mm. is maintained between the bottom of the dowel and the unison ring boss.

Refer to Figure 1 for new machining dimensions of the Location Dowel.

MACHINE WHERE SHOWN \checkmark
MACHINED SURFACE FINISH TO BE 125 MICROINCHES (3.2 MICROMETRES)
REMOVE THE SHARP EDGES $0.012 \pm 0.008 \text{ in}$ ($0.30 \pm 0.20 \text{ mm}$).
