**International Aero Engines  
NON-MODIFICATION  
SERVICE BULLETIN**

**ENGINE – HP COMPRESSOR, STAGE 6 ROTOR PATH - DUAL METCO 313 ENGINED AIRCRAFT  
- FLEET MANAGEMENT ACTIONS – NON-MODIFICATION SERVICE BULLETIN**

**V2500-A5 SERIES PROPULSION SYSTEM NON-MODIFICATION SERVICE BULLETIN**

**V2500-ENG-72-0445**

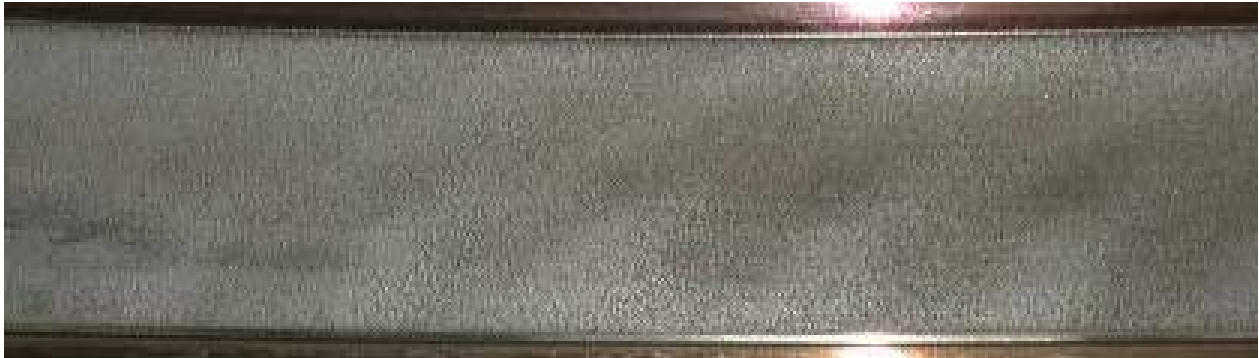
- A. Lining material sound and grey in colour or with light surface deposits, white in colour (Refer to Fig 1) – Acceptable.
- B. Missing topcoat not exposing basecoat. Remaining topcoat sound, without blistering or flaking (Refer to Fig 2) – Acceptable.

Fig 1 – Uniformly sound topcoat surface

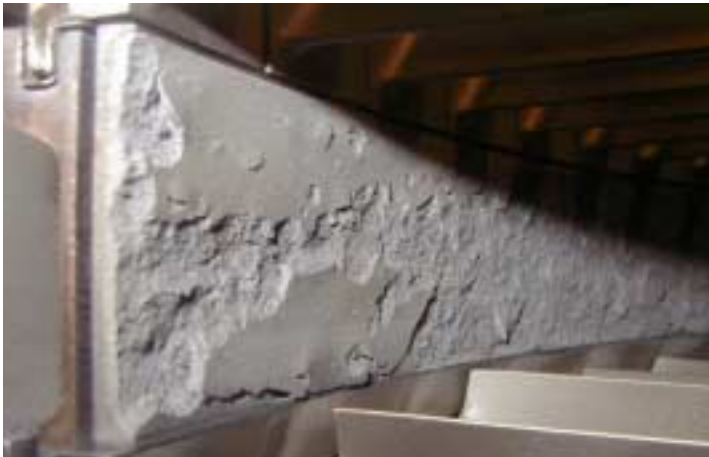
Fig 2 – Missing topcoat not exposing basecoat

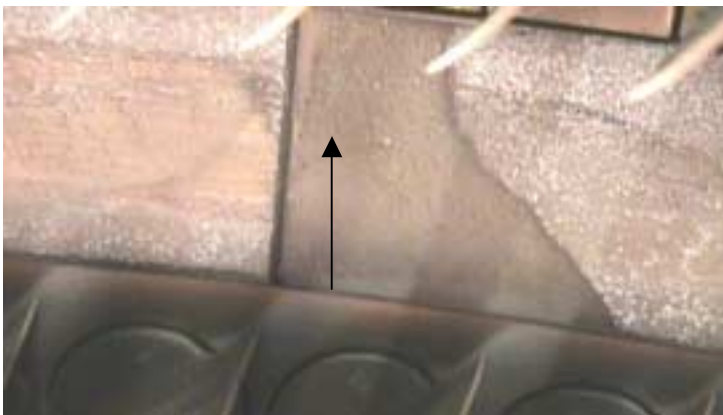
- C. Missing topcoat not exposing basecoat (Refer to Fig 3). Any areas of missing top coat up to 1 in<sup>2</sup> (645 mm<sup>2</sup>) each – Acceptable. Any areas of missing topcoat more than 1 in<sup>2</sup> (645 mm<sup>2</sup>) each – Unacceptable.

Fig 3 – Missing topcoat exposing basecoat

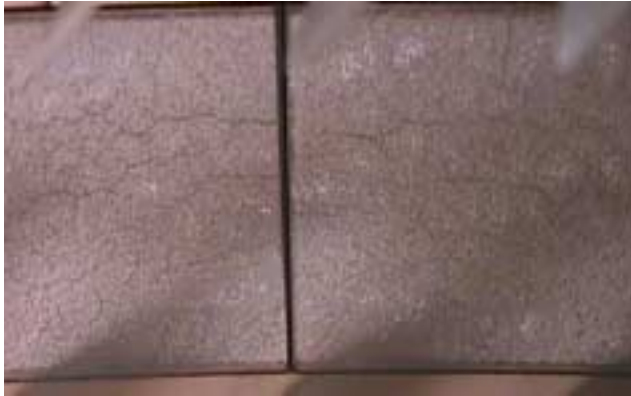
- D. Surface craze cracks with no missing material or lifting (Refer to Fig 4) - Accept. Large, open cracks – Unacceptable.
- E. Surface corrosion resulting in topcoat, lifting, blistering, bulging or swelling (Refer to Fig 5) – Unacceptable.

Fig 4 – Cracking of topcoat surface

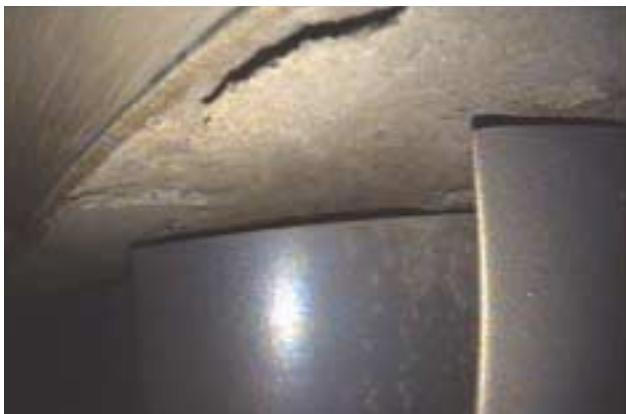
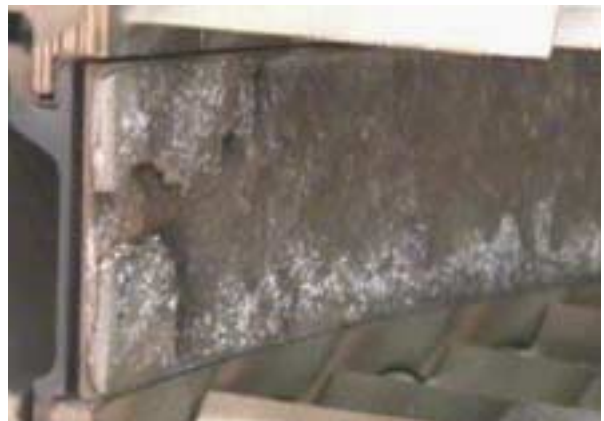
Figs 5 & 5a – Examples of corrosion related pitting, lifting, flaking or blistering of topcoat surface

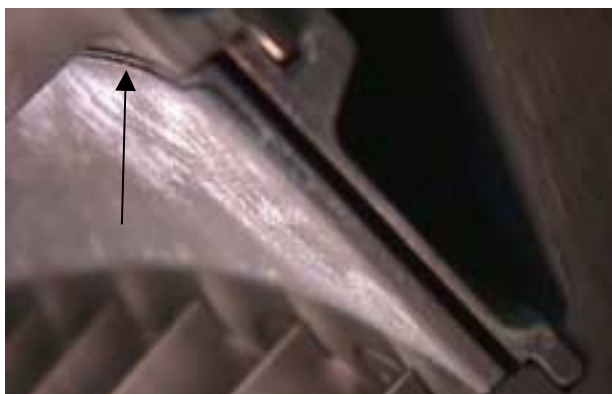
- F. Lifting/delamination. If there is evidence of delamination between the topcoat and bondcoat interface (Refer to Fig 6) – up to 1" (25 mm) circumferentially – Acceptable. More than 1" (25 mm) circumferentially – Unacceptable.

Fig 6– Delamination of topcoat/bondcoat interface
