V2500-A5 SERIES PROPULSION SYSTEM NON-MODIFICATION SERVICE BULLETIN

This document transmits the Initial Issue of Service Bulletin EV2500-72-0446

NON-MODIFICATION – ENGINE – INSPECTION OF TURBINE EXHAUST CASE LEADING EDGE PRESSURE
AND TEMPERATURE VANES

V2527-A5 Engine Serial Nos. V11324 and V11328

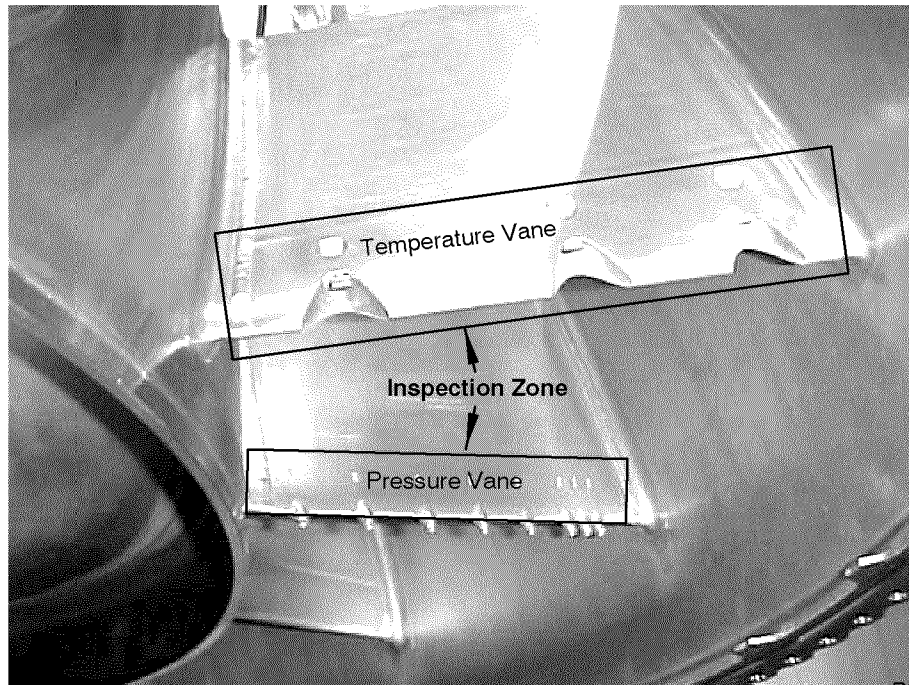
Turbine Exhaust Case – Inspection Zones
Figure 1

- (1) Problem: During manufacture of the Turbine Exhaust Case, the forgings used to fabricate the leading edges of the three Pressure strut vanes and the four temperature strut vanes may have been inadvertently produced from an incorrect material.

- (2) Background: The correct leading edge material is AMS 5616 (Greek Ascoloy). It has been confirmed that REX 734 forgings may have been used in two engines already in service, – V11324 and V11328. Engineering analysis has shown higher stress on the weld joint between the REX 734 and AMS 5616 due to the incompatibility of the materials. Cracking of this weld joint may affect the P4.9 reading resulting in the EEC switching to the N1 mode and generating a cockpit warning. Analysis has shown a B50 life of 2700 cycles to generate a 1/32 inch crack. This is not a Flight Safety issue.

- (1) Verify with a magnet that the leading edge of the three Pressure Strut Vanes, and four Temperature Strut Vanes exhibit magnetic properties. Suspect struts have a forged leading edge with either 'V' cuts or integral tubes protruding. Acceptable material will attract the magnet. Any questionable material can be further tested as follows:

- (viii) 5. When finished, turn the power switch to the center position marked 'OFF'. The unit should be plugged in as necessary to recharge the battery when using the DC operation.
- (b) If VANE tests prove material is not acceptable, remove engine prior to 2700 cycles.
 - (i) If any cracks are detected contact IAE for a detailed management plan.
- (2) Disposition.
 - (a) Report all results (Acceptable or Non-acceptable) to IAE.
- (3) Recording Instructions
 - (a) A record of accomplishment is required.
