**International Aero Engines
NON-MODIFICATION
SERVICE BULLETIN**

**ENGINE – HP COMPRESSOR, STAGE 6 ROTOR PATH - DUAL METCO 313 ENGINED
AIRCRAFT - FLEET MANAGEMENT ACTIONS – NON-MODIFICATION SERVICE
BULLETIN**

V2500-D5 SERIES PROPULSION SYSTEM NON-MODIFICATION SERVICE BULLETIN

This document transmits Revision 1 of Non-Modification Service Bulletin V2500-ENG-72-0448

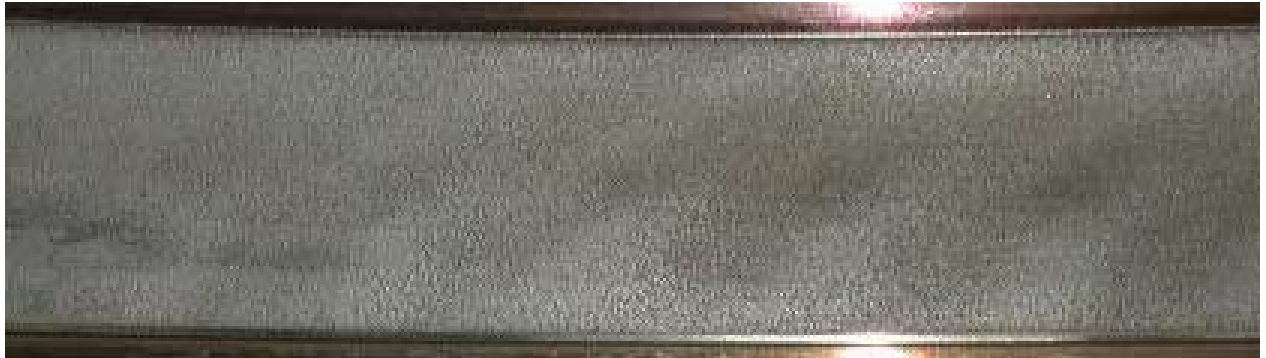
- A. Lining material sound and grey in colour or with light surface deposits, white in colour (Refer to Fig 1) – Acceptable.
- B. Missing topcoat not exposing basecoat. Remaining topcoat sound, without blistering or flaking (Refer to Fig 2) – Acceptable.

Fig 1 – Uniformly sound topcoat surface

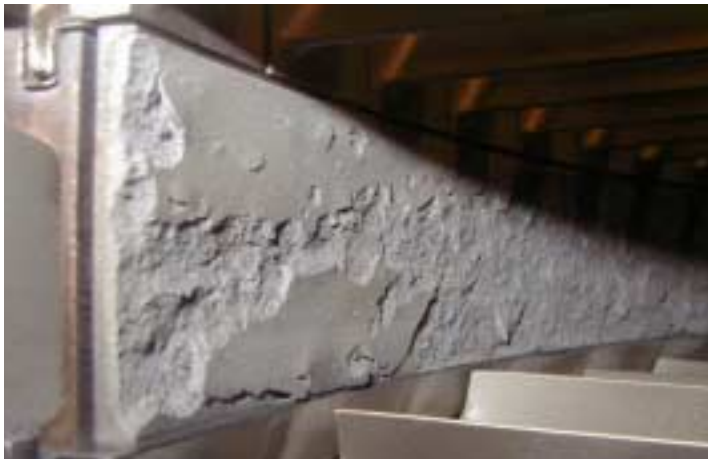
Fig 2 – Missing topcoat not exposing basecoat

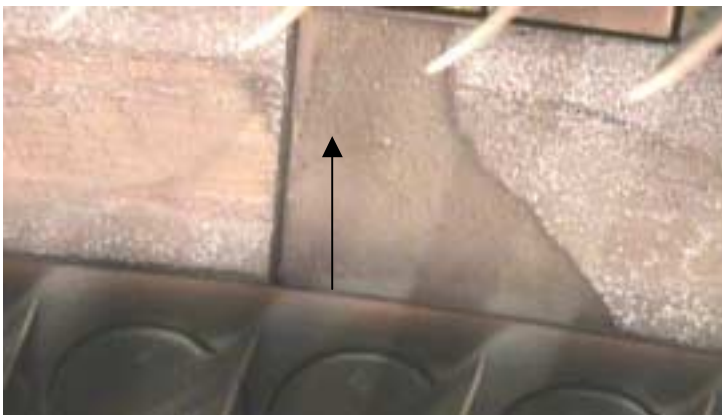
- C. Missing topcoat not exposing basecoat (Refer to Fig 3). Any areas of missing top coat up to 1 in² (645 mm²) each – Acceptable. Any areas of missing topcoat more than 1 in² (645 mm²) each – Unacceptable.

Fig 3 – Missing topcoat exposing basecoat

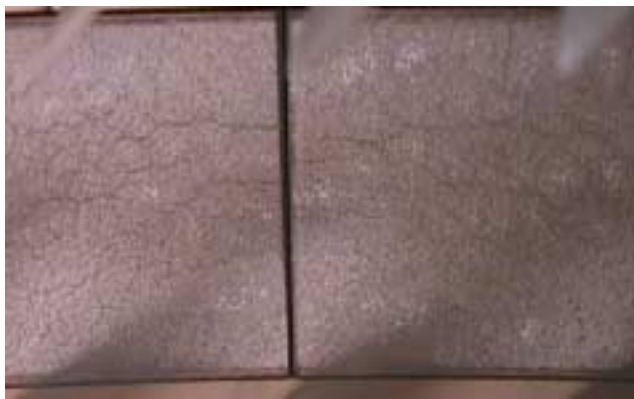
- D. Surface craze cracks with no missing material or lifting (Refer to Fig 4) - Accept. Large, open cracks – Unacceptable.
- E. Surface corrosion resulting in topcoat, lifting, blistering, bulging or swelling (Refer to Fig 5) – Unacceptable.

Fig 4 – Cracking of topcoat surface

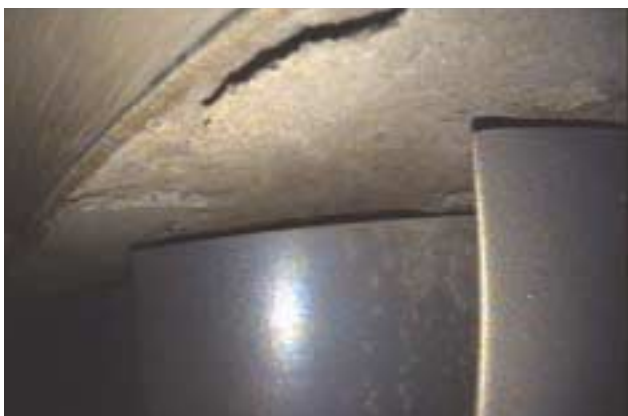
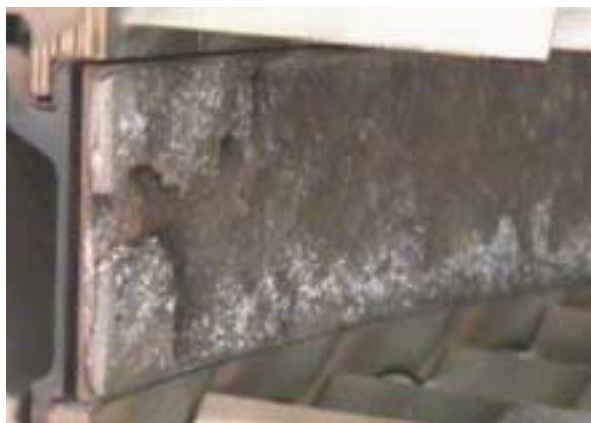
Figs 5 & 5a – Examples of corrosion related pitting, lifting, flaking or blistering of topcoat surface

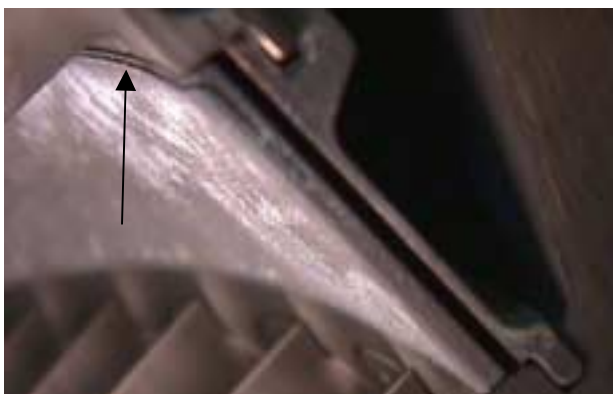
- F. Lifting/delamination. If there is evidence of delamination between the topcoat and bondcoat interface (Refer to Fig 6) – up to 1" (25 mm) circumferentially – Acceptable. More than 1" (25 mm) circumferentially – Unacceptable.

Fig 6– Delamination of topcoat/bondcoat interface
