V2500-A1 SERIES PROPULSION SYSTEM SERVICE BULLETIN

Bulletin Revision 3

V2500-ENG-72-0449

ENGINE – HP COMPRESSOR RING CASES – INTRODUCTION OF HPC STAGE 4 ROTOR PATH TRENCH
WITH INCREASED TIP CLEARANCE

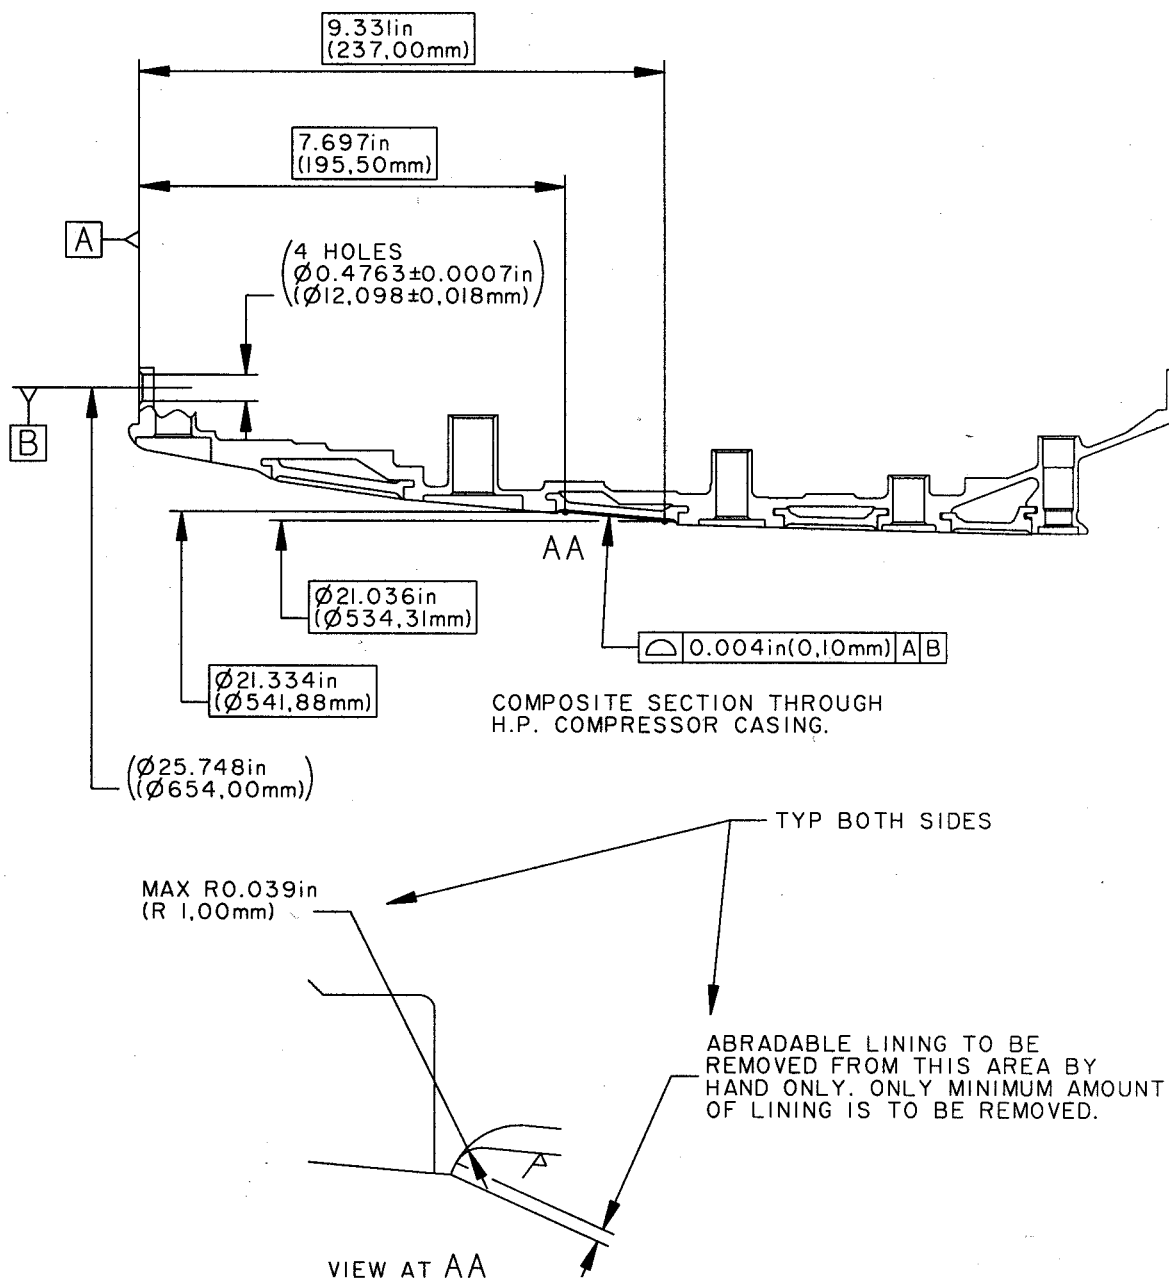
Assembly Instructions
Figure 1

NOTE: For Subtask 72-41-30-324-052-A00 Para 13.E, refer to Figure 1 of this Service Bulletin for dimensional profile of Stage 4 Rotor Path.

FOR ENGINES NOT INCORPORATING SB 72-0027

A trench has been introduced to the HPC Stage 4 Rotor path across the full axial width of the liner to a nominal depth of 0.040in. (1,016 mm.).

MACHINE WHERE MARKED ✓
MACHINED SURFACE FINISH TO BE 126 MICROINCHES (3.2 MICROMETRES).
THE GEOMETRIC SYMBOLS ARE AS GIVEN IN THE ISO MANUAL (R1101).

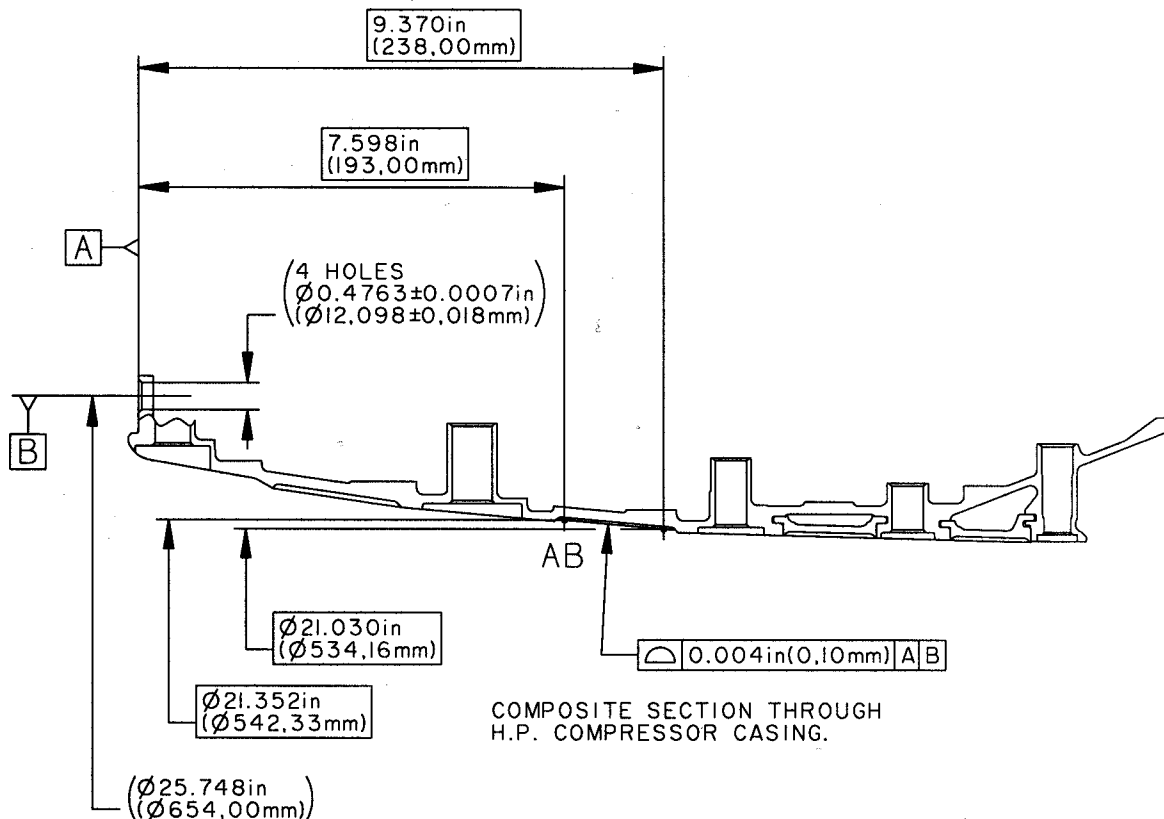
Assembly Instructions
Figure 2

For Subtask 72-41-30-324-052-B00 Para 14.E, refer to Figure 2 of this Service Bulletin for dimensional profile of Stage 4 Rotor Path.

FOR ENGINES INCORPORATING SB 72-0027

ABRADABLE LINING TO BE
REMOVED FROM THIS AREA BY
HAND ONLY. ONLY MINIMUM AMOUNT
OF LINING IS TO BE REMOVED.

MACHINE WHERE MARKED ✓
MACHINED SURFACE FINISH TO BE 126 MICROINCHES(3,2 MICROMETRES).
THE GEOMETRIC SYMBOLS ARE AS GIVEN IN THE ISO MANUAL (R1101).
