V2500-A1/A5 SERIES PROPULSION SYSTEM NON-MODIFICATION SERVICE BULLETIN

This document transmits the Initial Issue of Service Bulletin EV2500-72-0453

ENGINE - LP TURBINE INSPECTION OF LP TURBINE SHAFTS WHICH SUFFERED FROM INTERNAL FIRE
- NON-MODIFICATION SERVICE BULLETIN

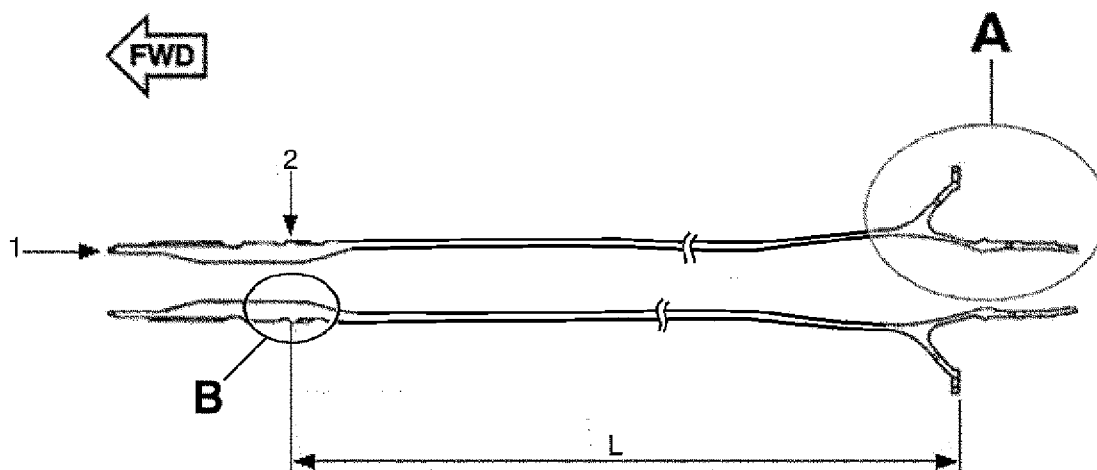
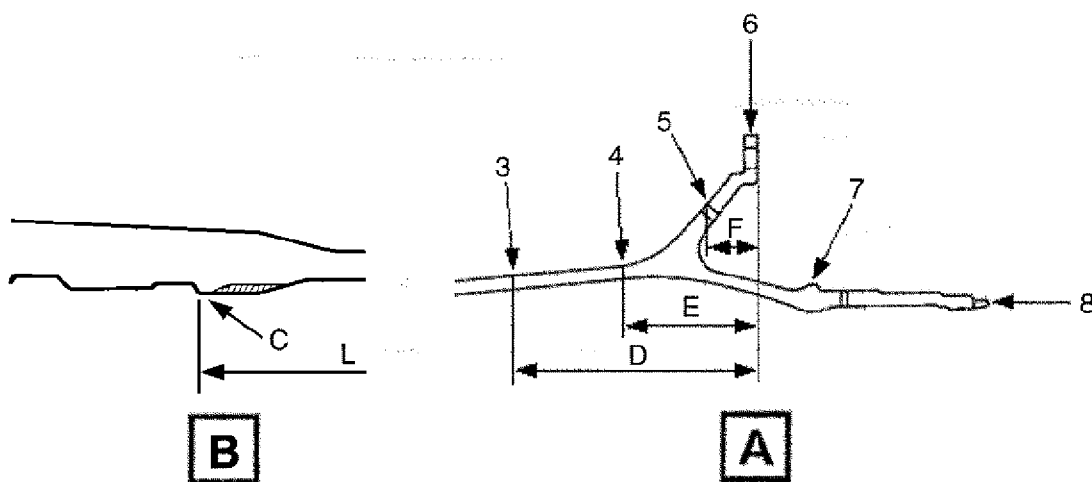
Requirements of Hardness and Dimensional Check
Figure 1

- (2) Identify the locations where hardness checks are done. Refer to Fig.1. Do not measure the hardness at the marked area of location 2 and 7.
- (3) Clean the shaft. Then, remove the corrosion resistant coating on the areas for the hardness check. Refer to EM 72-50-41 Cleaning.
- (4) Examine the LP Turbine Shaft for hardness.
 - (a) Do the hardness check at locations 1 thru 8. Use Vickers hardness tester. Each hardness check at locations 1 thru 8 must be measured circumferentially at 4 positions equally spaced. Record all data of the hardness on the data sheet of Appendix A.
 - (i) V2500-A1 V0168, V0210 and V0213:

Reject unless the hardness is between 377 HV and 420 HV.
 - (ii) V2500-A5 V10410:

Reject unless the hardness is between 406 HV and 454 HV.
 - (b) The indentations made by the above hardness check must be removed. Refer to EM 72-50-41 Repair 003 (VRS 1491).
- (5) Examine the LP Turbine Shaft for dimension
 - (a) Measure axial length L circumferentially at 8 positions equally spaced. Refer to Fig.1. Record all data of the length L on the data sheet of Appendix A.
 - (b) Do a check of Length J marked at location C. Refer to Fig.1. Record the data of Length J on the data sheet of Appendix A.
 - (c) Reject unless all measured length L are between Length J minus 0.0039 in. (0,1 mm.) and Length J plus 0.0039 in. (0,1 mm.).
- (6) Examine the LP Turbine Shaft. Refer to EM 72-50-41 Inspection.

5 IS THE AREA EXCEPT HOLES.

D : 6.38 TO 6.49 (162 TO 168)
E : 2.64 TO 2.87 (67,0 TO 73,0)
F : 1.03 TO 1.25 (26,0 TO 32,0)
