DATE: **Apr.28/03****V2500-A1/A5/D5 SERIES PROPULSION SYSTEM SERVICE BULLETIN**

This document transmits the Initial Issue of Service Bulletin EV2500-72-0455

ENGINE – PROVIDE NEW ADAPTER AND TUBE FOR DIFFUSER 10TH STAGE POSITIONS 72 AND 288 DEGREES

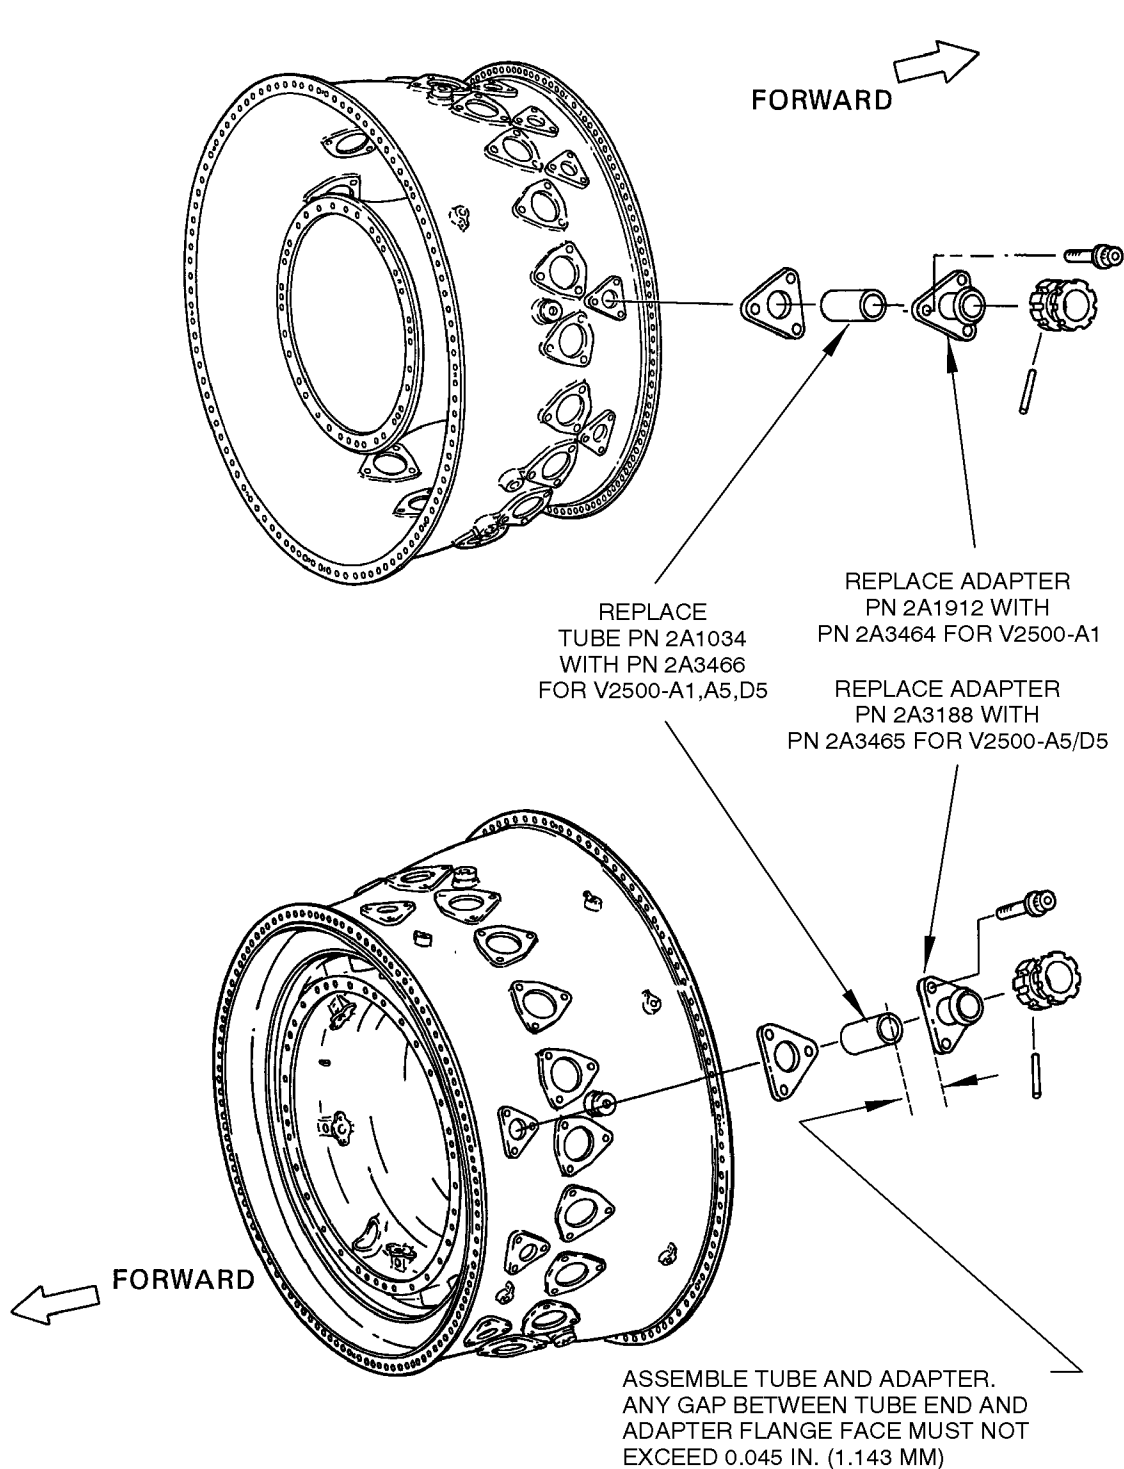
- (1) Problem: Air leakage has been detected at the Diffuser 10th Stage make-up air bosses during new engine testing.
- (2) Background: Tight fits between the 10th Stage make-up air diffuser hardware may not allow the mating Gasket to be properly sealed against the Diffuser Case boss. The resulting vibratory distress on the Gasket results in air leakage.

NUMBER 4 BEARING COMPARTMENT TUBE AND ADAPTER LOCATION REF. CATALOG SEQUENCE NO.
72-40-20-FIG. 06

(a) Replace Tube PN 2A1034 with PN 2A3466, see Figure 1.

(b) Replace Adapter PN 2A1912 with PN 2A3464, see Figure 1.

(c) After assembling the Adapter and Tube check for space between the adapter flange and the tube. This distance may not exceed 0.045 (1.143 mm).

(a) Replace Tube PN 2A1034 with PN 2A3466, see Figure 1

(b) Replace Adapter PN 2A3188 with PN 2A3465, see Figure 1.
