V2500-D5 SERIES PROPULSION SYSTEM NON-MODIFICATION SERVICE BULLETIN

This document transmits the Initial Issue of Service Bulletin EV2500-72-0457

ENGINE - LP COMPRESSOR FAN BLADES - DOVETAIL ROOT FLANK INSPECTION AND APPLICATION OF
DRY FILM LUBRICANT - NON-MODIFICATION SERVICE BULLETIN

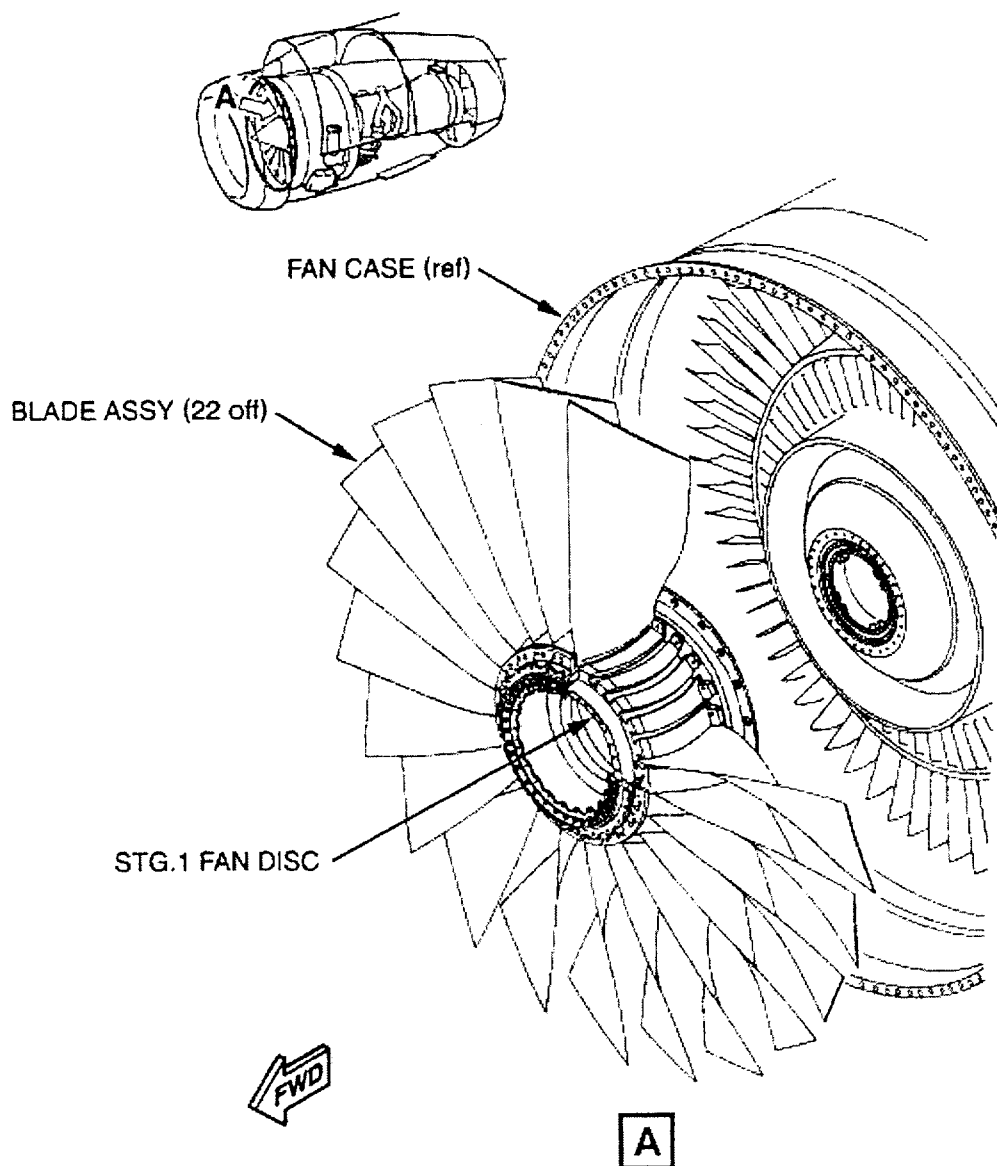
Location of blade assembly and Stage 1 fan disc
Fig.1

- (1) If the fan blade set has accumulated less than 2000 cycles since last inspection (ultrasonic, fluorescent penetrant or binocular):
 - (a) Remove the fan blades from the fan disc and inspect before the fan set life reaches 3000 cycles. Refer to Fig.1 and AMM, 72-31-11, Removal/Installation.
 - (b) Repeat at C Check intervals.
- (2) If the fan blade set has accumulated more than 2000 cycles since last inspection (ultrasonic, fluorescent penetrant or binocular):
 - (a) Remove the fan blades from the fan disc and inspect within 1000 cycles or the next C Check, whichever is the sooner.. Refer to Fig.1 and AMM, 72-31-11, Removal/Installation.
 - (b) Repeat at C Check intervals.

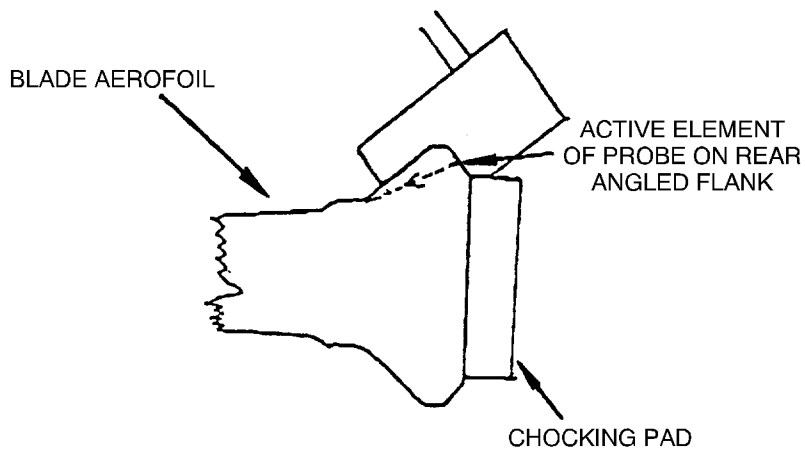
FIGURE 2

Position of probe on fan blade concave root flank
Fig.2

- (b) Apply the couplant to the concave face of the blade root flanks at the area to be inspected. Position the probe at the front of the leading edge of the concave blade root flank and move the probe along the first 2.4in. (60 mm.) of the chordal width of the blade root. (Refer to Fig. 2)

- (c) Monitor the signal very carefully as you move the probe over this area
- (d) Reject the blade if a signal greater than 60 percent screen height is produced between the 4.5 and 5.5 division lines on the time base

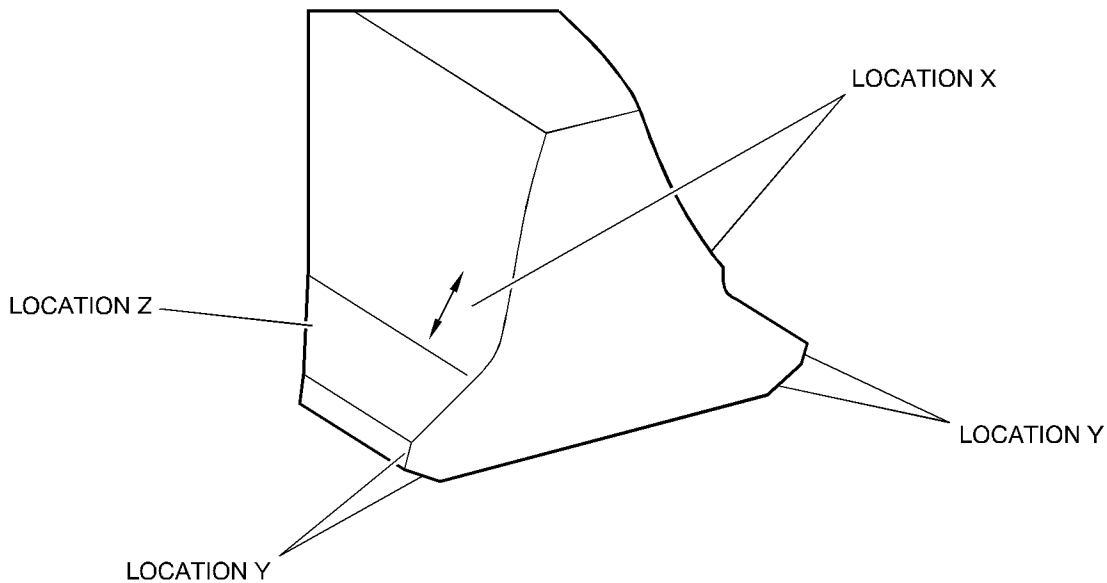
Removal of excess dry film lubricant
Fig.3

- 1) At the ultrasonic reject indication locations, on either the concave or the convex flanks, remove any excess Dry Film Lubricant (DFL) by lightly rubbing with 'Scotchbrite' using CoMat No 05-125 to 05-127 in the following areas:
 - above the top edge of the bedding (location X)
 - at the lower corner of the root where the ultrasonic probe locates (location Y)

CAUTION 1: On post SB 72-0375 and post SB72-0384 (Metco 58 coated root) fan blades it is essential not to "scotchbrite" the fan blade bedding surface (Location Z) as this will have a detrimental effect to the coating.

- 2) If excessive DFL is present, at location X and/or Y that cannot be removed by lightly rubbing with 'Scotchbrite' it is permissible to remove this using a non metallic scraper and then remove any loose residual DFL using 'Scotchbrite'

CAUTION 2: On post SB 72-0375 and post SB72-0384 (Metco 58 coated root) fan blades it is important not to damage the fan blade bedding surface (Location Z) when using a scraper

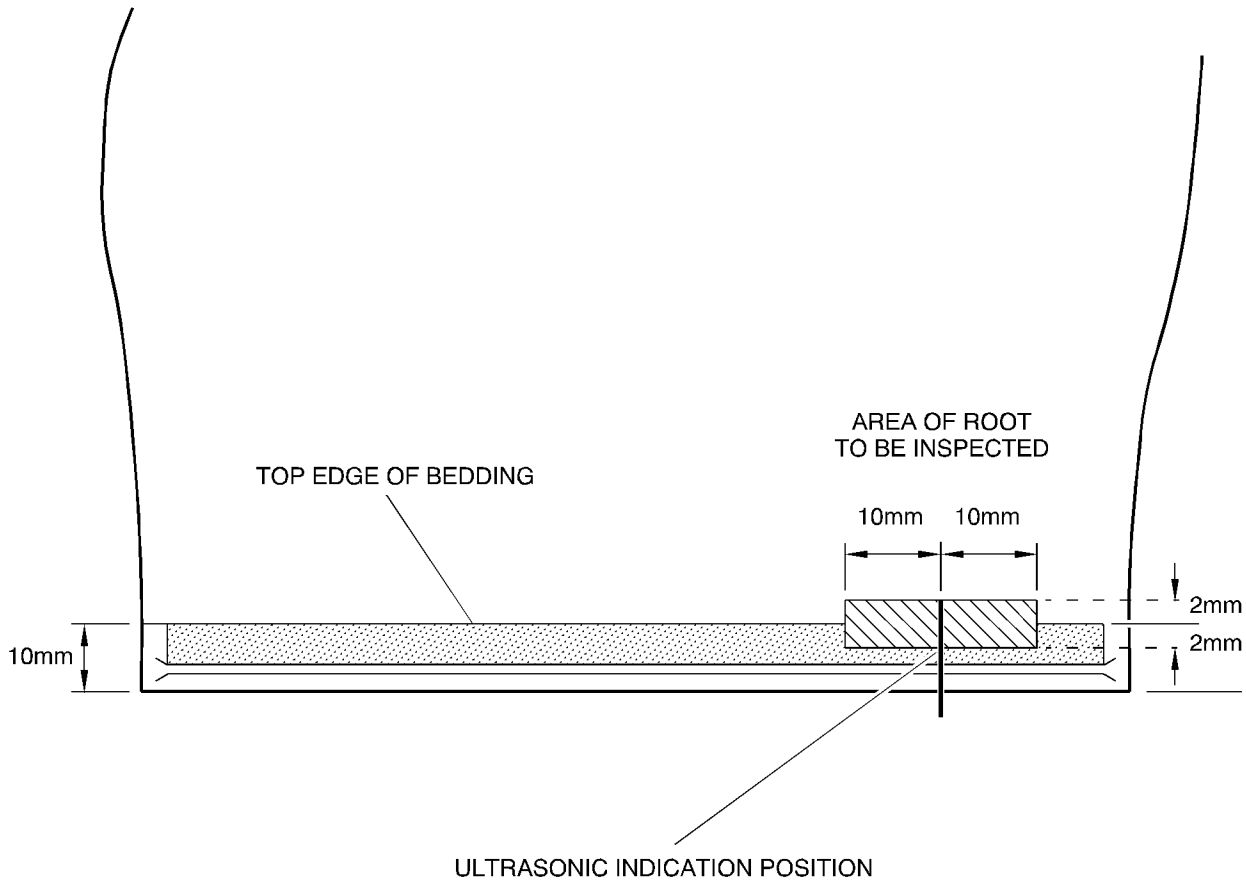
- (i) Reject any blade exhibiting a crack-like feature running axially along the root in the inspected region.
- (ii) Reject any blade exhibiting a 'scar' or crater-like feature.
- (iii) If no cracking is present it is recommended to record that inspection has been successfully completed. Prior to return to service the fan blade root must be re-coated with DFL (Refer to AMM, 72-31-11, VRS1030)

Inspection areas
Fig.4

- (i) Position the fan blade in mounting fixture to view the side of the fan blade root presenting an ultrasonic indication
- (ii) Adjust lamp to optimum illumination position for highlighting top edge of bedding at ultrasonic position. See Figure 4.
- (iii) Set magnification of binocular to x10 and bring the top edge of bedding at the ultrasonic indication position into focus. Adjust magnification to x30 and re-focus if necessary.
- (iv) Slowly traverse along the blade, inspecting the top edge of bedding 10 mm. either side of the ultrasonic indication position. See Figure 4.
